**DERBENDIKHAN HYDROPOWER STATION  
REHABILITATION WORKS FOR TURBINE UNIT NO. ٢  
RUNNER CRACKS REPAIR REPORT**

Project name	Derbendikhan hydropower station-rehabilitation works for turbine unit No.2- Runner cracks repair
Document title	Runner and draft tube inspection and welding procedure unit No.2 runner repair report.

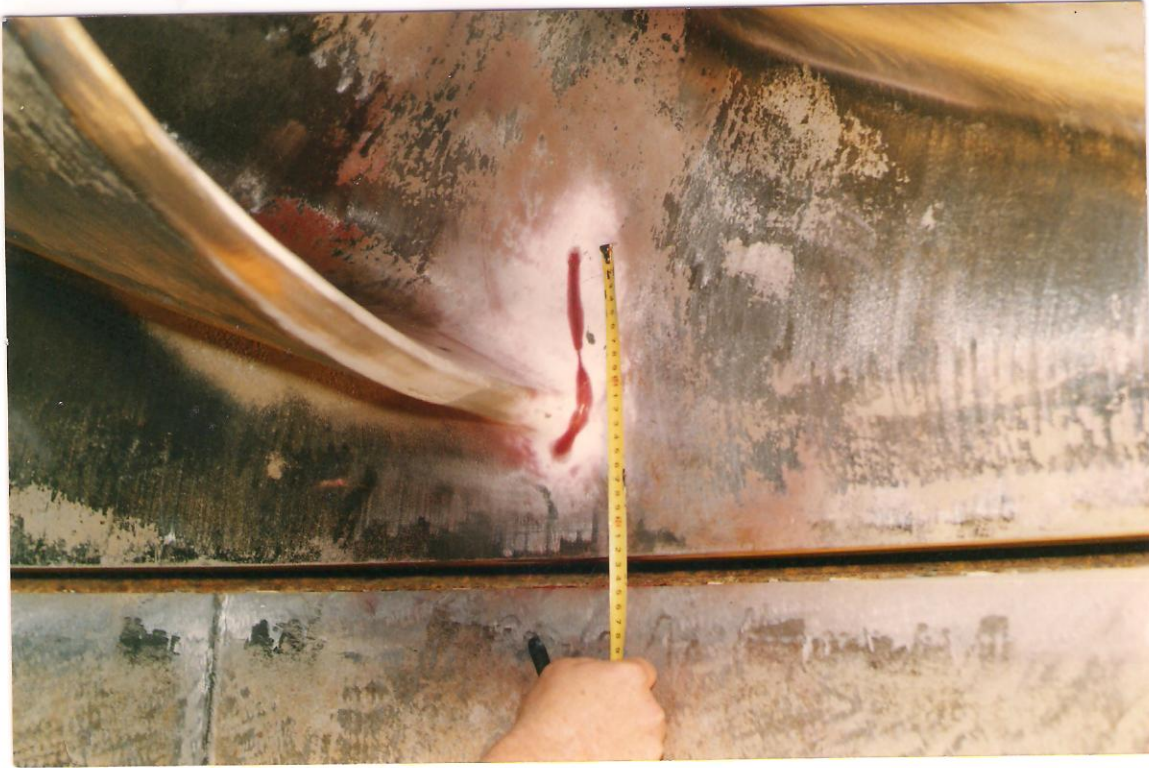
Blade 2 and skirt (plate 1)

BLADE	LOCATION	STRAIGHT LENGTH	STRING LENGTH followed loose string).	LINE (crack with)
No 2 and skirt (Ref plate 1)	Lower skirt	208 mm	278 mm	
Adjacent no 12 (ref plate 2)	Nose cone	386 mm	386 mm	outside nose cone.

The crack is at the trailing edge of the blade at the blade to the lowerskirt transition (welded joint and then vertically up into the skirt well away from the joint, straight line length 274mm.it may well be that the crack is full depth, but this would need to be determined by ultrasonic inspection technique or assessed during grinding apart of a repair procedure.

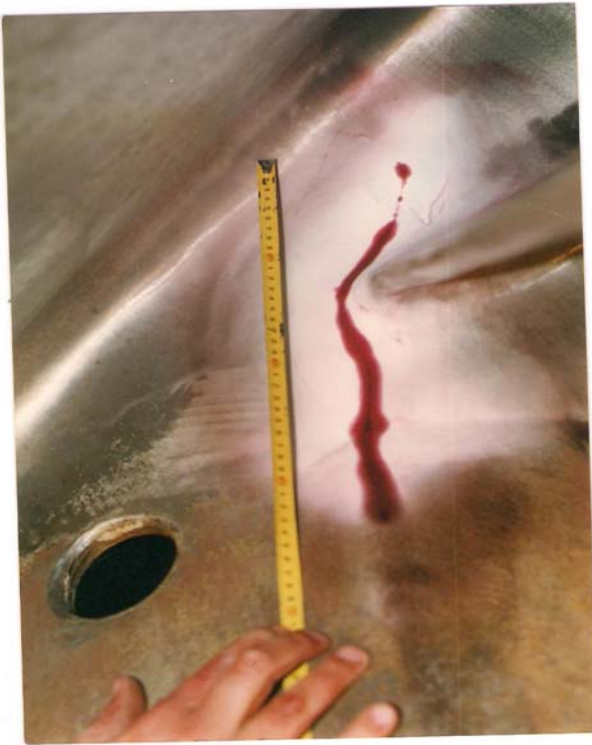
Outside nose cone adj. blade 12 (plate 2)

A large crack was clearly visible on the outside of the cone vertically beyond blade No 13 in the direction of blade No 12, this crack was also on the inside of the nose cone, indicating full depth cracking over the smaller length.

The crack is longer on the inside of the nose cone at 440 mm compared to on the outside at 206 mm. It is outside the transition of the welded joint between the blade and the nose cone and extends well above and well below this transition. It is not known where the vertical nose cone joint is (having been manufactured from plate).

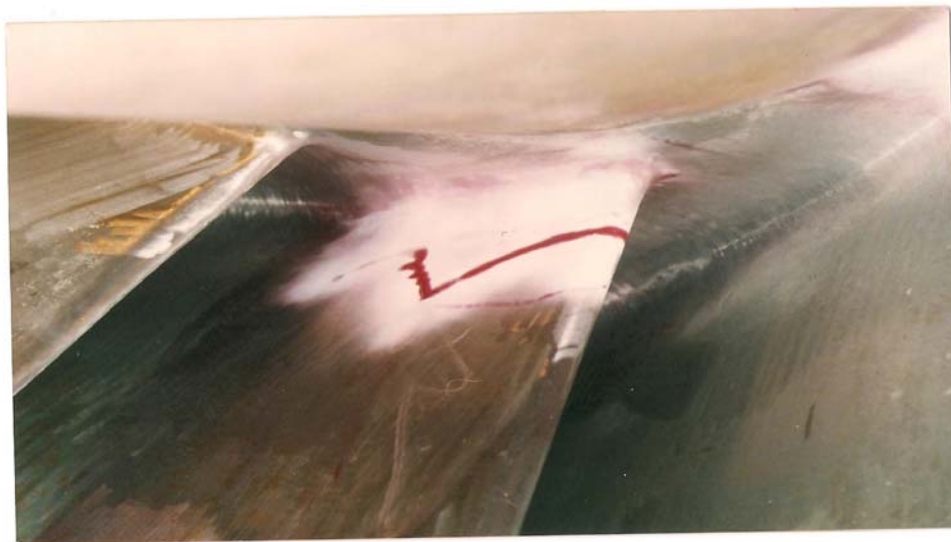
Blade ۱۳ on nose cone side (plate ۳)

Horizontally large crack was clearly visible in blade no 13 between the trailing edge and a point well towards midway back in to the blade, horizontally in a zigzag manner (veepattern) and near the top of the blade, (see plate 3a and plate 4).

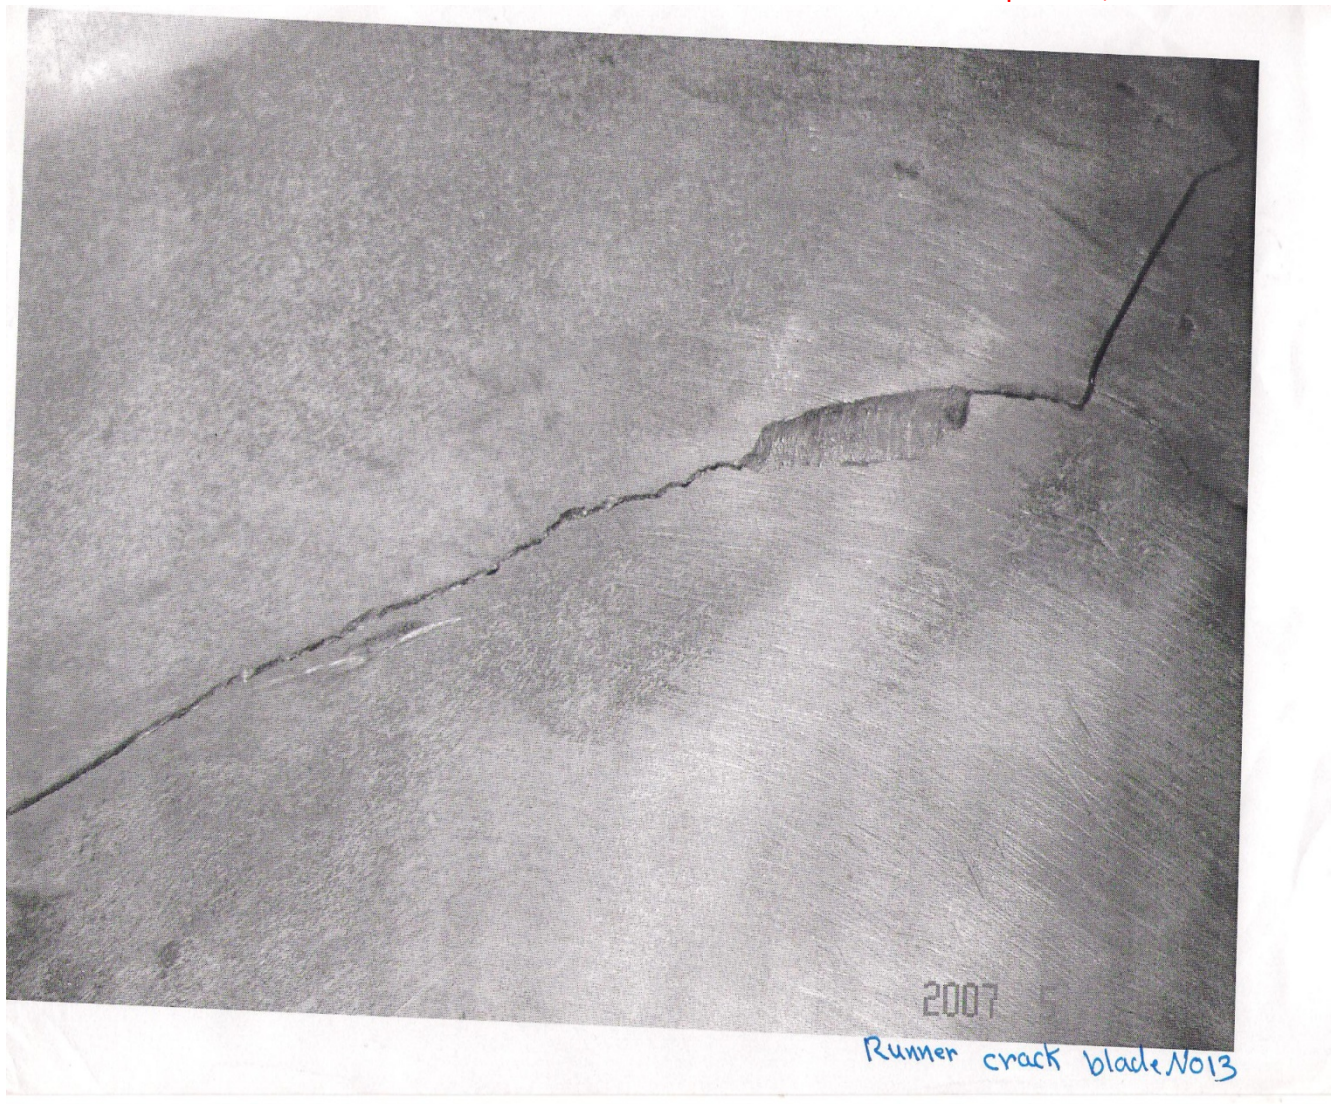
Blade No. 13 crack ( plate 4 )

This crack has a total actual length of 60.0mm (followed with loose string) on the nose cone side (see plate 4). The sharp change in direction is a significant phenomenon as if two separate cracks have been propagating at right angles and towards one another and have met. It is clearly trailing off towards the inlet edge the blade and the indistinct curve appears to be surficial rather than deep until the very end-not seen on the other side until this point. The camera was able to pick up the end mark but there was

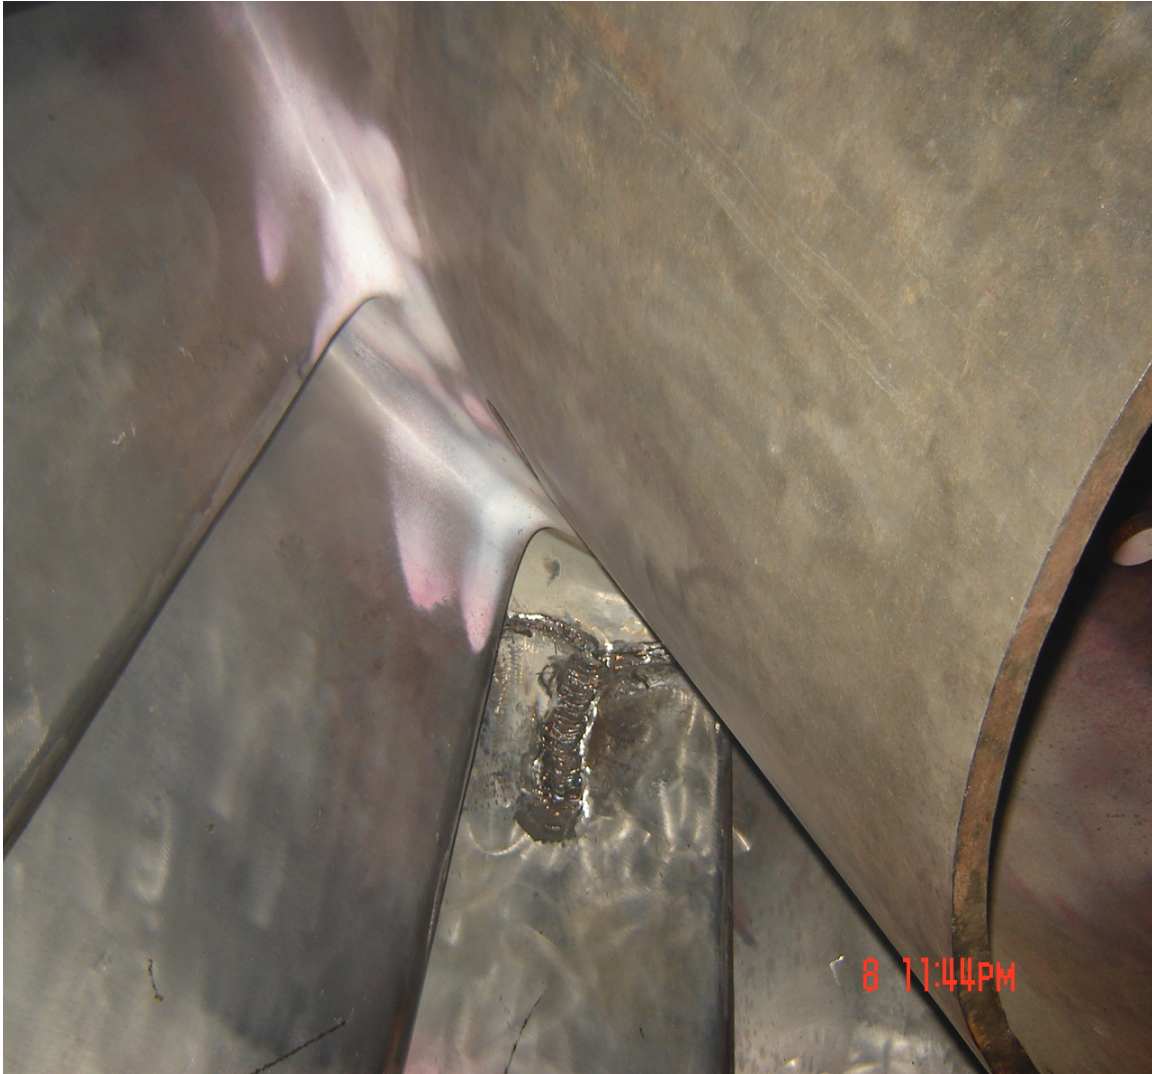
Blade No 10 crack ( plate )

The crack extends right around the trailing edge near to the nose cone joint. It continues 44mm from the trailing edge of the blade on the wicket gate side and 60mm from the trailing edge on the nose cone side, with a total length of 104mm (followed with loose string).

There is excess developer away from the crack which gives the impression of discontinuities in the surface. These do not exist.

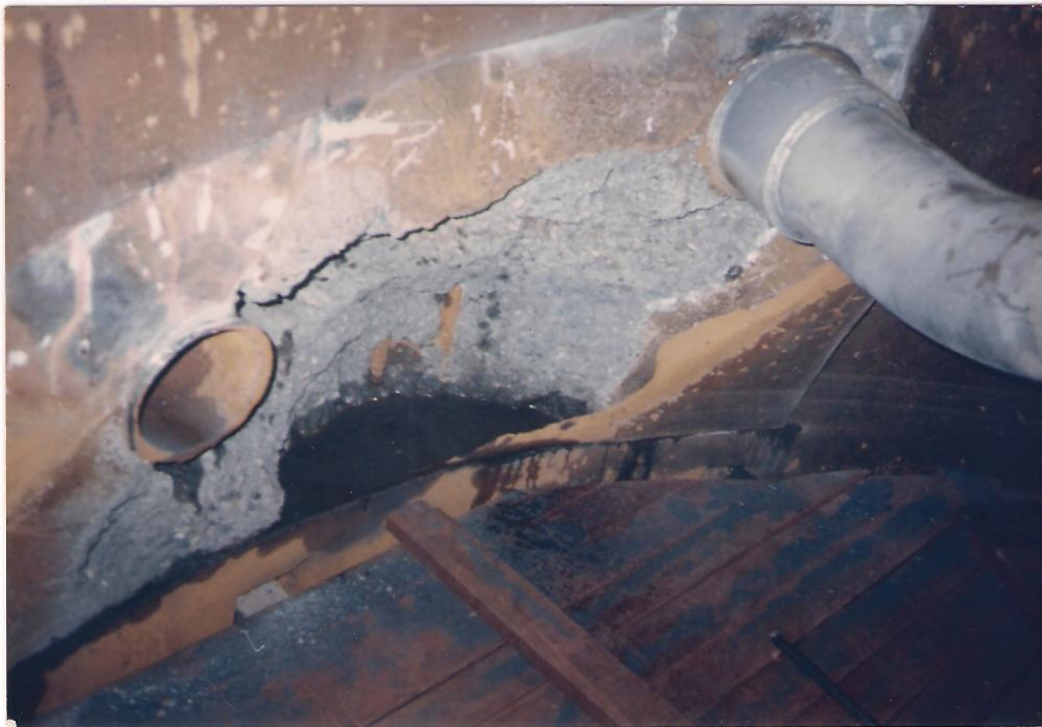
The worst part is near the first leg of the air admission pipe No.1 ( see plate 11 ), at the right of the entrance door. The heavy cavitations erosion at the bottom left has holed the plate and cavitations are now eroding the concrete in this area very deeply.

Heavy cavitation damage-liner holed in the wake of air admission pipe (plate 11)

- Repair by welding in new sections of plate, minimum, in the short term, perhaps including stainless steel overlays to better resist the cavitation prone areas.
- Establish adequate anchorage of the liner.
- Rerouting of voids behind the liner and the area (s) that have been affected by cavitation/water ingress.
- Application of a proven protective coating to manufacturer's specification including abrasive blast cleaning and coating build under correct application condition is also required as soon as possible.

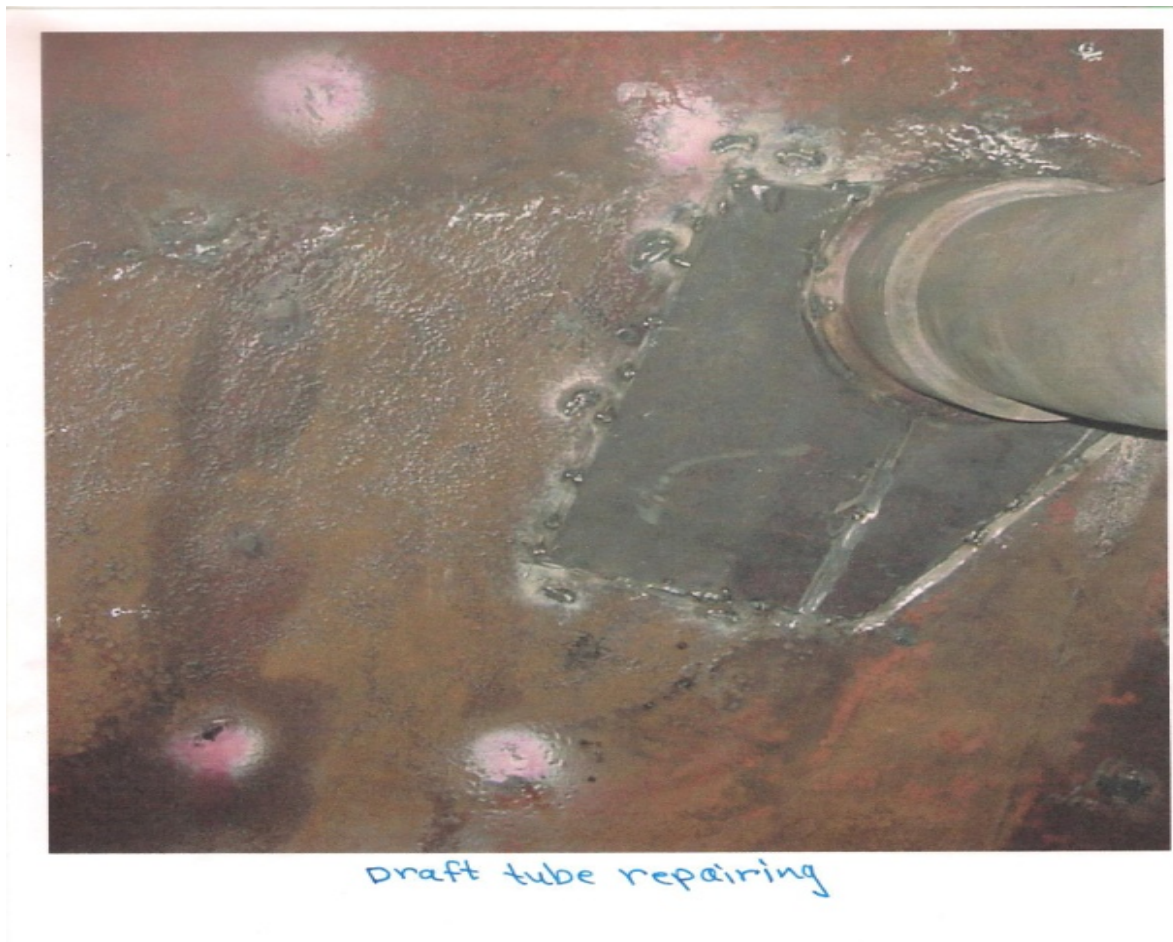
Draft tube repairing (plate 12)

The transition area between the stainless steel and carbon steel sections is in poor condition (see plate 12) and exhibits cavitation erosion by small holes in areas through to the concrete, right around the draft tube to approximately 11 cm below the weld join.

In this area, the liner plate appears to be about 3 mm thick which is considered inadequate for the required service. The implication is that this section of draft tube liner was no more than 3 mm thick when installed as has been suggested on previous occasions for unit 1 during its repair under the HECEC contract.
