Assessment report of a R.C. retaining wall in Sulaymaniyah area/ Kurdistan Region.

Assessment and consultation report prepared by Smko A. AL-Daoudi B.Sc&M.Eng C.Eng.

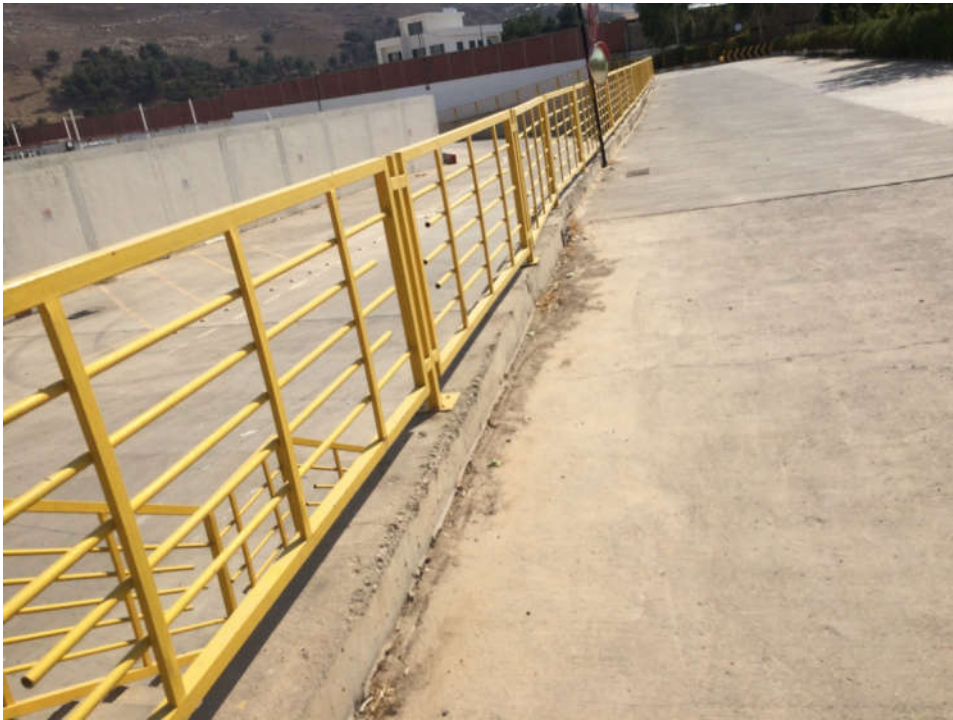
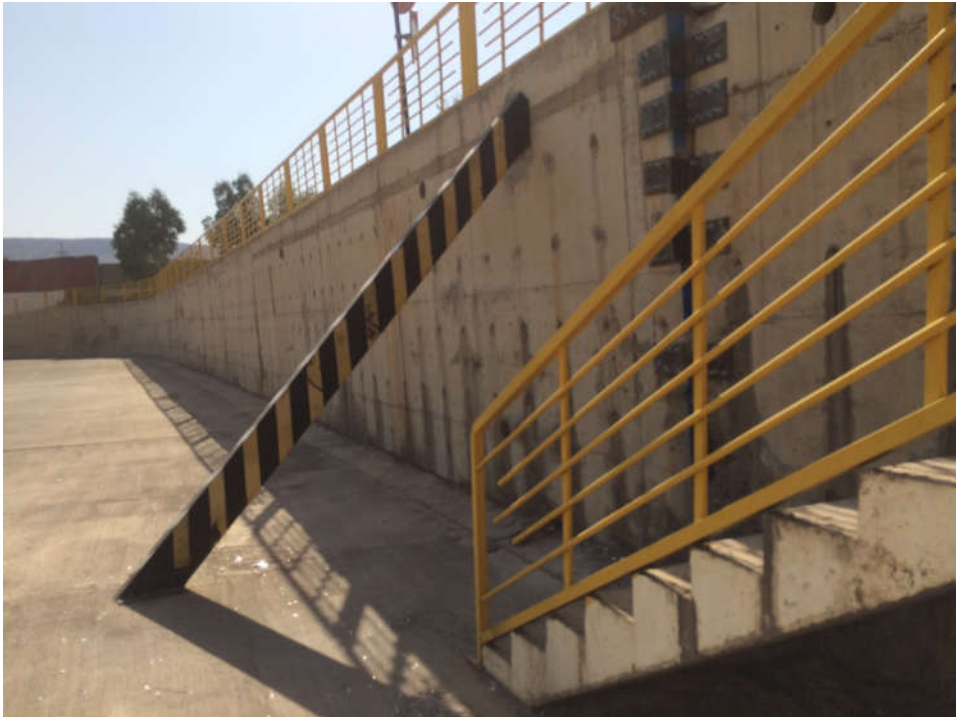
Figure 1

On September 8 2021 a site visit had been conducted to the site of an old built distressed retaining wall. The wall is reinforced concrete cantilever wall supporting a rigid paved road inside a functioning factory (Figure1& Figure2). This assessment aims to inspect the distress of referred structure and elaboration of the reasons and proposed solutions about the deterioration of the mentioned structure. Afterward, looking for, alterations that may reverse the wall condition positively. No destructive and non-destructive tests performed and the assessment totally relied on visual inspection and evaluation of attendants interviews. Worth to say, this structure does not have any project profile and history that may essentially enhance us in implementing our assessment properly, therefore, some assumptions adopted in this report for analyzing purpose.

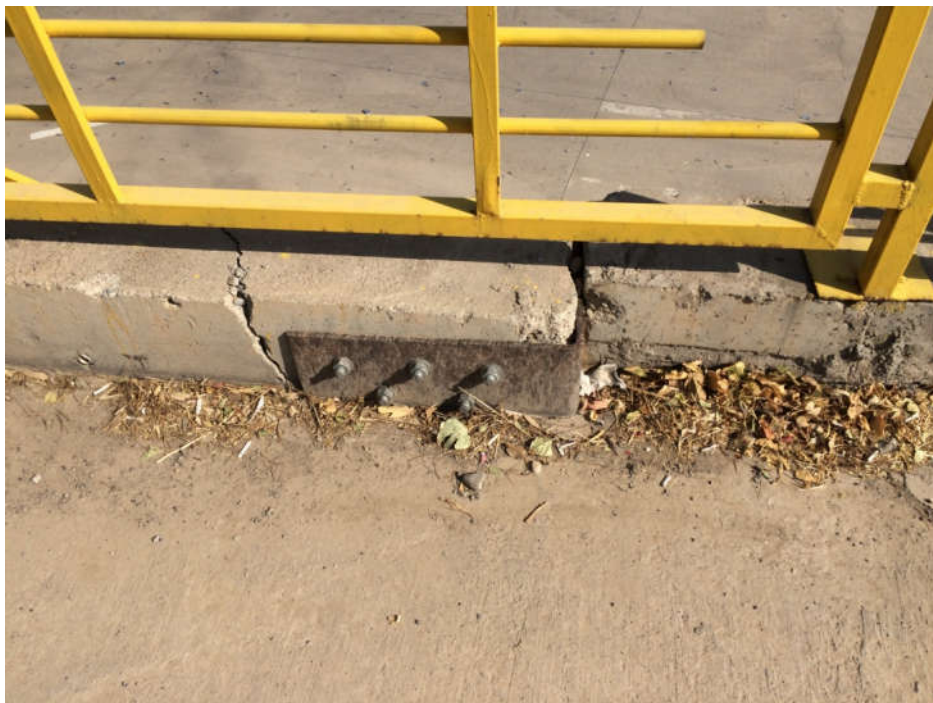
Figure 3

The defected concrete wall is about 43.9m length and 0.3m thickness at the top and the height varies from 3.3m to 3.42m without clear information about the hidden parts of the wall due to lack of project file for previous works regarding of this structure. However, some precautions previously applied to this concrete wall, in order to maintain it and prevent it from collapse. But, it did not work adequately and couldn't stop the structure failure as we can see in (Figure3). The bolted steel plate, pulled up the crest of approached concrete wall and caused serious failure in the location that had been adhered to.

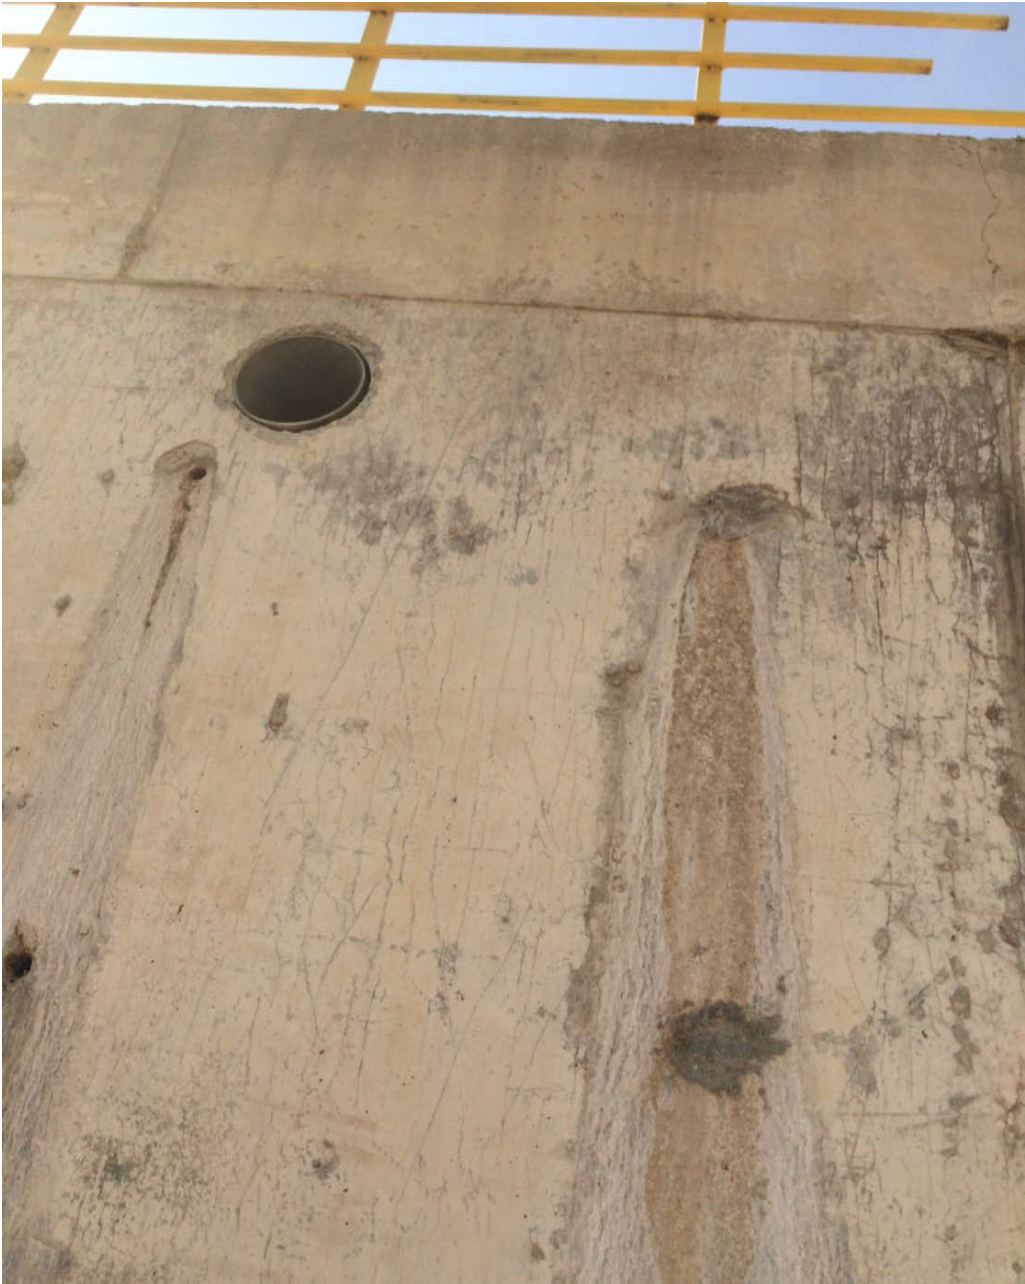
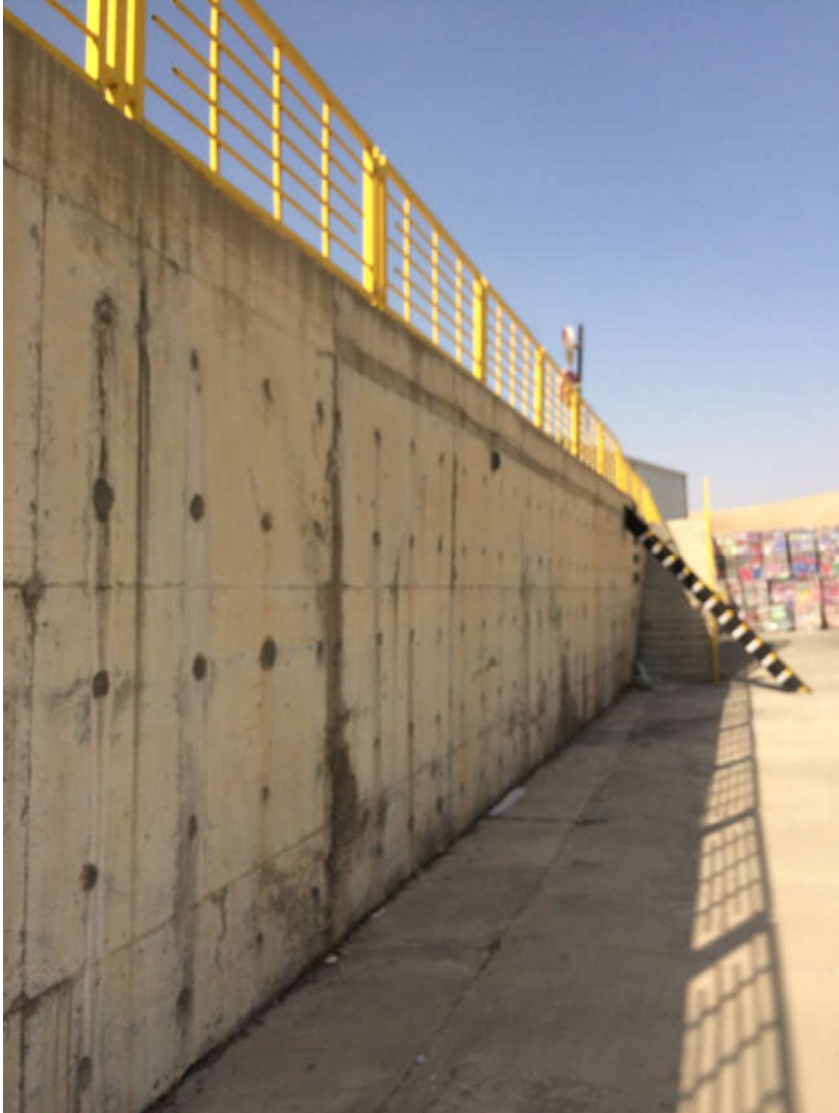
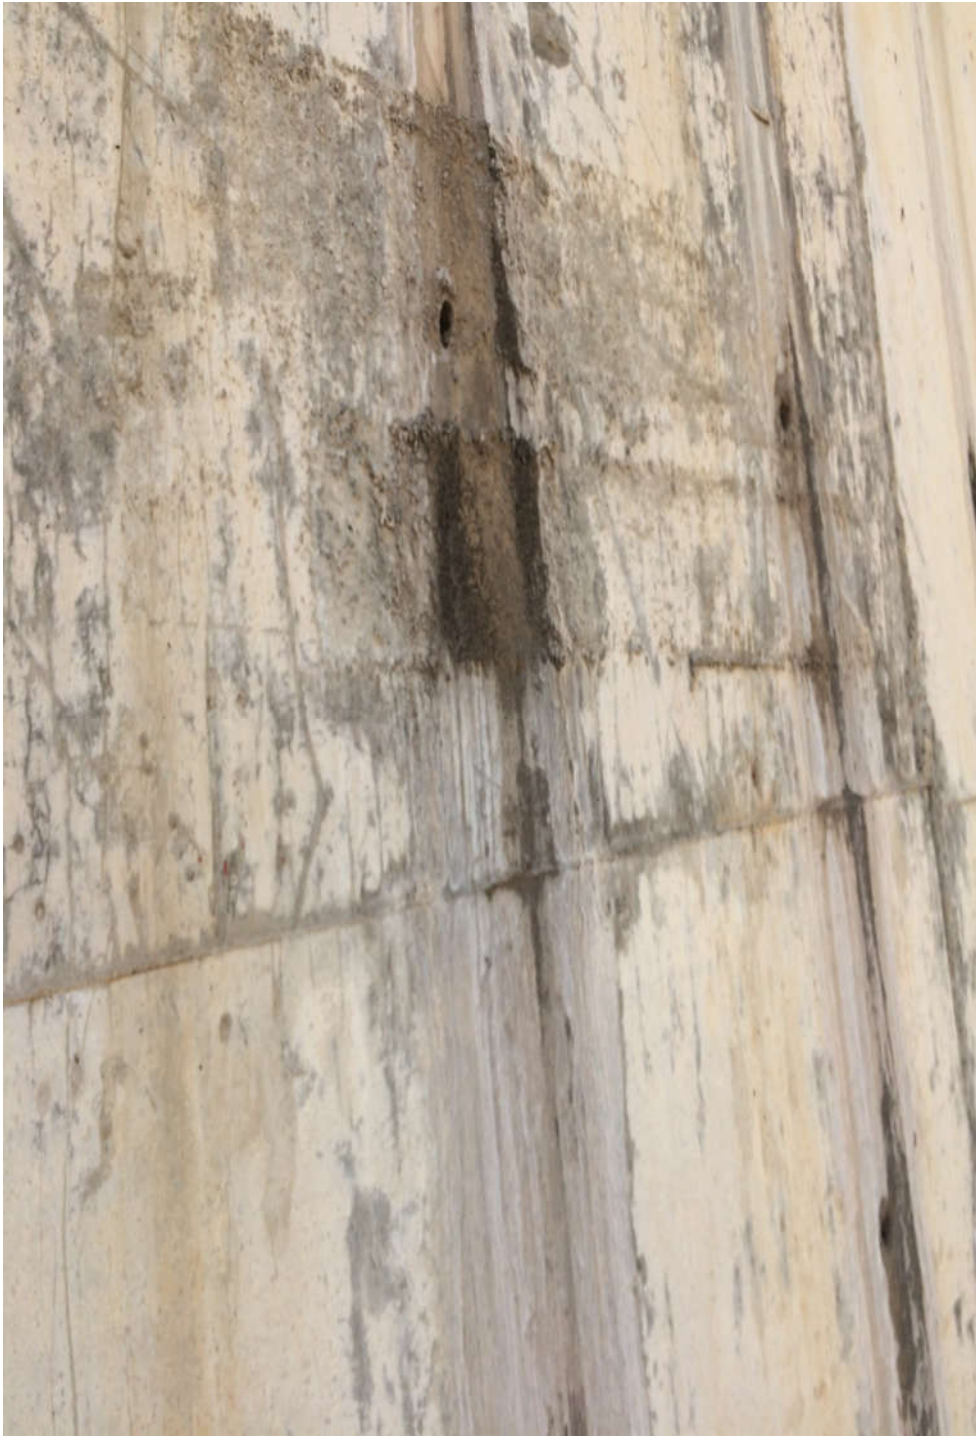
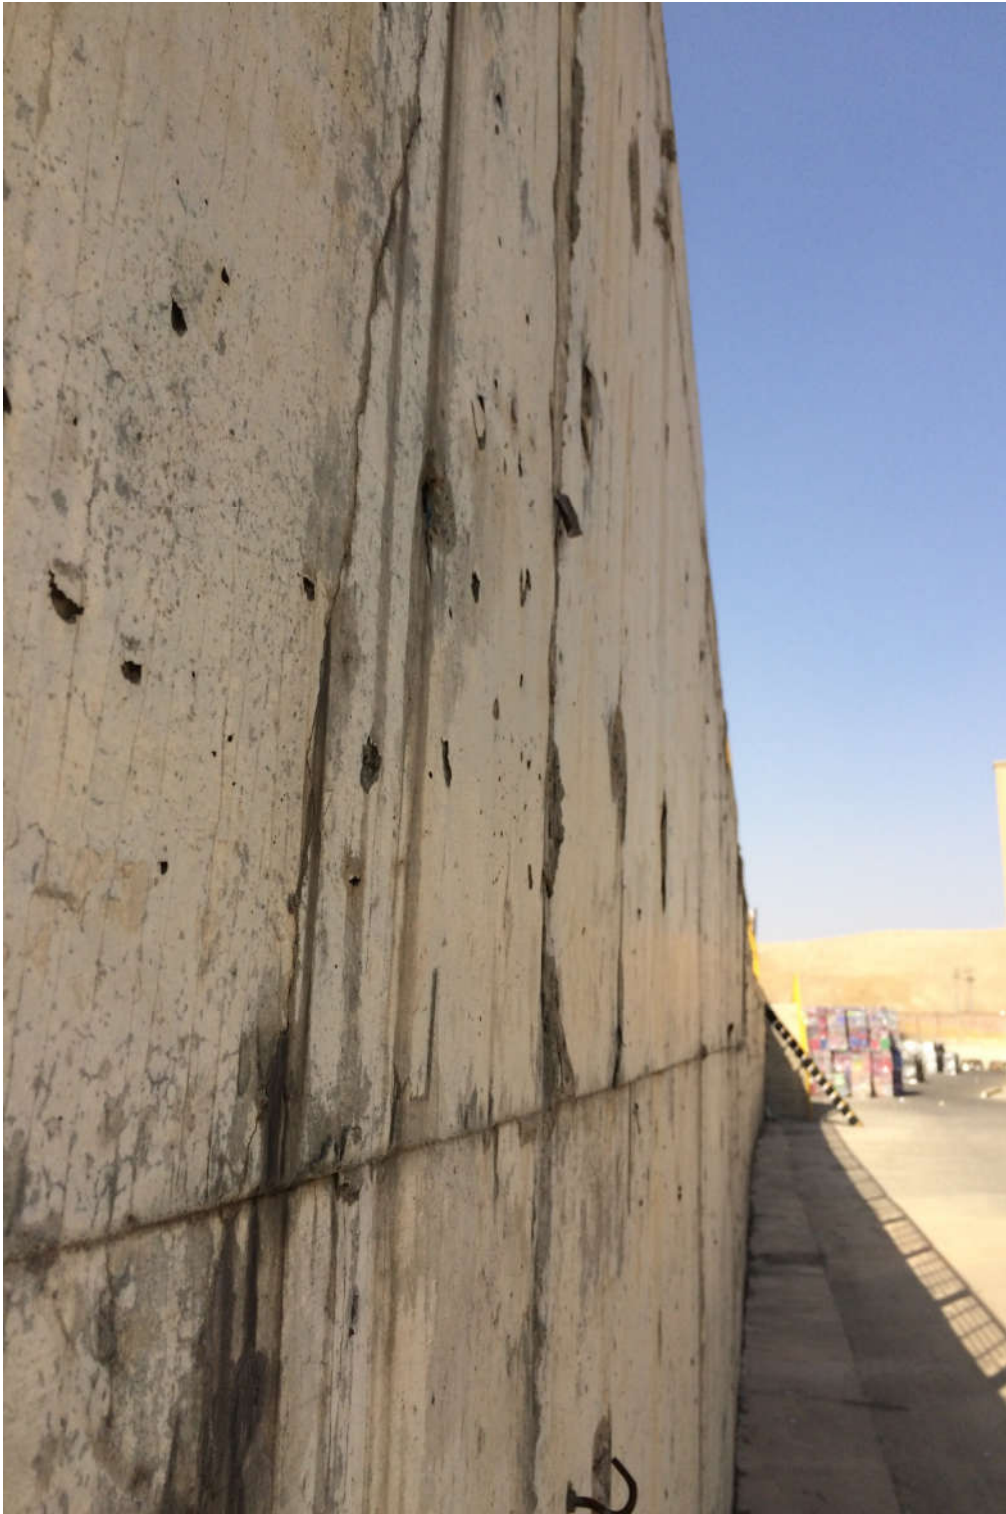
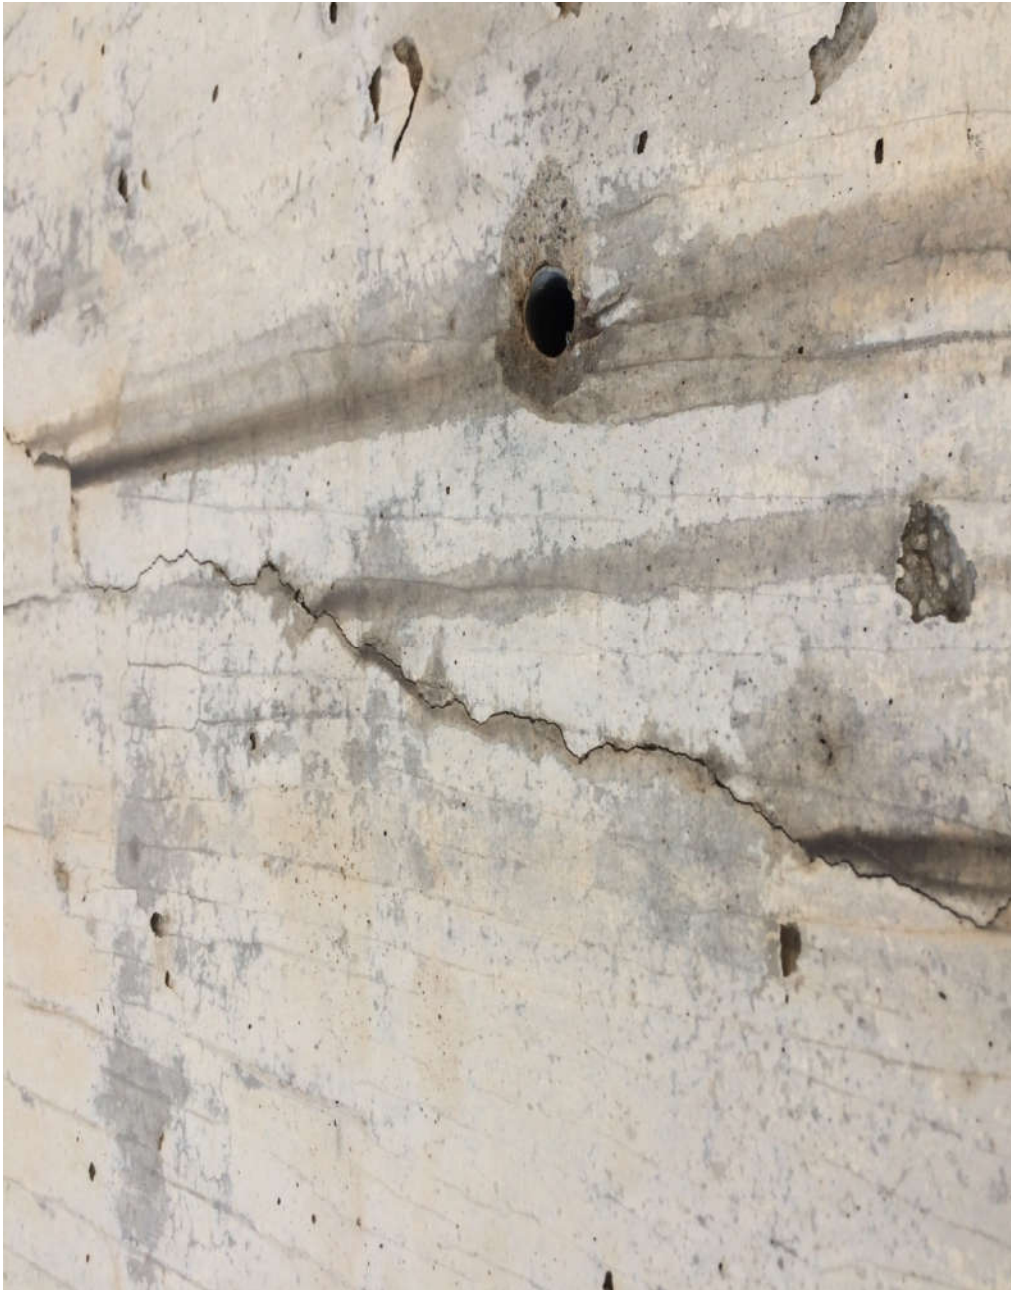
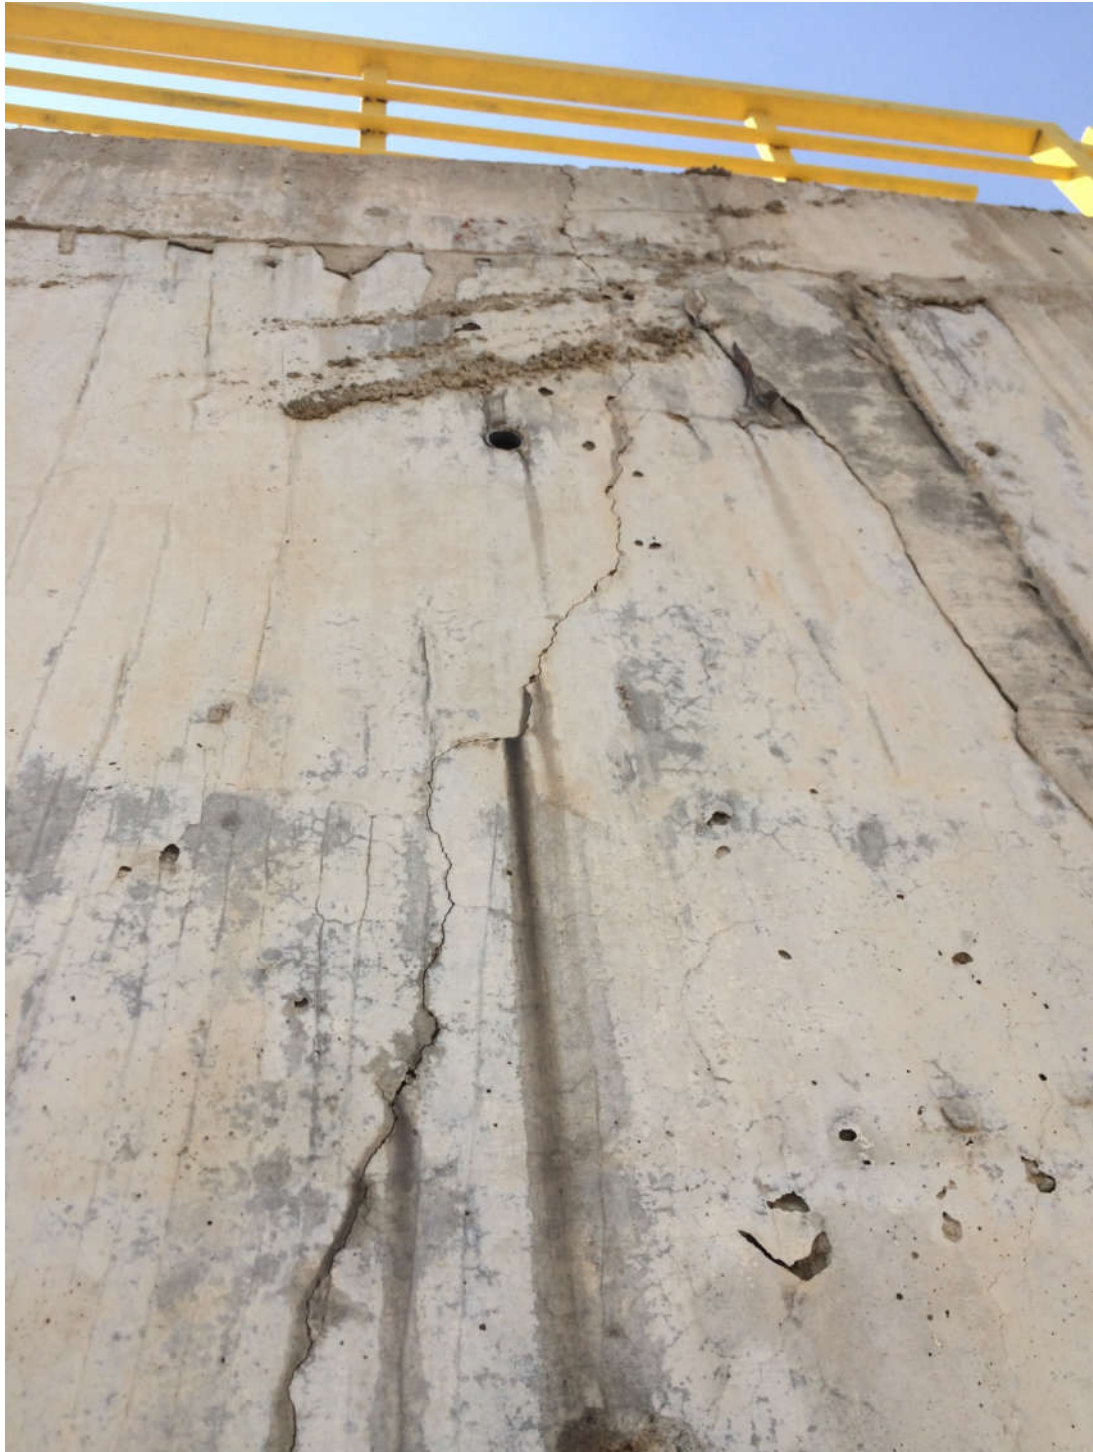
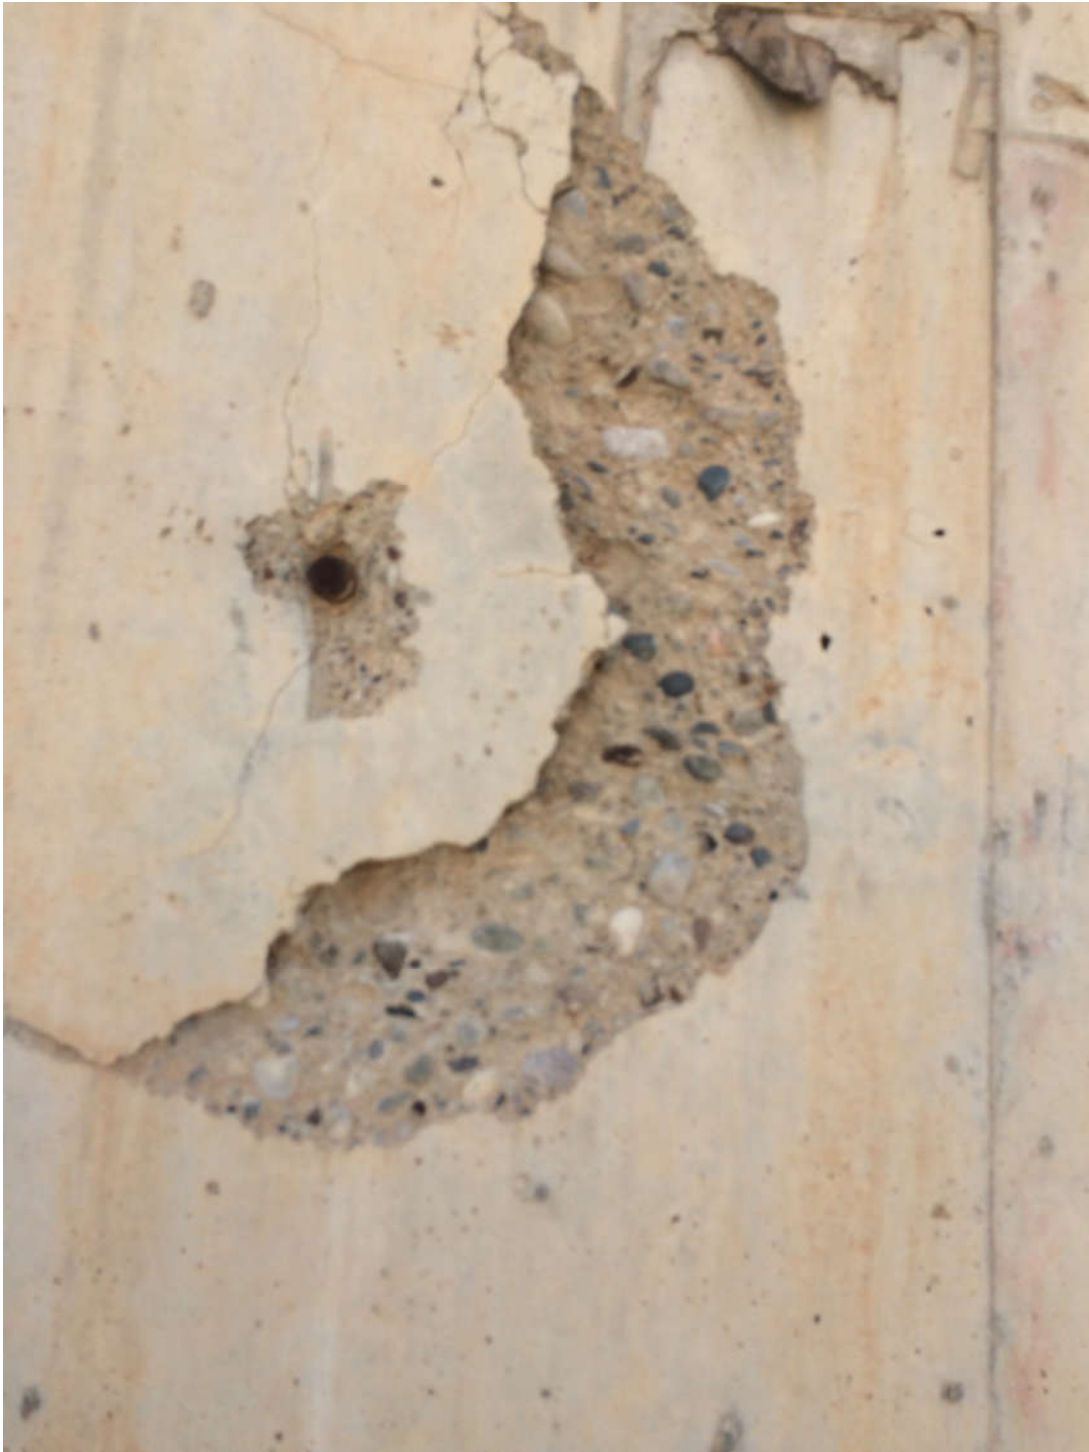
The modes of failure may be summarized in the following set and see (Figures 4,5,6,7,8,9,10);

- 1- Lack of design including:

- a- Steel details
- b- Dimensions
- c- Concrete grade
- d- Drainage distribution defect.
- e- Lack of granular material behind of the wall.
- 2- Deterioration of concrete wall due to high water pressure behind the wall.
- 3- Cracks
- 4- Spalling

- 1- Because of the severe deterioration of mentioned above concrete. It may be better to remove it and demolish the existed concrete wall, and replace it with another reinforced concrete wall with adequate design and implementation under proper quality control.

- 2- Rehabilitation and repairment, can be applied successfully to the mentioned above defected concrete wall under good safety circumstances and precautions during the repairment process. It can be made according to the following procedure:

- A- Construction of a new reinforced concrete wall as support wall with a certain grade of at least C30 for sever environment. According to attached design with distance gap of 2m, through the length of the old concrete wall from down street side or in front of the defected wall with adherence to certain methods of implementations. Which will be instructed during the detailed design and construction process.

- B- Apply of certain I shape steel members in interval among the support wall three for each distance gap of 2m, so as to prevent the wall form deflection to outward and according to the design.

- C- Apply of new drainage openings in the important spots with not more than 3m intervals, in order to drop down the water pressure behind and beneath the existed wall.
- D- Repair of the serious cracks and defected spots with special construction materials.
- E- Apply of three layers of plastic paint to the defected wall completely, in order to overcome the wetness from entering the cover part of concrete.

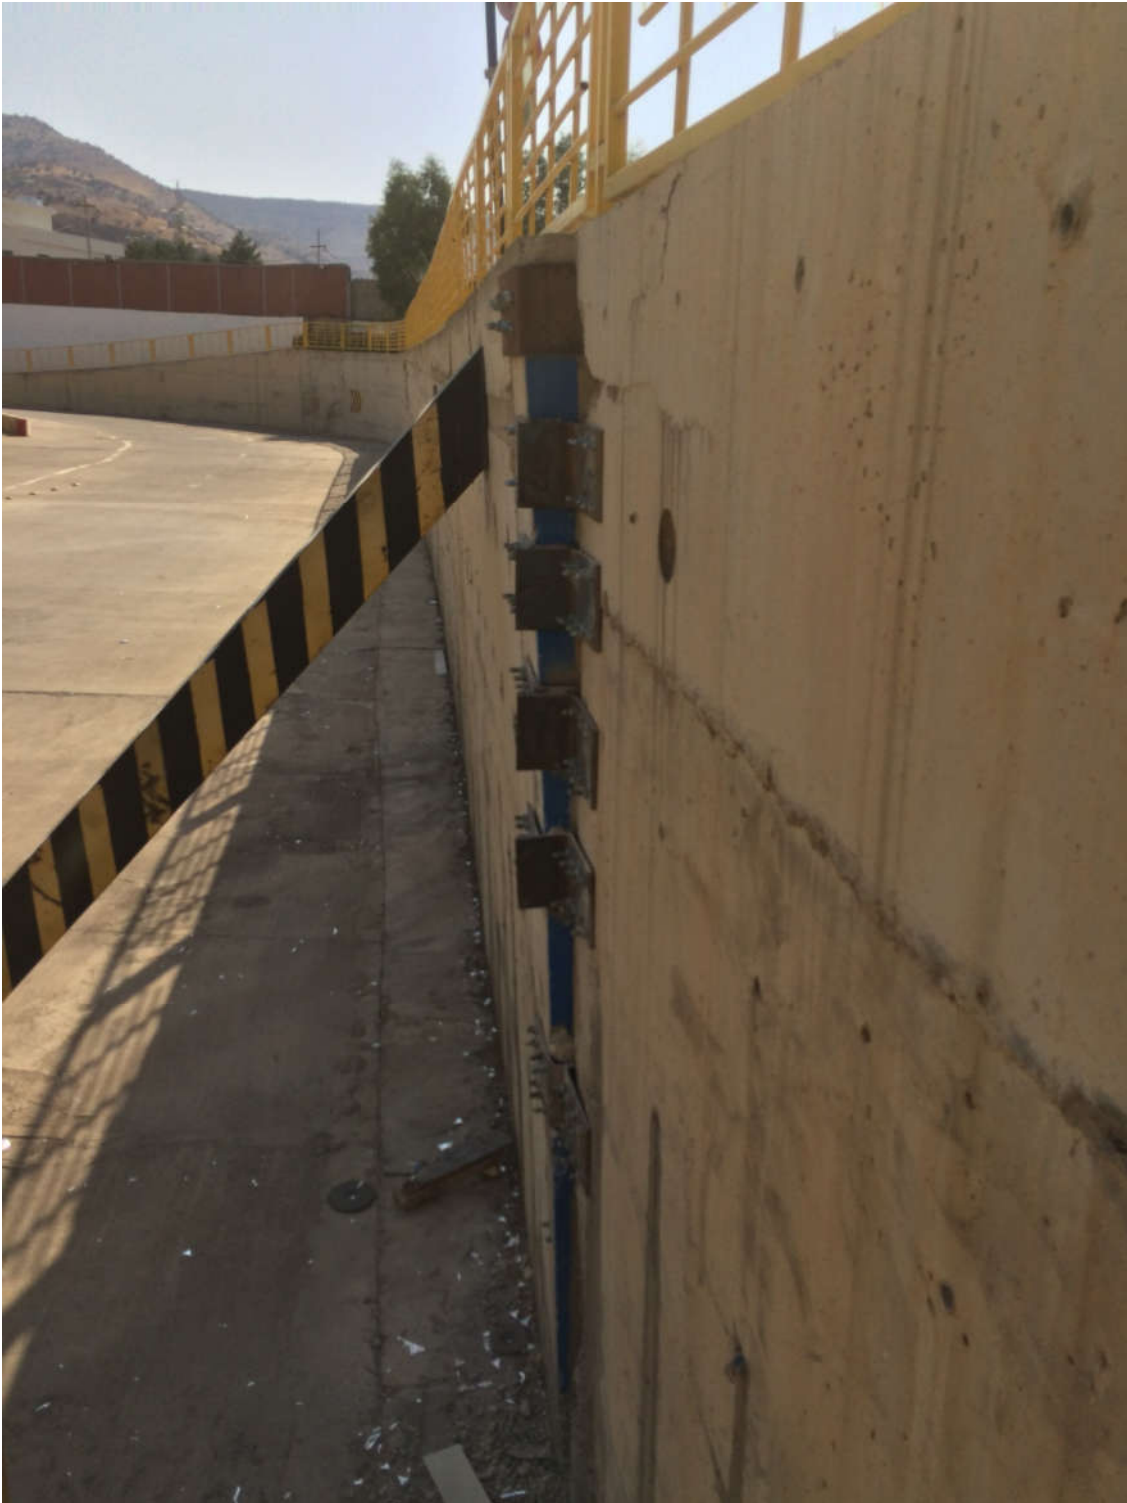
Figure 11

Upper mentioned modes of failures lead to very serious defects and distress in the wall and may cause finally to prevent it from functioning adequately. Eventually, may lead to hazardous occasions to surrounded people. Mentioned above modes of failures are caused some kind of overturning failure aspect in the cantilever concrete wall, which essentially need to be solved as soon as possible. See (Figure11) for **Overturning failure**.
