Salah Al Dain University

Earthquake

Hawar Farhad Ahmad

16th, August, 2016

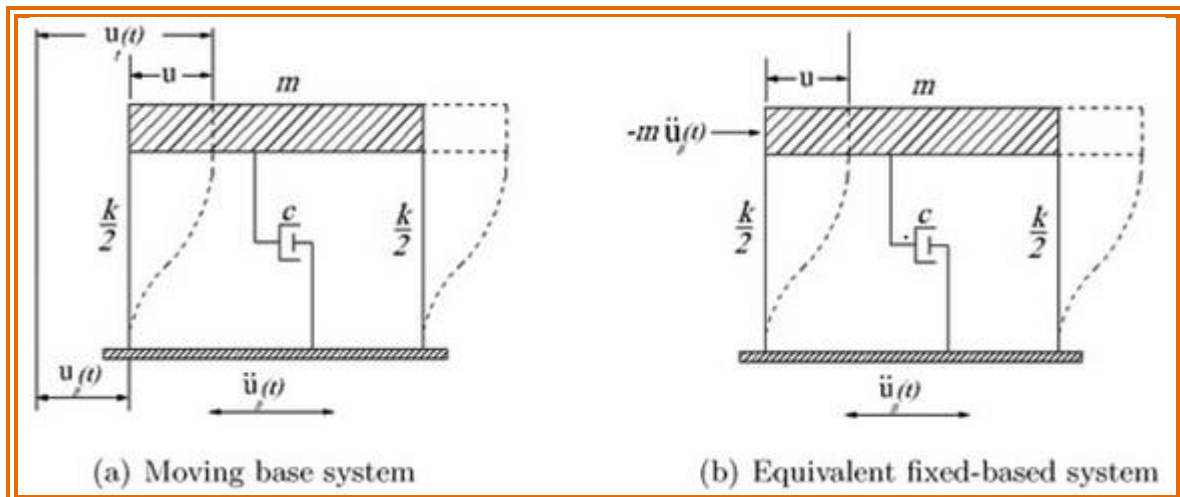
fog(1) SDOF system subjected to lateral earthquake (Booth and Key, 2006)

According to equation of motion $m\ddot{U}''+c\dot{U}'+KU= mUg(t)$ the seismic force consist of the following terms based on SDOF system.

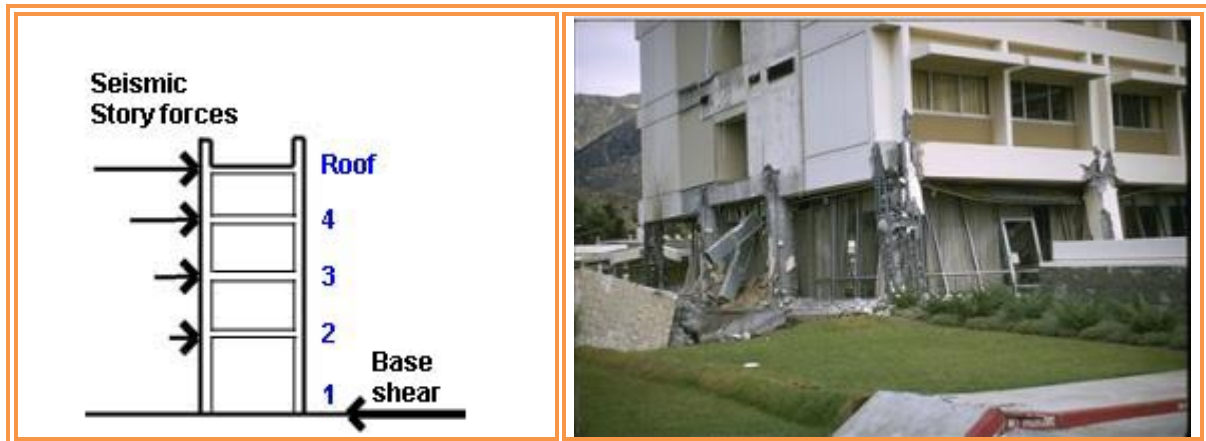
Fig (4) base shear mechanism and effects on the building (Ochshorn, 2009)

This force is a reaction of lateral earthquake load which accumulates downward of the foundation of the building. It can be described as largest earthquake load which damage the building at the lower part of the building. Mainly this failure is overcome by design base isolation for building (reference).

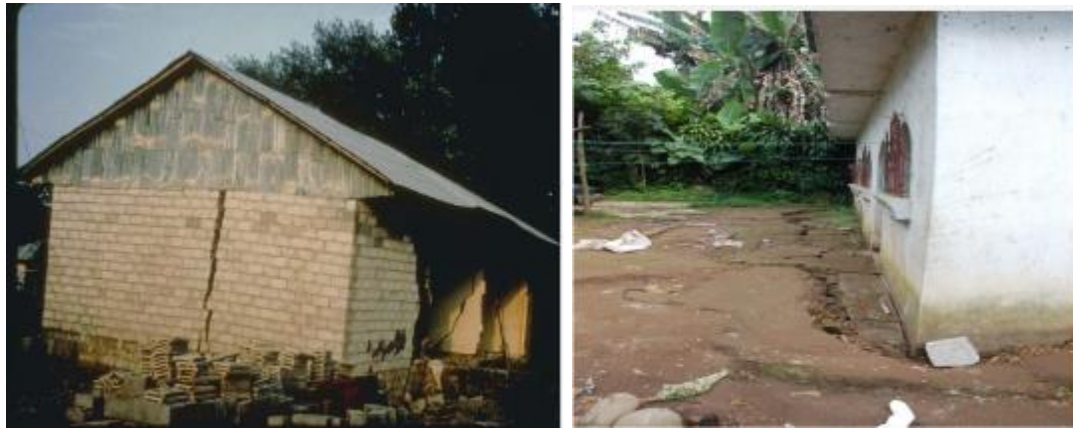
Fig (6) foundation settlement (Damage, 1990) foundation settlement foundation settlement (EERI, 2011a)

Mostly foundation settlements result in additional stresses of the building which may produce by earthquake. The differential settlement is also potential settlements occur in irregular shape in plan of building during earthquake. These failures are end up with wall cracks and floor sagging

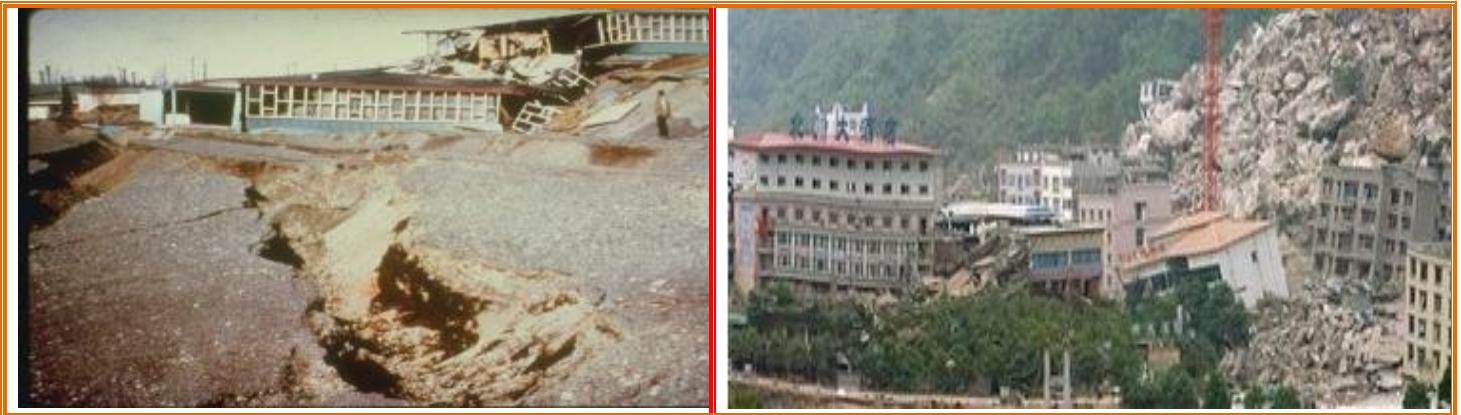
Fig(8) Landslide failure (NOAA, 2010)

Landslide failure (PHOTOBLOG, 2010)

Phenomenon occurs frequently in building are constructed on the steep inclined hills which it relates to destructive earthquake loads. The failure caused by moving ground layer affected by horizontal force of earthquake.(Chen & Lui, 2005)

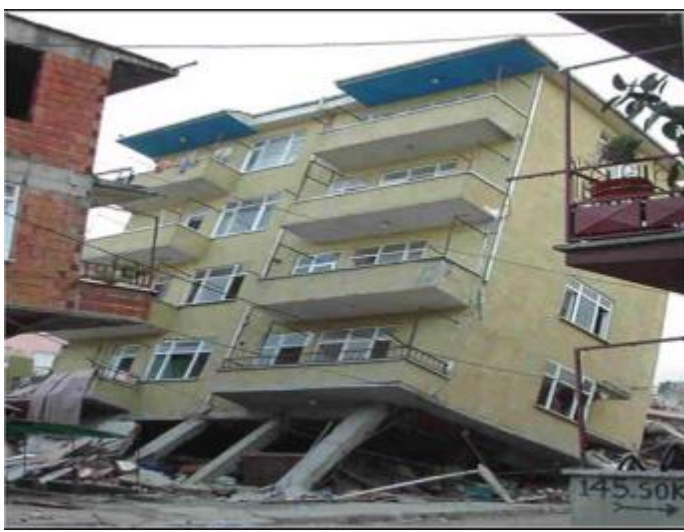
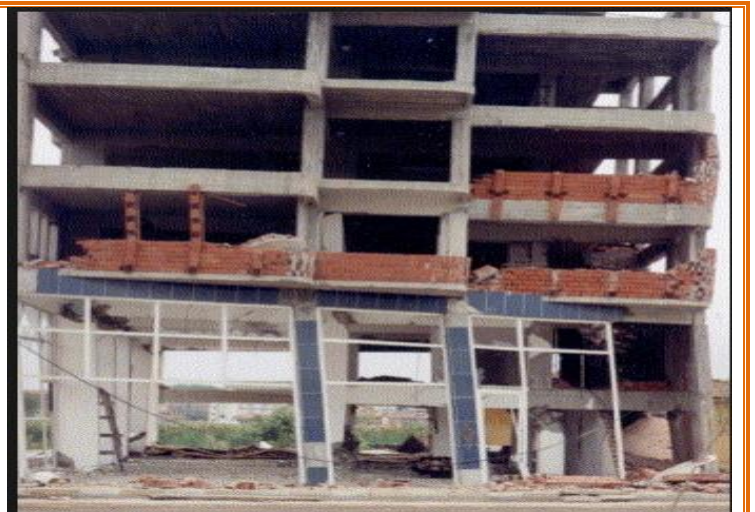
Fig (11) soft story failure (Alarcon, 2009)

The most severe mechanism of building failure by earthquake loading, this failure mode is globally happen due to irregularity in the vertical direction namely different floor heights. The most frequently occur in the ground floor.

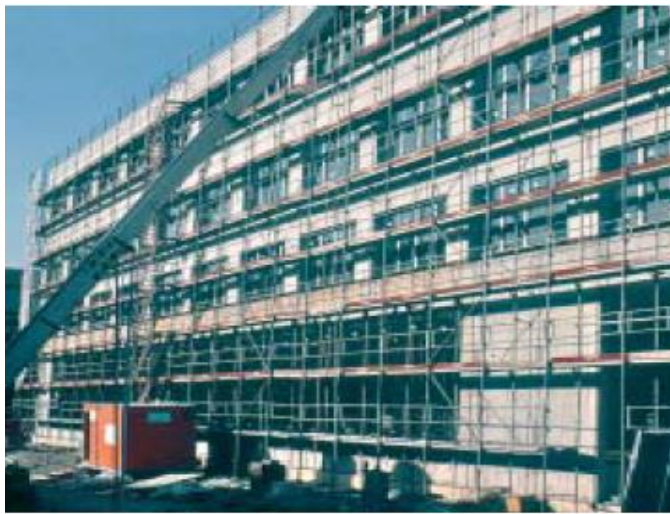
Fig (12) vertical geometry irregularity (Bachmann, 2002)

Building frame can rise failure due to irregularity of bracing stiffness in the vertical direction . it can be noticed from figure below column are unavailable in the ground level as well as shear wall only exist in the ground floor this can be described the most vulnerable condition during earthquake.

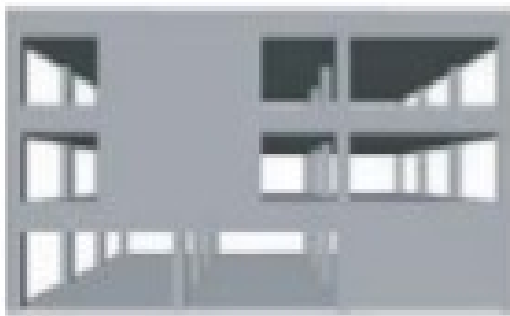
Fig (13) in-plane discontinuity (GEM, 2013)

This failure mode can rise from discontinuity load path, generally happens in bracing discontinuity in some levels of building as shown in fig (). The mechanism of failure can be idealised by insufficient section of lower levels to carry compression or tension loads.

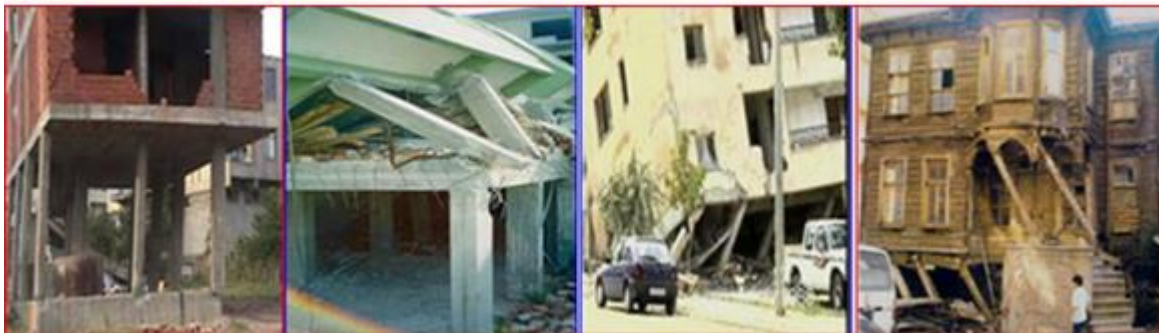
Fig (15) weak story failure (Nevzat Kirac, 2011)

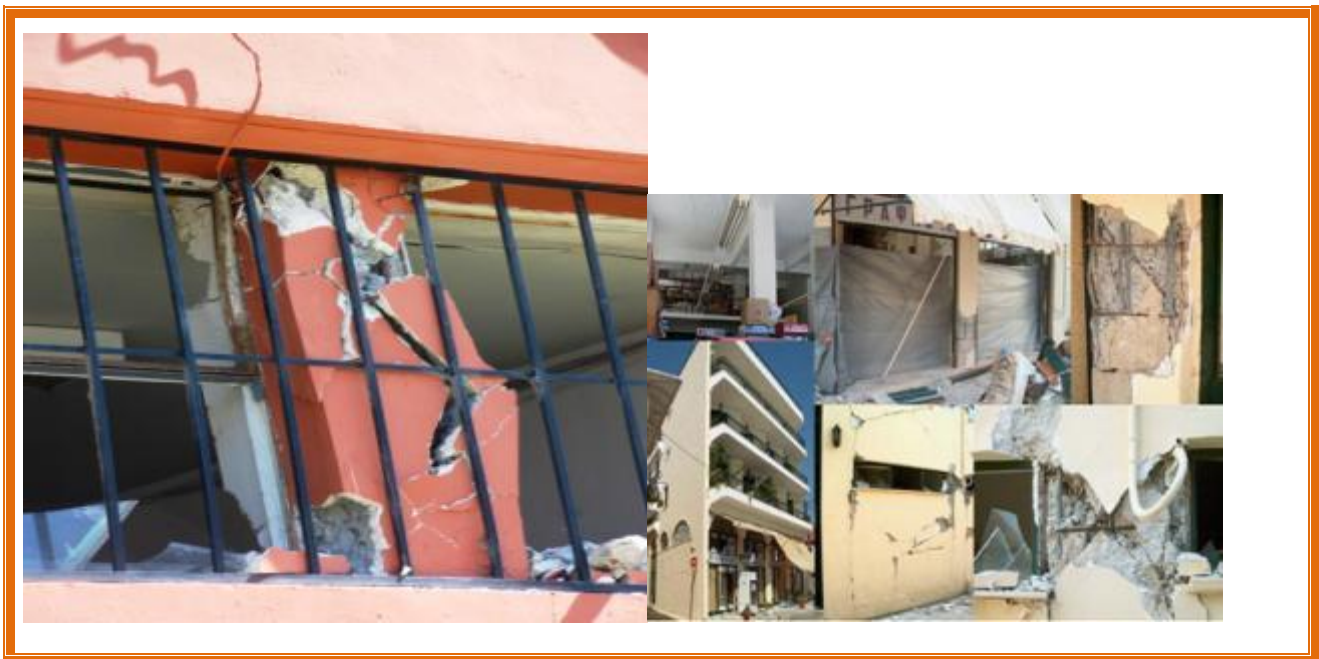
FIG(20) SHORT COLUMN FAILURE(EERI, 2013) SHORT COLUMN FAILURE (Anastasios G. Sextos, 2011)

(Bachmann, 2002) determines that short column perform negatively during earthquake. in the fact this short column which are relatively stocky in comparison to their length, considering that these column are less stiffness than beam and slab. The same mechanism of weak column and strong beam will develop in these columns. Therefore the shear pattern failure develops in the column.

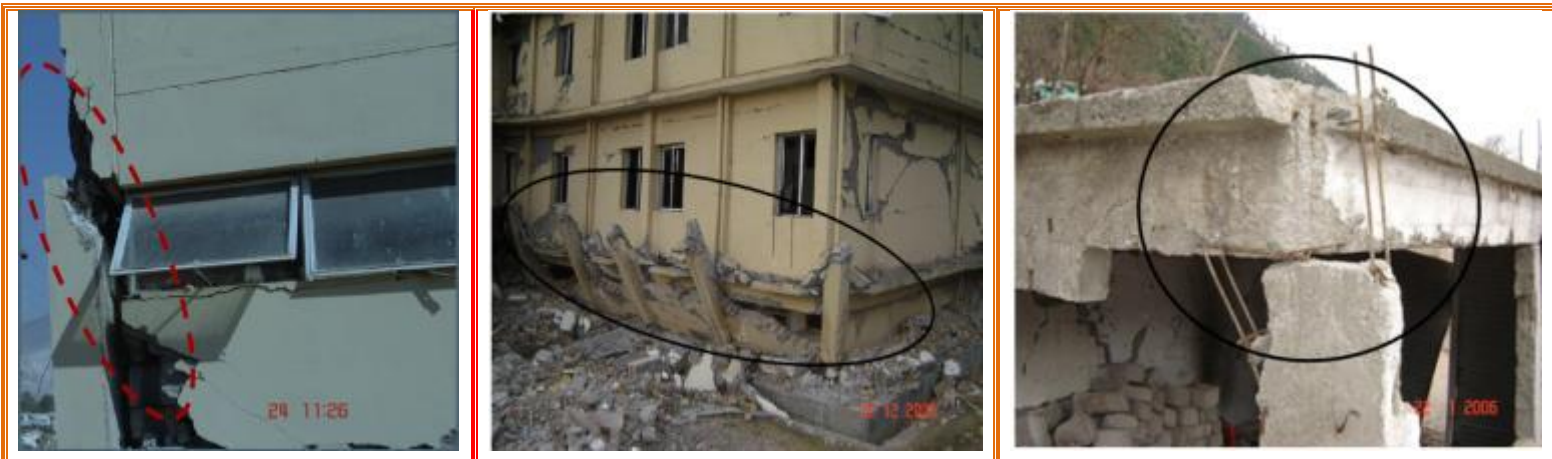
Fig (21) failure due to poor detailed reinforcement and poor construction (Y B Marhatta, 2007)

This mechanism of Shear failure develops in the columns casted in different stages. By this the shear resistance should be very low to resist inherent shear force induced by lateral force of the earthquake. the separation can develop between column and slab and then the failure may be more catastrophic than expected.

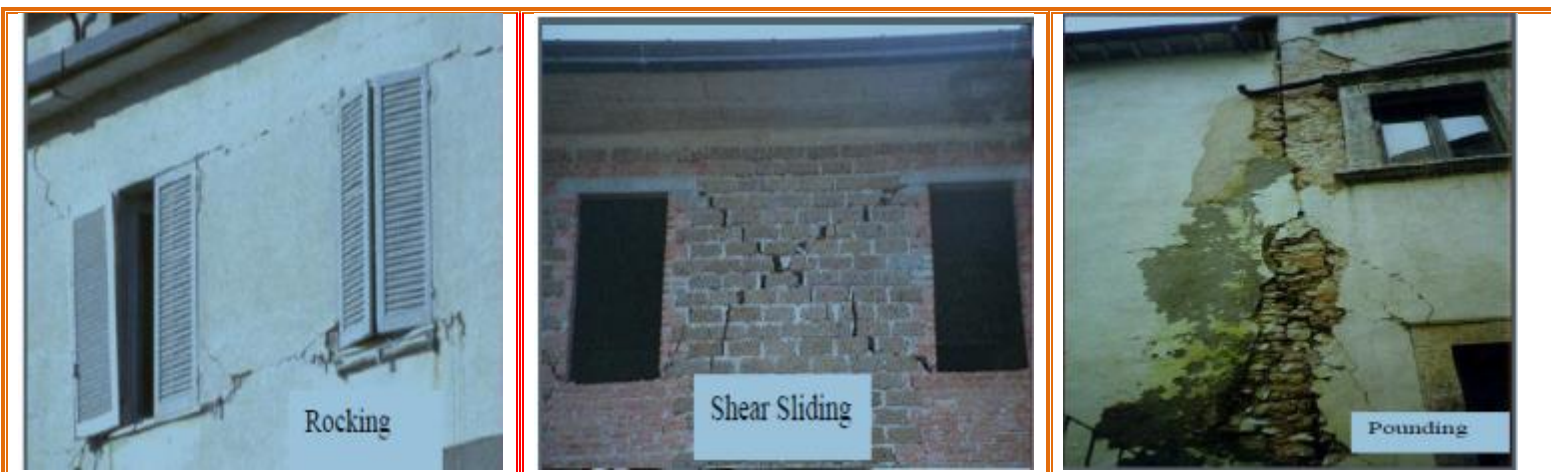
Fig(22) failure modes in masonry (Rocking, shear sliding and Pounding)(Rush, 2007)

The mode of rocking failure is developed in the masonry building are related to global response of building to seismic force

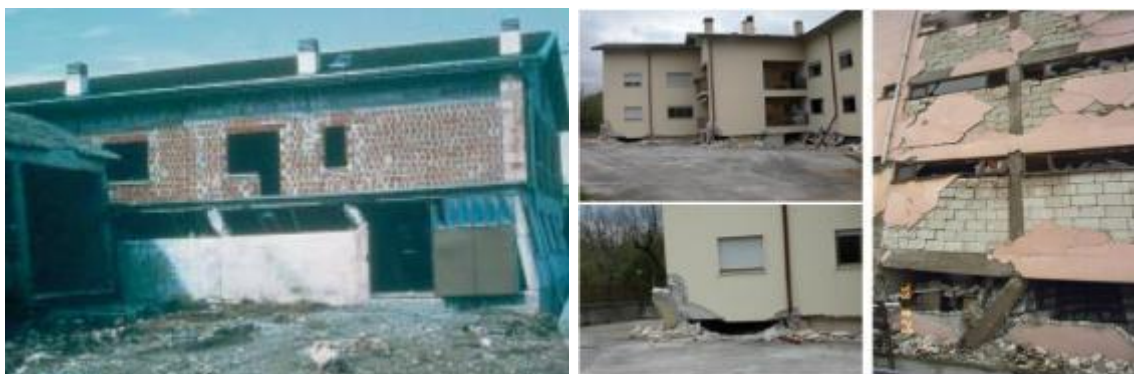
Fig (23) failure in column due to partially infill masonry(Bachmann, 2002, G. Uva, 2012)

This kind of collapse are common in the building that have openings at the top of infill wall. The columns become partially restrained by masonry so the mechanism of short column failure arise in that column(G. Uva, 2012)

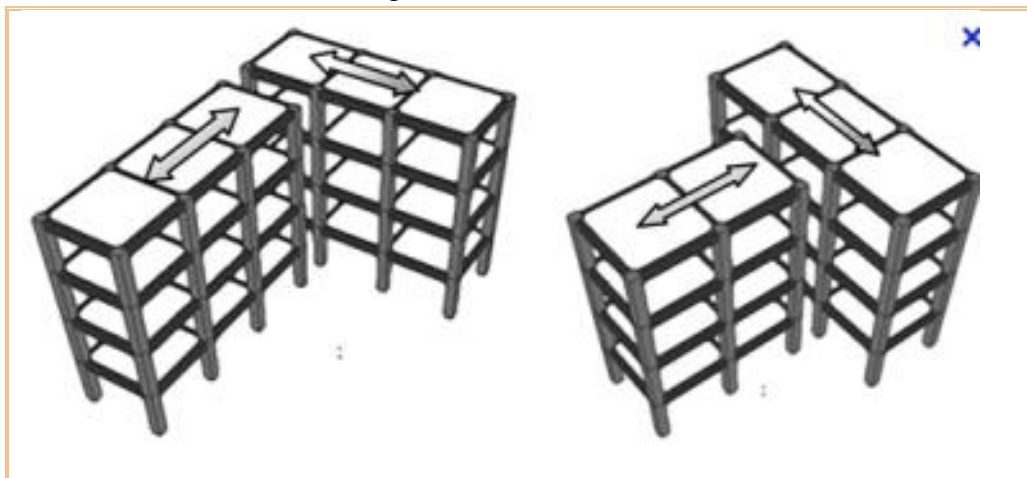
Fig(27) dividing building into simpler shape to avoid re-entrant corner (Korkmaz, 2011)

5.2.1.2 Re-entrant corners: this can be addressed by separation the building into simple shapes. When two unit buildings to be apart by seismic movement joints which needs to be enough to ensure the pounding will not occur due to different mode of vibration of each building.

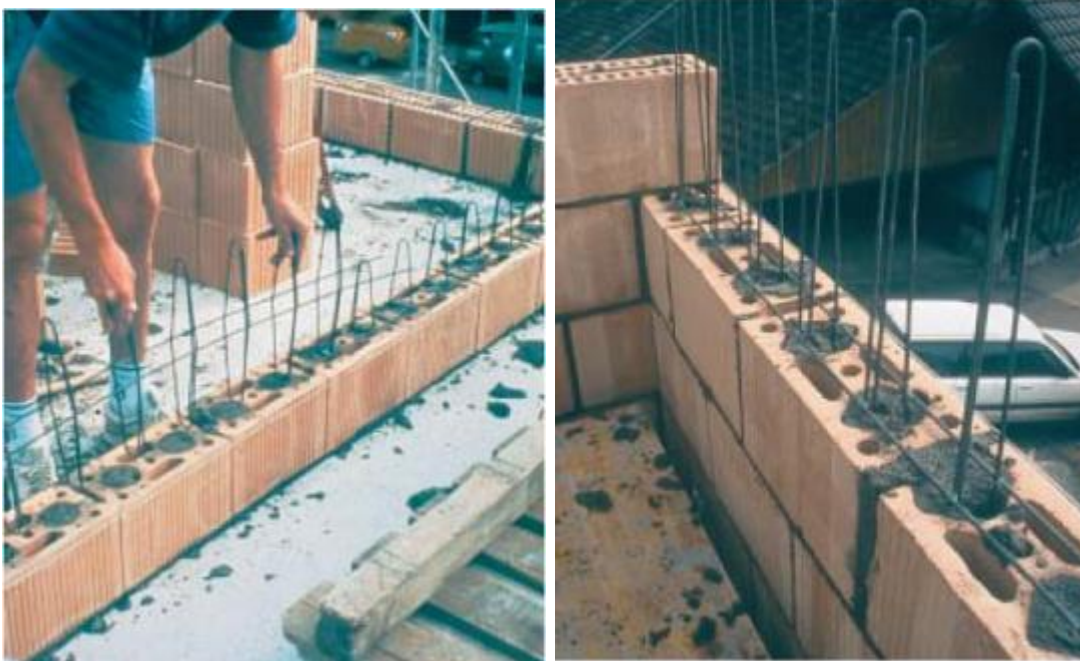
Fig (33) improve the masonry wall against earthquake loading (Bachmann, 2002)

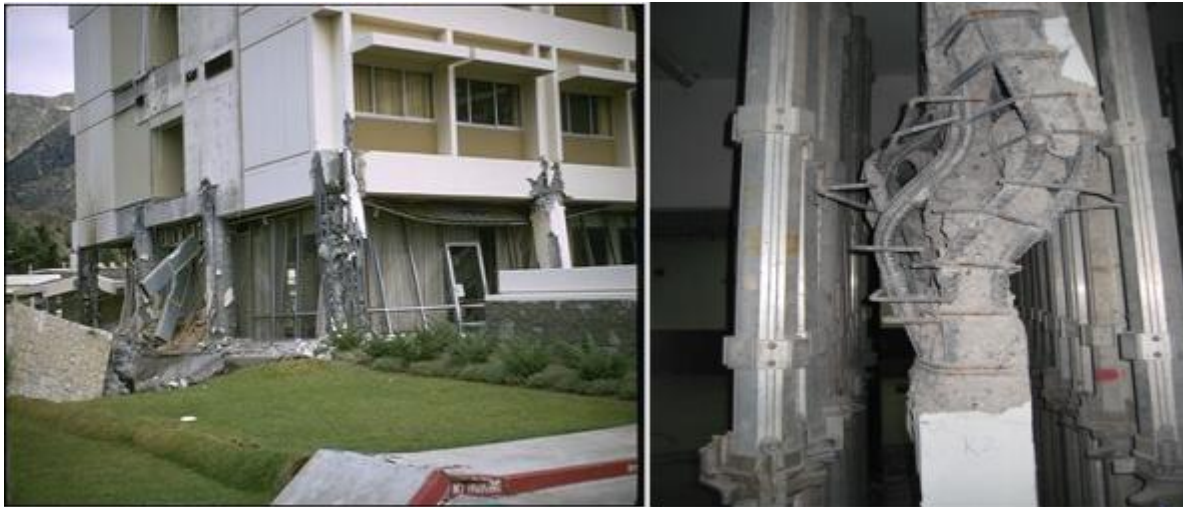
(FIG(54) failure in column due to discontinuity in lateral resisting force San Fernando- California-USA) (Mahin, 1991)

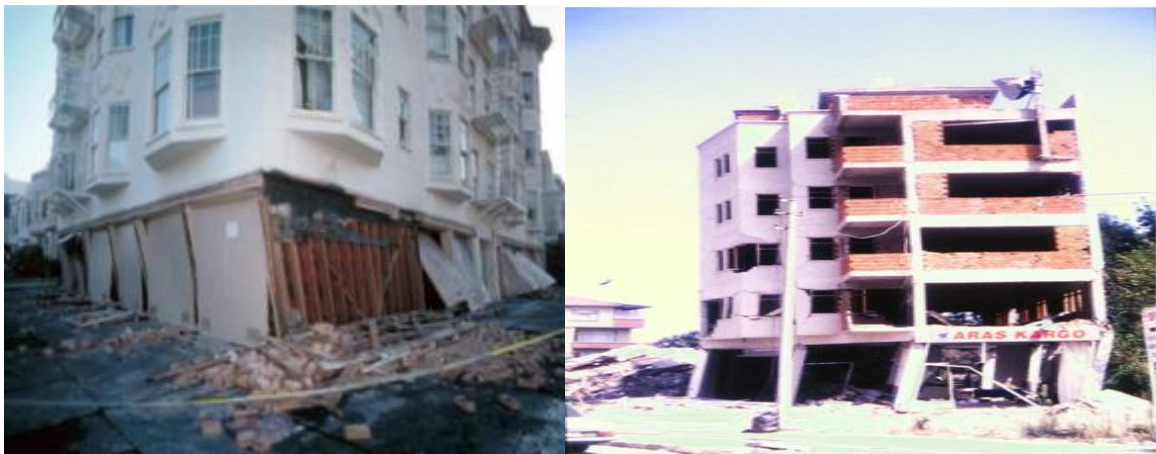
Fig (55) soft storey failure in Loma Prieta earthquake damage in San Francisco (Braile, 2003) and in Turkey (Polat Gulkan, 2002)

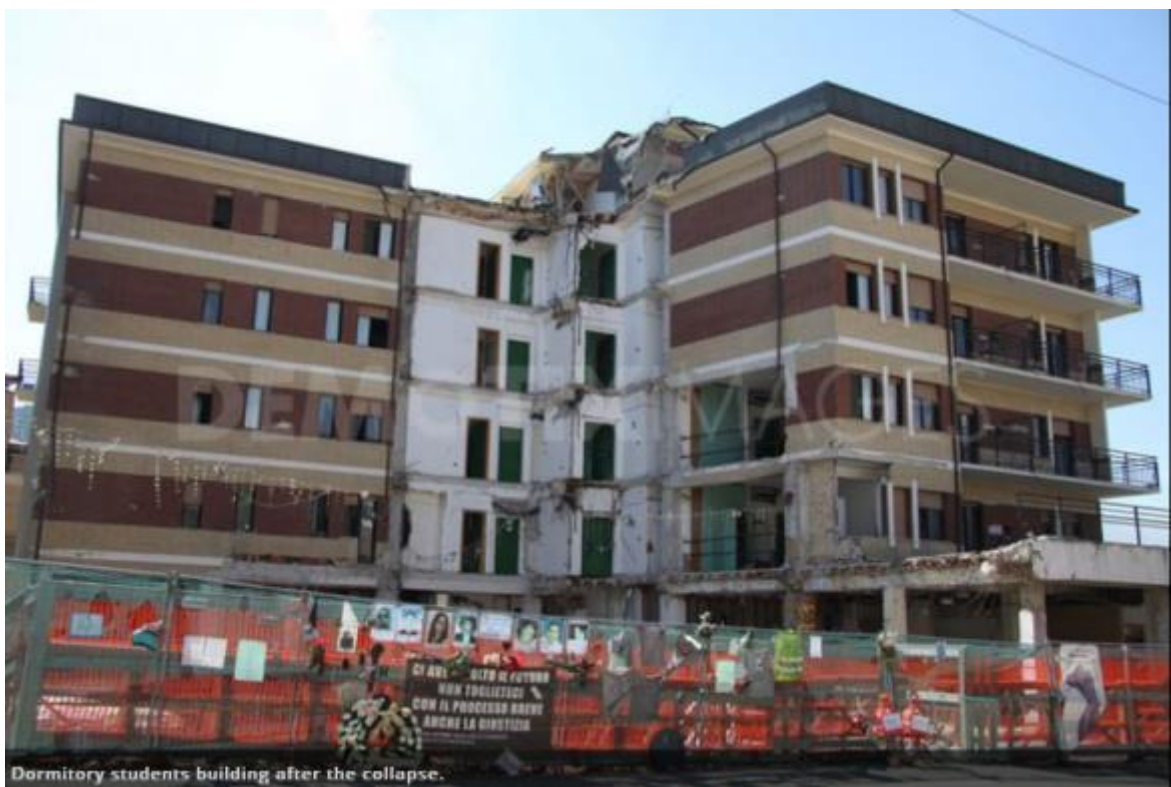
Fig (56) re-entrant corner failure in Aquila, Italy (albani, 2012)

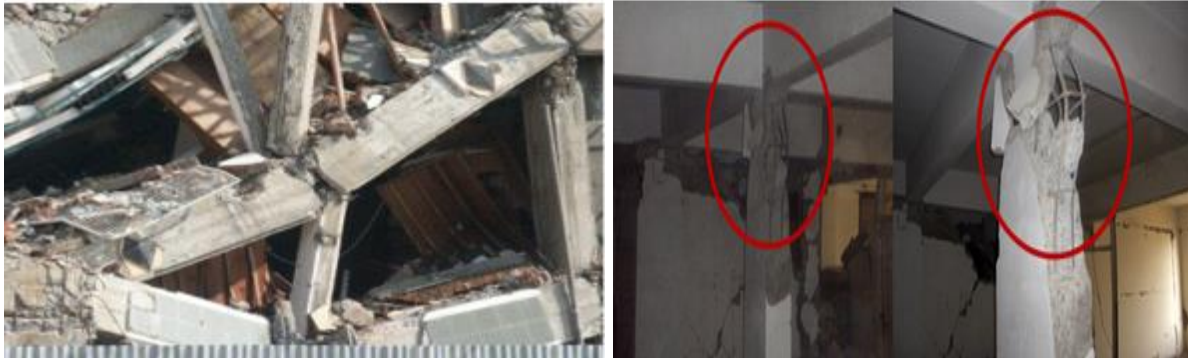
Fig (57) weak column strong beam failure in Banda Aceh, Indonesia (Ahmed Ghobaraha, 2006) and in Pakistan (Yasir Irfan Badrashi, 2010)

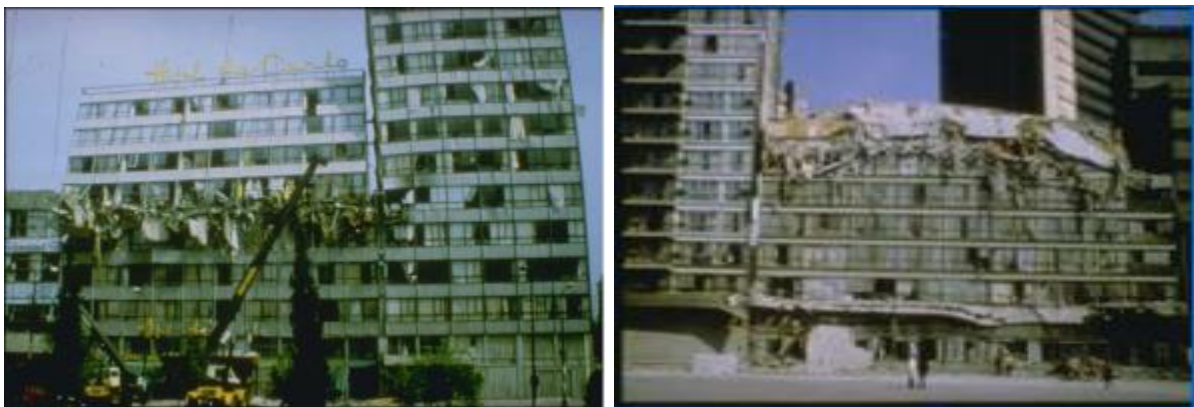
Fig (58) pounding failure Maxico-city (Index)

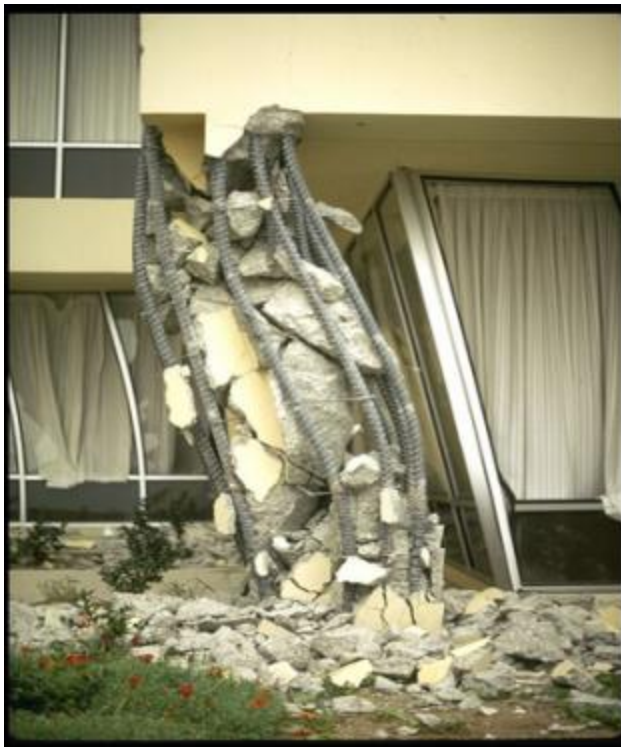
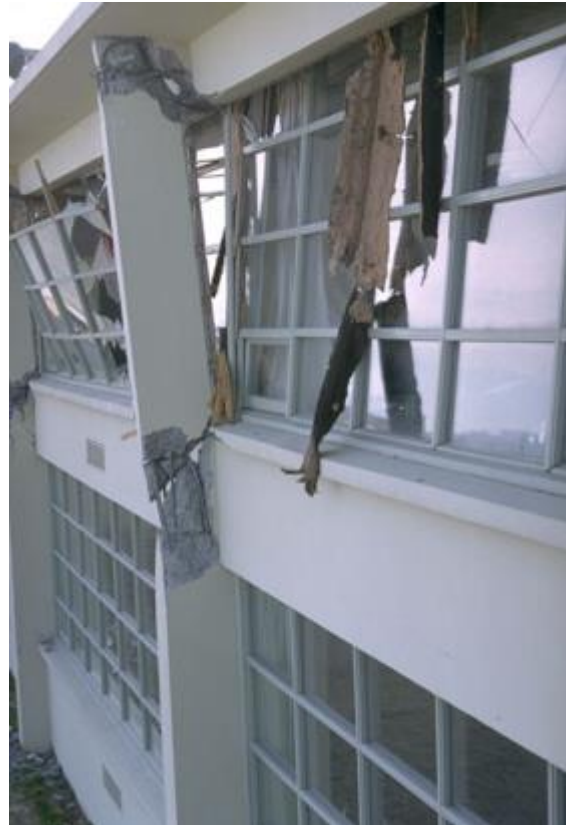
Fig (59) column failure due to poor detailing column (Heidi Faison, 2004)

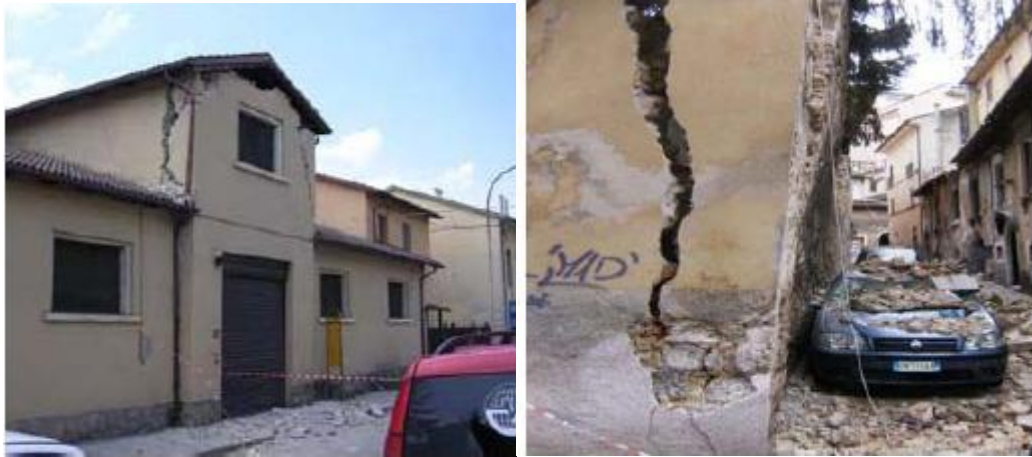
Fig (60) out-of-plat failure (unipv, 2013)

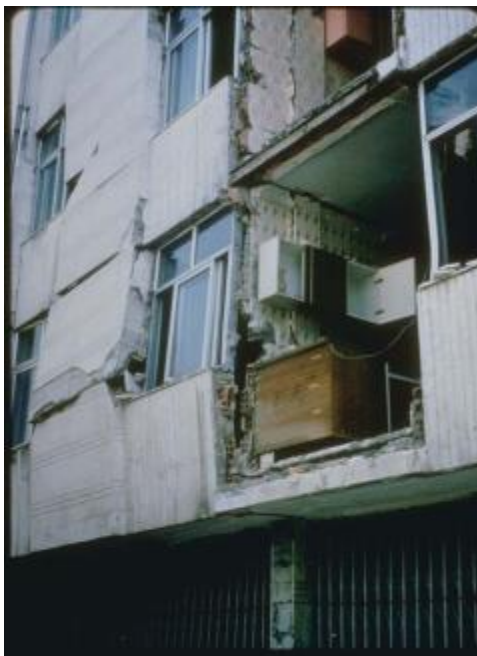
Fig (61) Masonry in filled failure (Earthquake Damage, 1990)

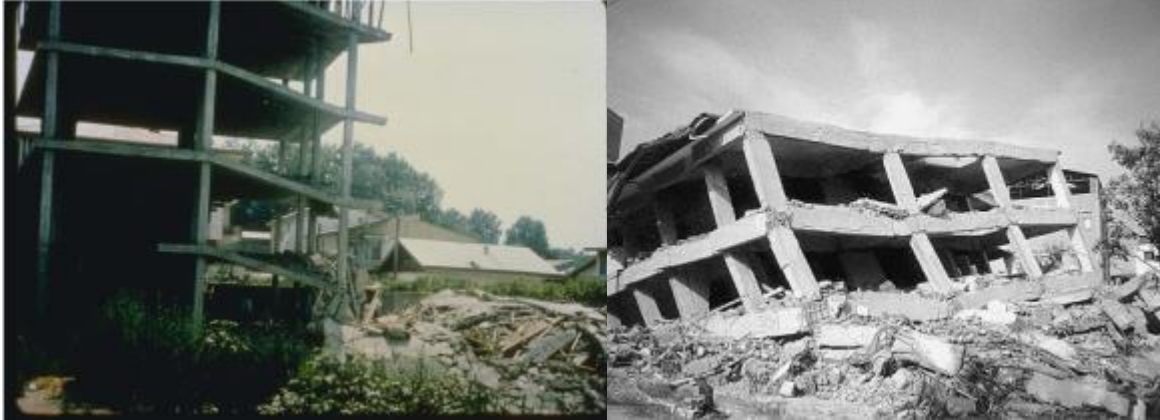
Fig (62) beam failure due to excessive plastic hinge occurrence (NOAA, 1990)

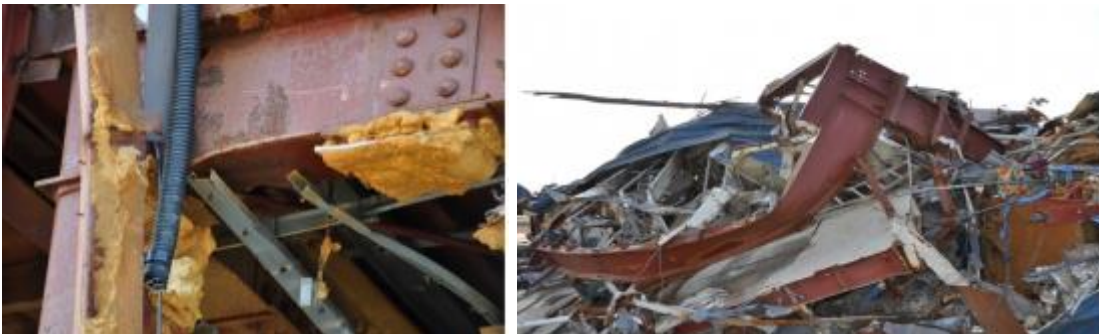
Fig (64) beam failure due to excessive plastic hinge occurrence (James M. Ricles, 2011)

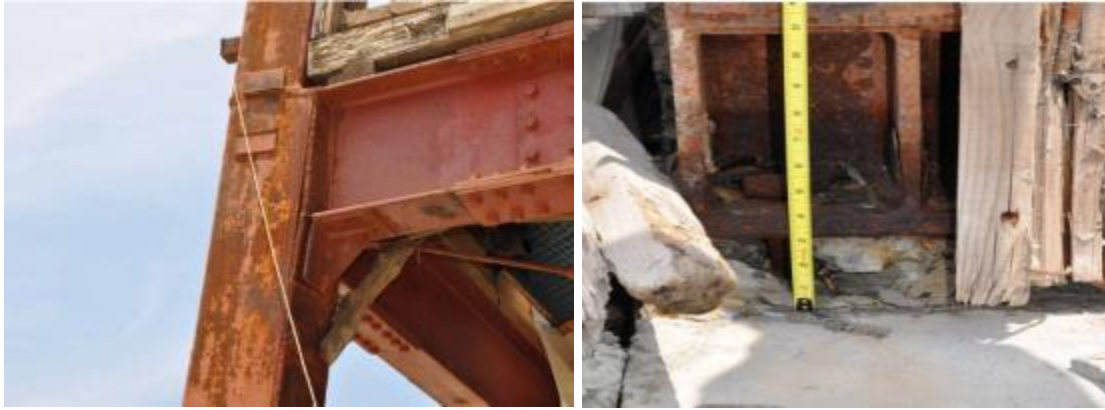
Fig (65) weld failure due to excessive inter-story (James M. Ricles, 2011) base plate detached due to excessive interstory drift (James M. Ricles, 2011)

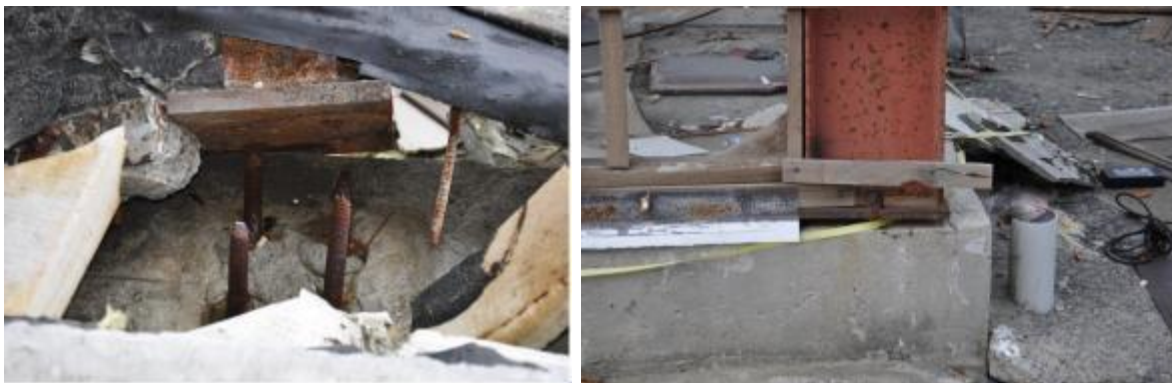
Fig (66) overturning failure caused base plate rapture (James M. Ricles, 2011)

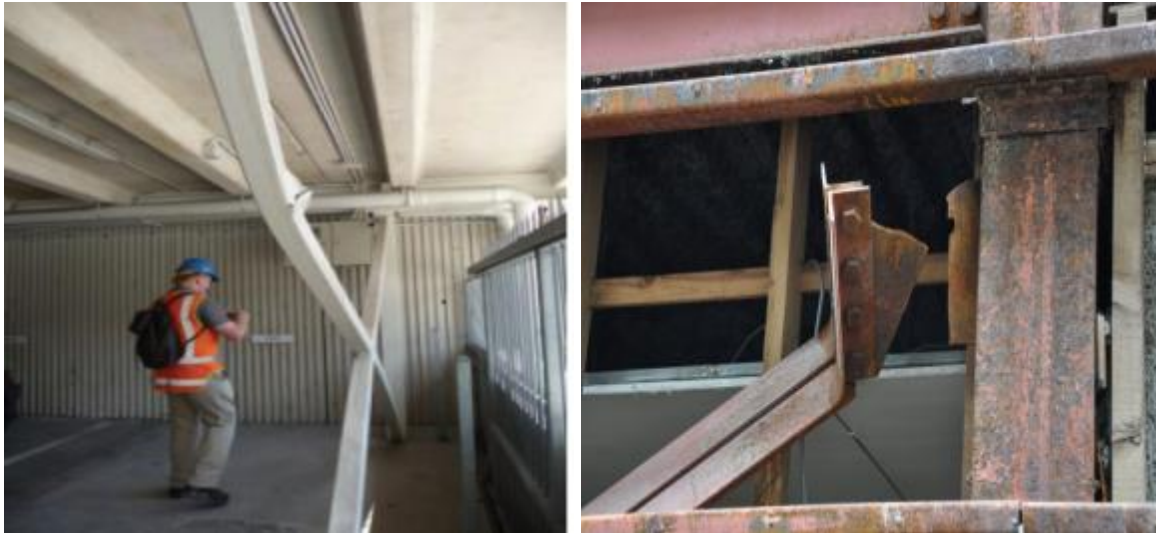
Fig (67) bracing failure due to insufficient section (Clifton, 2011) (James M. Ricles, 2011)
