## How should we go about bringing new life to old ruins, and are some ruins just too precious to alter?

# New Life for Old Ruins

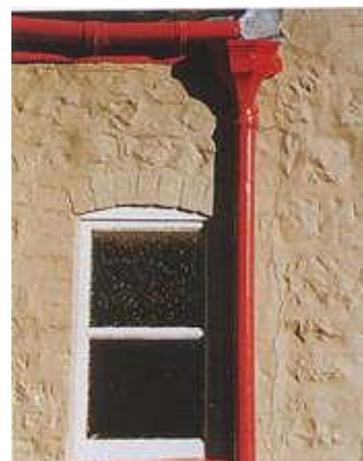
Evaporation of moisture from a wall is concentrated by an impermeable coating at cracks, leading to localised stone decay due to salt crystallisation. The use of colour to emphasise the drain pipe is also questionable

- Cementations coatings and most modern paints and stone consolidate are not porous and will lock moisture in the walls: evaporation is concentrated at cracks where any salts present crystallise, causing decay.
- Damp patches may appear on the inside wall as more moisture is forced to evaporate here.
- Certain materials will deteriorate rapidly as a result of the increased moisture levels, including cob, daub and other earth mixtures, and timber is more likely to rot.

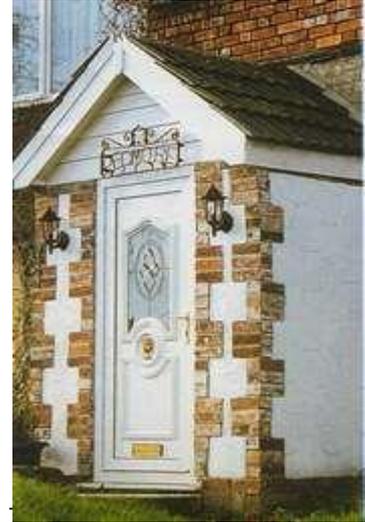
These details have been chosen to look 'quaint', but would be more in keeping with the character of a modern housing estate than this 18th century cottage

- The addition of reproduction features for uses never originally intended, such as 'carriage lamps' on either side of a front door, external shutters particularly where they are fixed to the walls and clearly serve no functional purpose, and 'bulls-eye' glass panes make old buildings look cheap and phoney.
- Poor 'period-style' features such as front doors with press-moulded panel mouldings, black rubber seals, fanlights within the door itself, stuck-on strips in imitation of leaded lights, and other fancy details look incongruous in a genuinely historic building.

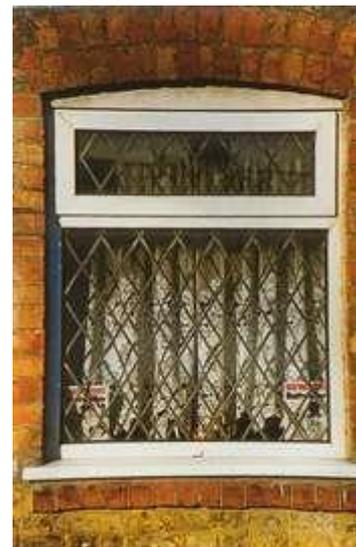
New plastic windows in particular detract from the character of old buildings

Replacement plastic windows in particular (see right) fail to match the appearance of old windows: they invariably have larger, heavier sections than timber windows; black rubber gaskets are visible around the glass; and fine glazing bars cannot be incorporated convincingly. Their claim to be 'maintenance-free' is also misleading as plastic, like paint, becomes scratched and disfigured by dirt in time, and it will eventually need to be painted regularly to maintain its appearance.

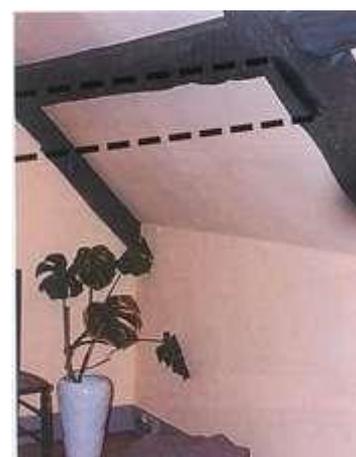
The tie beams literally tie the two sides of the roof together. Their removal to make an attic usable can lead to the collapse of the roof (the location of the tie beams removed in the past is indicated by the dotted lines)

- Replacing slates with concrete roofing tiles can cause rafters to bow and even collapse under the increased weight unless the structure is reinforced.
- Underpinning part of a building can move loads onto other parts of the structure, exacerbating settlement damage, and is often carried out unnecessarily.
- Removing low ties of a roof truss (the horizontal beams which run at eye-level across the attic, at right angles to the ridge) can cause the roof to spread and collapse.

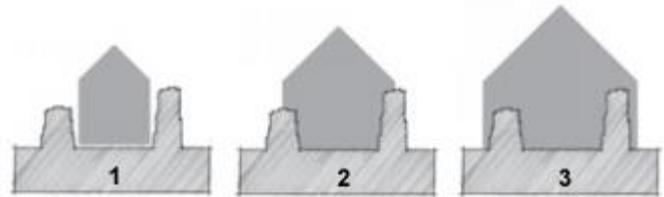
#### **1. Building *inside* the ruin**

This method tends to express the ruin most fully but provides the greatest difficulty in making a weather-tight seal between old and new.

#### **2. Building *on* the ruin**

The ruin can be seen from both sides, but the interface between old and new often means that the 'ragged edge' of the ruin may be lost, as is the case with Norwich Cathedral's new refectory building.

#### **3. Building *over* the ruin**

This provides the simplest and least destructive solution. The ruin is enclosed inside a museum-like building. However, the ruin is now separated from its context.

The visual impact of the new structure will largely depend on its relationship with the old. For example, does the new sit within the old as if it is growing out of it: the reptile in the process of shedding its old skin? Or does the new building sit directly on top of the old structure, either bearing on it or supported on a frame so that only the outer skin rests on the historic fabric? Or does the new building enclose the ruin: a new shelter that protects the historic fabric like an exhibit in a museum, as can be seen at Richard Meier's Ara Pacis Museum in Rome (right)?

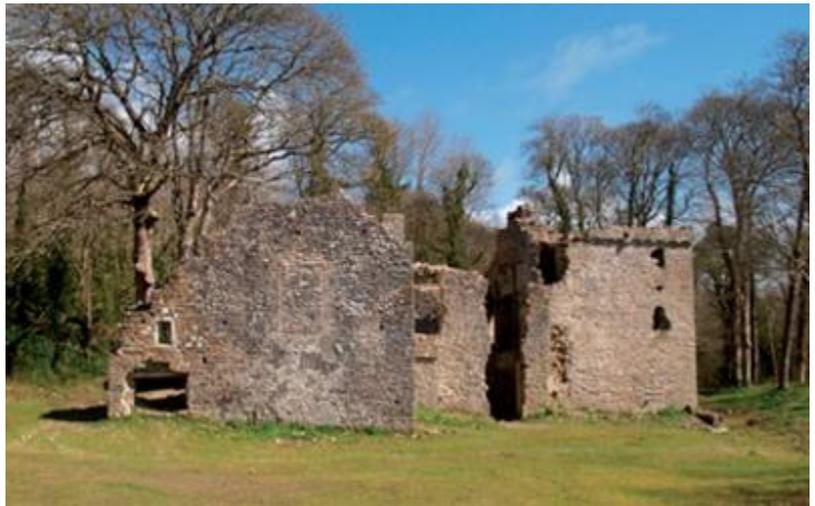
Candleston Castle, part of the Merthyr Mawr Estate in Glamorgan

Candleston Castle (above) forms part of the Merthyr Mawr Estate in Glamorgan, and stands adjacent to a large range of sand dunes. The building forms part of the ruinous remains of a 14th-century manor house. The owners were committed to preserving the ruin but felt they needed to find a commercial solution to funding maintenance costs after the initial repair work had been completed.

Putting a roof back on the building and giving it a new beneficial use was considered, but this would have been expensive and was not commercially viable. The estate then considered another alternative: the domestic range of the castle forms one side of a walled courtyard and although the curtain wall is dilapidated there is still enough remaining to form a significant enclosure.

Using the romantic ruin as a backdrop, a marquee will be erected on the grassed courtyard space and hired out for wedding parties. This solution offers a commercial return to support the continued maintenance of the ruin, while involving minimum intervention in the structure itself. The marquee is a temporary structure so the setting of the castle is not compromised

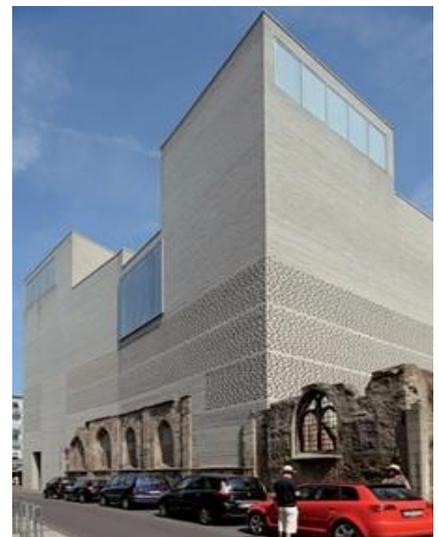
Kolumba Museum, Cologne: the new structure is fused to the walls of the ruined medieval church that it protects (Photo: Yuri Palmin)

The new structure both incorporates and shelters the original. The contrasting light grey brick was developed for the project and provides a contrast in colour, in texture and in the monolithic simplicity of the massive new structure. But this is not an uncoordinated relationship between old and new: there is a subtlety to this holy alliance. Directly above the exposed ancient fabric, the weight of the new masonry is relieved by small perforations in the masonry that also admit a dappled light into the cavernous interior, where the remains of the old church lie.

The interface of the undulating rubble stonework and stone dressings of the old structure, and the small masonry units of the new brickwork, provides a workable junction for building new on old. The overall visual contrast is striking but, like many great buildings, new and old, this is one that needs to be experienced first-hand to fully appreciate the success of this approach.

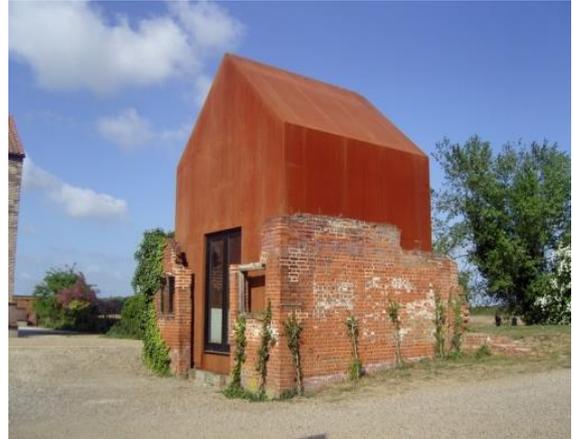
Dovecote Studio, part of the famous music campus at Snape Maltings

The regeneration strategy concentrated on preserving existing fabric, with all its patina of age and use, and adding to it – where necessary – in a legibly contemporary architectural language that should be as uncompromising and industrial as the original buildings, and should age gracefully to unite with the existing structures. Literal reconstruction of the dovecote would have contradicted this strategy. Instead, the new studio was conceived in a form that reflected the shape of the original building, but in a material, cortex weathering steel, that was strikingly modern. This form was seen as a separate structure that could be placed within the shell of the existing ruin, while leaving it untouched.

Although contemporary, Cortex steel weathers to a shade of rust-red almost exactly the same as the colour of Suffolk red bricks. Meanwhile, although its form echoes the shape of the old dovecote, its construction from a single material gives the new studio an enigmatic quality. The result is a building that from a distance evokes the ghost of the original structure, but, seen from close up, reveals itself as entirely new.

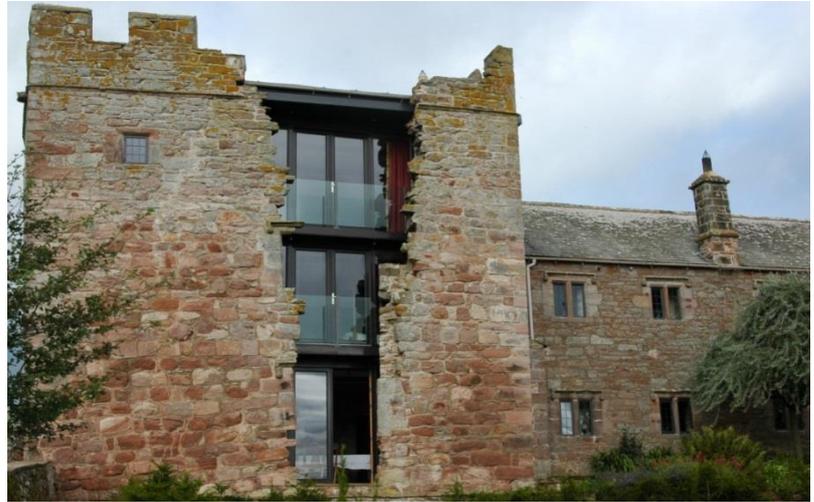
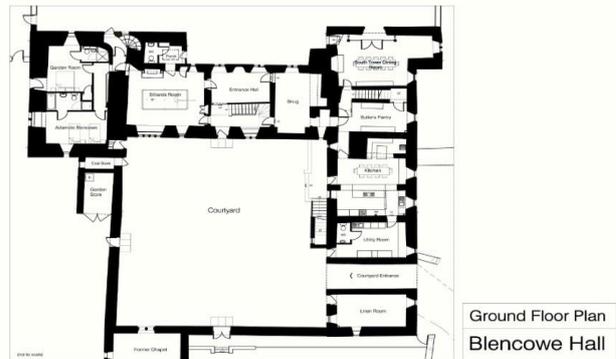
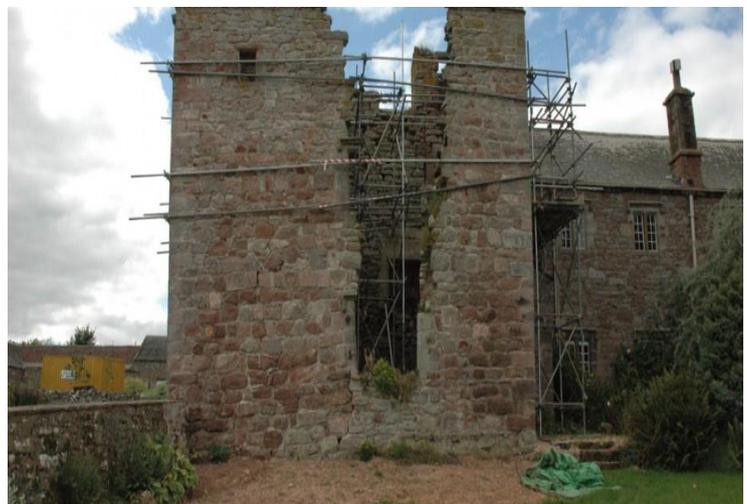
It was decided to retain the breach in the outer wall as it is part of the story of the building, and a steel frame was used to support the leaning external walls. The new glazed wall behind the breach was set back from the original walls, so that the raw edges of the broken masonry remained visible. The recreated rooms on all three levels within the south tower were designed to make the best advantage of the stunning views to the south east and they offer light open interiors that contrast with the more enclosed remaining rooms which retain their traditional windows.

Reinstating the original roof provided most of the necessary waterproofing for the tower, leaving only the junction between the new glazed wall and the old stone walls. The new wall is well set back behind the edges of the breach with the vertical abutments being protected by the small balconies and the overhanging roof. These abutments have been waterproofed with a

compressible water resistant foam seal strip to take up the irregular profile of the rubble stonework. Apart from the consolidation of the exposed ragged edges of the masonry, there was no intervention into the masonry structure either side of the breach.
