# Comparison of Long-Term and Short-Term Tests for Electrofusion Joints in PE Pipes

**November 2021**

## **Abstract**

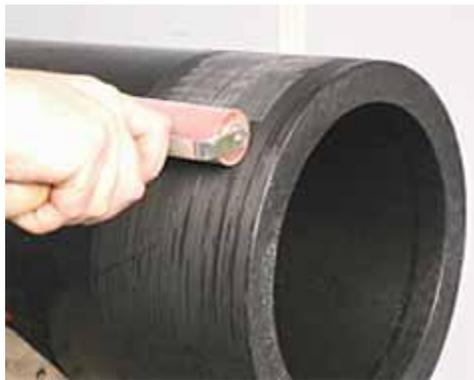
The particulate contamination was applied to the scraped surface of the pipe to be welded using a rubber roller (see *Fig.1*). The talc (Westmin D100) had a median particle size of 22 $\mu$ m; and the sand (Fraction D natural uncrushed silica sand to BS 1881-131:1998 <sup>[2]</sup>), had a particle size of 150-300 $\mu$ m.

Fig.1. Application of particulate contamination

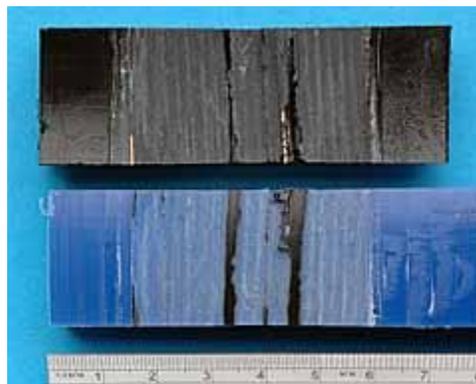
The above results show that this test could only differentiate welds containing talc contamination, all of which failed in a mainly brittle manner through the weld interface (see *Fig.4*). All other specimens either failed in a fully ductile manner through the plane of the heating wires ( *Fig.5*) or through the pipe ( *Fig.6*).

Fig.4. Fracture surface of ISO peel decohesion test specimen containing talc contamination

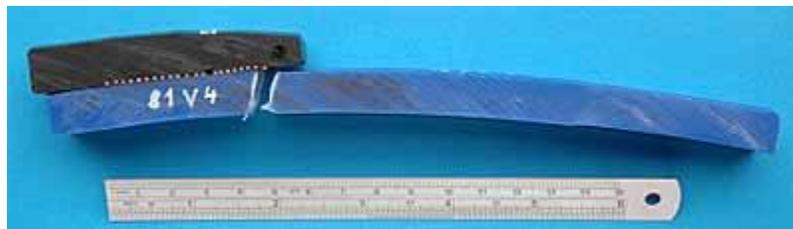
Fig.6. ISO peel decohesion test specimen showing fracture through the pipe wall

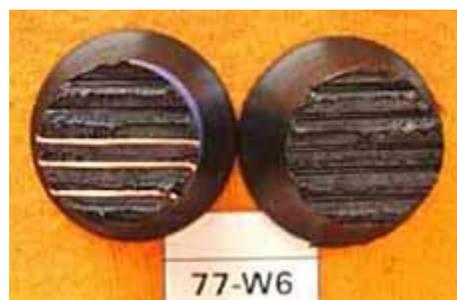
As can be seen in the above table, the welds containing no flaws, sand contamination and unscrapped pipes all failed through the plane of the heating wires (see *Fig.10*). Even though the average times-to-rupture for these specimens are different, this cannot be due to the flaws because the failures were not through the weld interface. Two out of the six specimens containing talc contamination failed through the weld interface (*Fig.11*), with one specimen failing partly through the weld interface and partly through the plane of the heating wires (*Fig.12*). Also, the average time-to-rupture for these specimens was lower than for the welds with no deliberate flaws.

**Fig.10. Fracture surface of tensile creep test specimen through the plane of the heating wires**

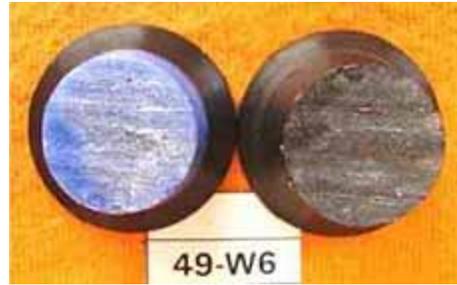
Fig.11. Fracture surface of tensile creep test specimen through the weld interface

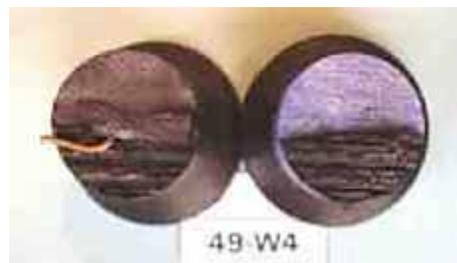
Fig.12. Fracture surface of tensile creep test specimen showing a mixed failure mode

Two of the specimens containing cold welds also failed partly through the weld interface and partly through the plane of the heating wires, with the remainder failing fully through the plane of the heating wires. The average time-to-rupture for the cold weld specimens was very similar to average value for the welds containing no deliberate flaws.
