REVIEW OF CURTAIN WALLS, FOCUSING ON DESIGN PROBLEMS AND SOLUTIONS

ABSTRACT

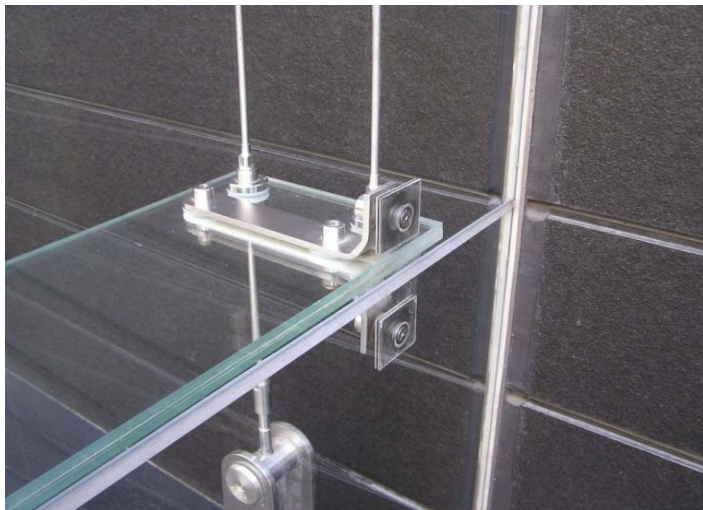
Figure 1. Example of the vocabulary challenge. The structural glass wall, with horizontal structural glass mullions suspended on stainless steel cables. The glass fins play structural role by resisting lateral load, as opposed to the traditional load-collecting role of glass. No structural sealant used here.

As many specification writers are well aware, even classification of this, relatively narrow group of curtain walls may present a challenge. An example of possible ambiguity is the adjective “structural” used in the expression „structural curtain wall.” It’s traditionally interpreted as a description of the characteristic of the adhesive used for bonding glass to its framing substrate. More recently it became used to describe the desired characteristics of glass used to build the frame itself (as opposed to the infill material) sometimes without use of any adhesive material. (See Figure 1). Some countries developed early code-referenced standards and glossaries, e.g. UK, Germany, China, and Australia. (e.g. EN 13119: Curtain walling – Terminology. 2007)

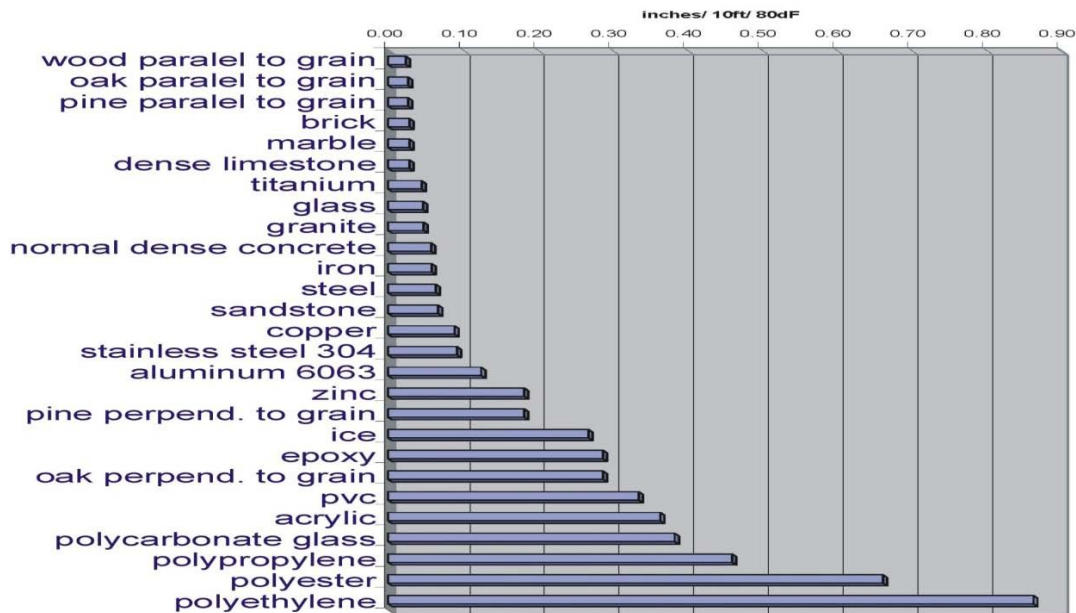
Figure 4. Thermal movement of a 10ft long piece of a material subjected to an 80°F temperature differential

Once the main frame movement is analyzed, the next step should be analysis of movements of the curtain wall, including thermal movements. The decoupling of the outer shell layers from the relatively stable building interior by thermal isolative layers caused more volatile thermal movements. (See Figure 4). This effect is compounded in mullions, as they are of greater dimension (Hinks and Cook. 1998). These movements are particularly challenging in systems where the wind-resisting framing is placed outboard or split by a thermally isolative layer.

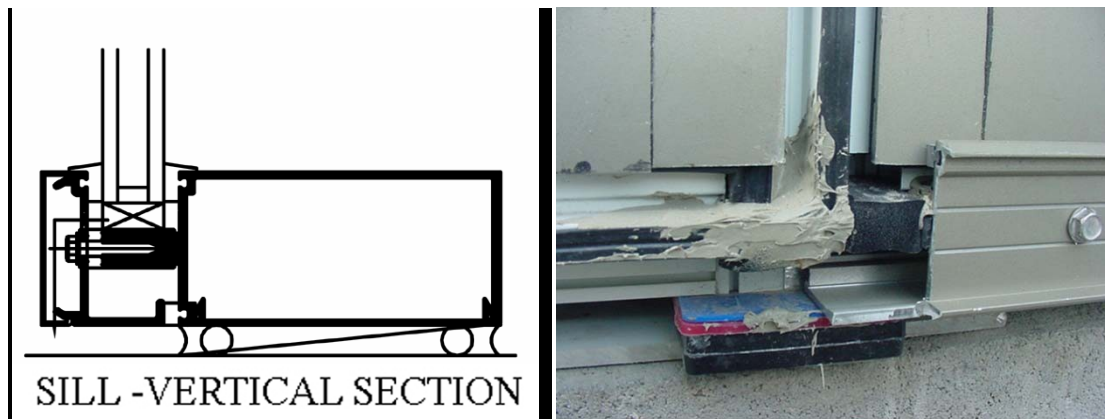
Figure 5. A typical vertical section detail of exterior wall's sill and a photo of the same condition in the field. The front sealant joint is discontinued at every anchor and corner. The back sealant attaches to horizontal mullion which is discontinued at corners and forms gaps at every end. Both sealant beads have insufficient substrate width. The sealant joints, traced 360° around the fenestration perimeter, would typically not withstand the differential movement. The horizontal aluminum leg bridges the mullion thermally. Field-applied systemic sealant separates wet and dry zones of the curtain wall.

A capable joinery employed to accommodate the movements is the key to wall's integrity. A wall is only as good as its weakest component, which almost invariably happens to be joinery. Seals of the systemic joinery and intra-system transitions should perform all the required façade protective functions and allow for free movement. (See Figure 6). The recognition of this principle led to development of many well-performing detail solutions seen in the off-the-shelf foreign systems and sophisticated domestic custom curtain walling, (ranging from use of a dedicated inserts and collars of elastomeric membrane coupled with generous overlaps). These solutions are contrasted with the poorly performing details characterized by a single sealant joint performing all façade control functions, subjected to differential movements in excess of its elasticity, and interrupted at every anchor and corner, with another sealant joint placed in the back, attaching to a non-continuous substrate (horizontal mullion) and interrupted at every anchor and corner. This solution was publicly identified as incorrect in America almost 30 years ago (R.L. Quirouette, 1982). Unfortunately, this solution is still seen prevalent in domestic manufacturers' catalogs and stems from misunderstanding of functions performed by curtain wall components and the exact location of the boundary between wet and dry environments. (See Figure 5).

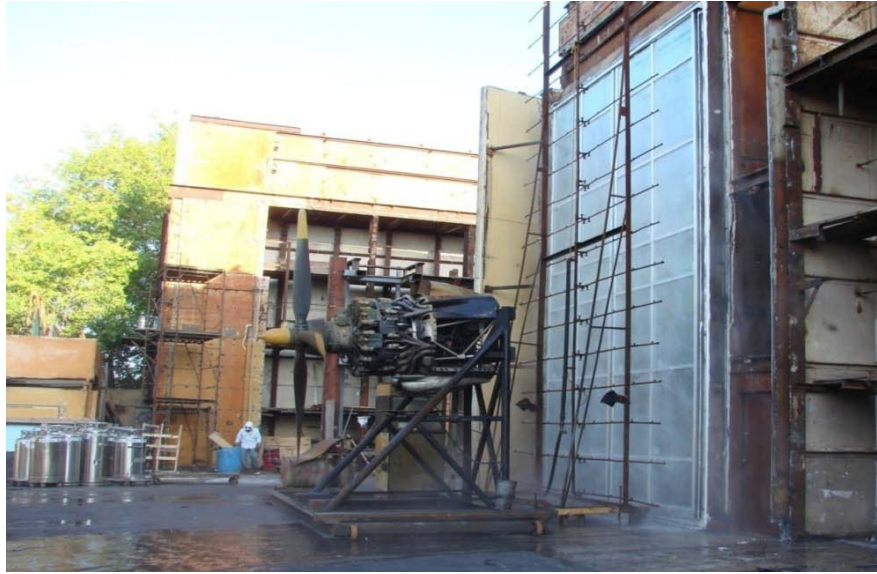
Figure 7. Dynamic water testing of a curtain wall in a laboratory. Only 5% of walls generally pass their first test.

Generally, how resistant are curtain walls to failures? The data is not easily available. Owners and managers, who would be the best source of the data, are incidentally the party least eager to speak up for public relations purposes. The data is available from construction testing instead. Mockup testing is crucial in assessing unproven systems and for the purposes of contributing to subsequently finalized designs. Generally, only the most prominent projects have sufficient funding to individually test their walls. The mockups built for the laboratory tests generally represent the highest and best contractors' efforts on the largest and best projects. Therefore, the results are hardly random. The owner of one of the largest wall mockup testing laboratories in the world, where many of the most prominent building walls were tested, ranging from Sears Towers in Chicago to Petronas Towers in Kuala Lumpur, estimated in 2007 that 95% of walls tested in his laboratory failed their first tests. The typical testing includes a dynamic water testing and structural test at 100% and 150% of the design wind pressure. (See Figure 7).

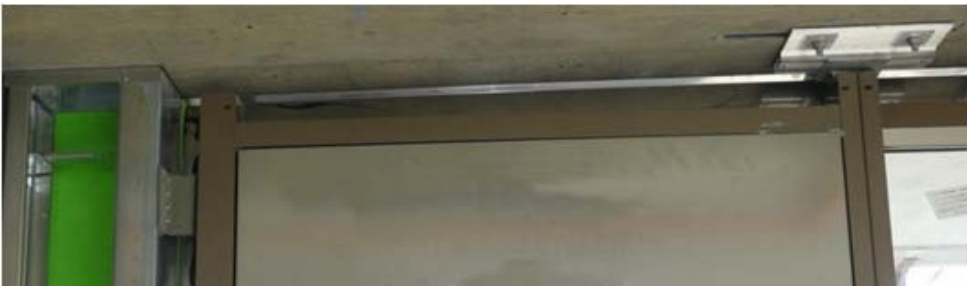
Figure 11. Interior photograph of the head of exterior wall. Indirect support of a glazed curtain wall jamb mullion through an adjacent light gage metal framing. (Note the stub of the single deflection track on the left side.)

Results: The ultimate result of the "triple witching" described above is failures observed in the field. One spectacular failure stems from the attempts of detailing a curtain wall like a window: with perimeter attachments, as opposed to a simple span frame. A curtain wall is seen with jamb mullions attached to an adjacent structure, as opposed to the remaining mullions which are attached directly the structure. The adjacent structure would need to have sufficient load resistance to take the reactions from the jambs. (See Figure 10 exemplifying this challenge). This may be correct if the adjacent system is capable of safely transferring the curtain wall reactions onto the main frame and the differential movements are verified. However, more often than not, the adjacent system is not fully coordinated. (See Figure 11). An example of a resulting failure is shown in Figure 12. The wall was designed to 110mph fastest mile wind load and failed during Hurricane Wilma. Initial breakage of glass caused unanticipated service condition: pressurization of the building interior. Aluminum jamb mullions were exclusively supported onto adjacent CMU piers, which were not designed to collect reactions from the curtain wall.

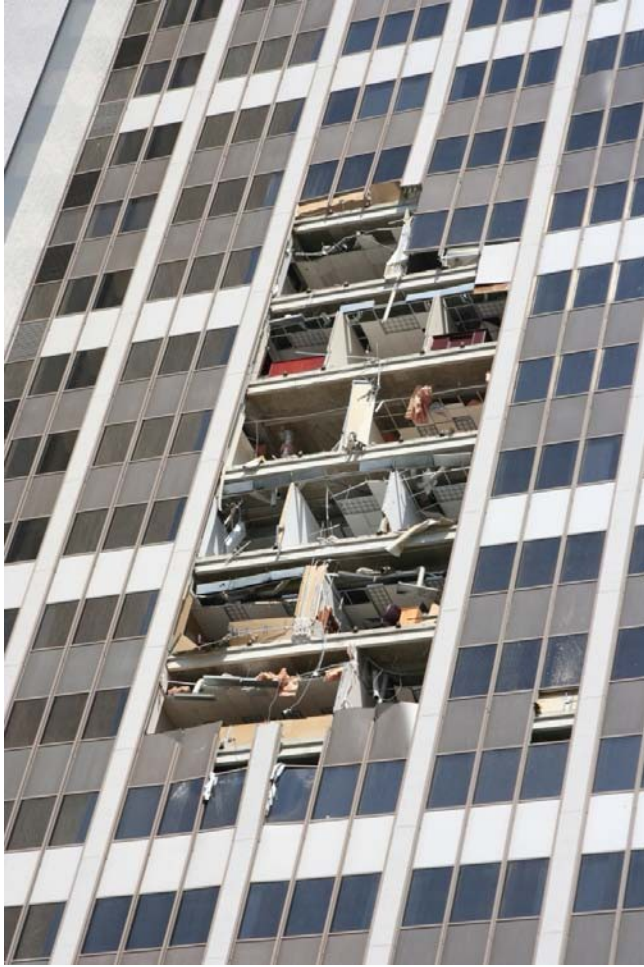
Figure 12. Exterior photograph of exterior wall. A spectacular, catastrophic collapse resulting from uncoordinated support of a curtain wall.. Jamb aluminum mullions were exclusively supported onto adjacent CMU piers, which had insufficient load resistance to collect design reactions from the curtain wall. Photo credit – Mr. Alessandro Abate.

If only 5% of the best walls passed their first mockup test, how well would the average wall perform? Mother Nature conducted an informative, accidentally random test up to the wind requirements set by previous building codes but no curtain wall specific statistical data is available. The Hurricane Wilma became a true test fir hurricane resistance of building inventory in South Florida. According to the weather data collected by NOAA, generally no wind speed was recorded that significantly exceeded the wind resistance requirements set by previous Florida building codes (110 and 120mph). The highest recorded gusts were in the 100-120 mph range. Wilma's eye passed over five counties in South Florida: occupied by population of 5.3 million, living on 8303 square miles according to the 2000 census (U.S. Census Bureau). Property damages reported in Florida, (not limited to the wind peril and not limited to walls), exceeded \$10 billion of 2005 USD (Pasch et all, 2006) – which makes approximately \$2000 per capita. There is no specific curtain wall damage actuarial data available. The analysis is complicated by several factors, e.g. two different methodologies in calculating wind gusts (fastest mile and 3 second gust) and by the following hurricane Katrina, much gentler than Hurricane Wilma in South Florida, but causing damage difficult to distinguish from Wilma. The general conclusion is that significant percentage of construction doesn't meet basic building code requirements. Based on this author's observations, curtain walls frequently failed by water infiltration and detachment and fall of wall components (characterized by e.g. missing aluminum trim - snap caps) in addition to sustaining widespread impact damage by windborne debris. Some assemblies failed catastrophically, revealing a defective assembly. (See Figure 12).
