Using Pavement Condition Index PCI Method to Evaluate the Service Condition of Flexible and Rigid Pavements

(A case study in Sulaimani)

HARDI SAADULLAH FATHULLAH

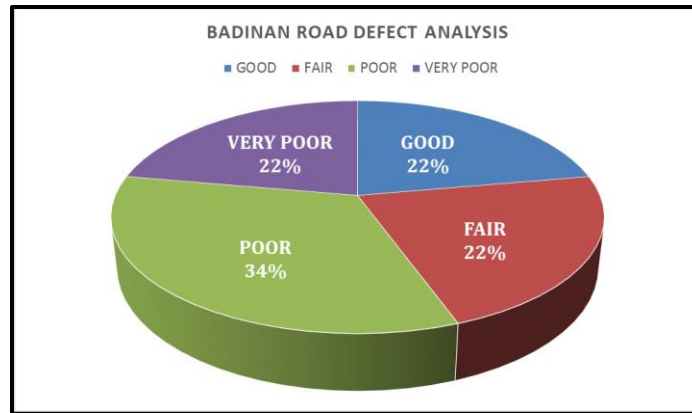
Figure 3: Badinan Road Defect Analysis

From the analysis results for PCI, it was found that 22% of the road was in a very poor condition, 34% was in a poor condition, 22% was in a fair condition, 22% was in a good condition and the average road condition was found to be in a fair condition. Since the exact location of the defects are known, a proper action can be taken and the treatment which required can be applied as explained previously.

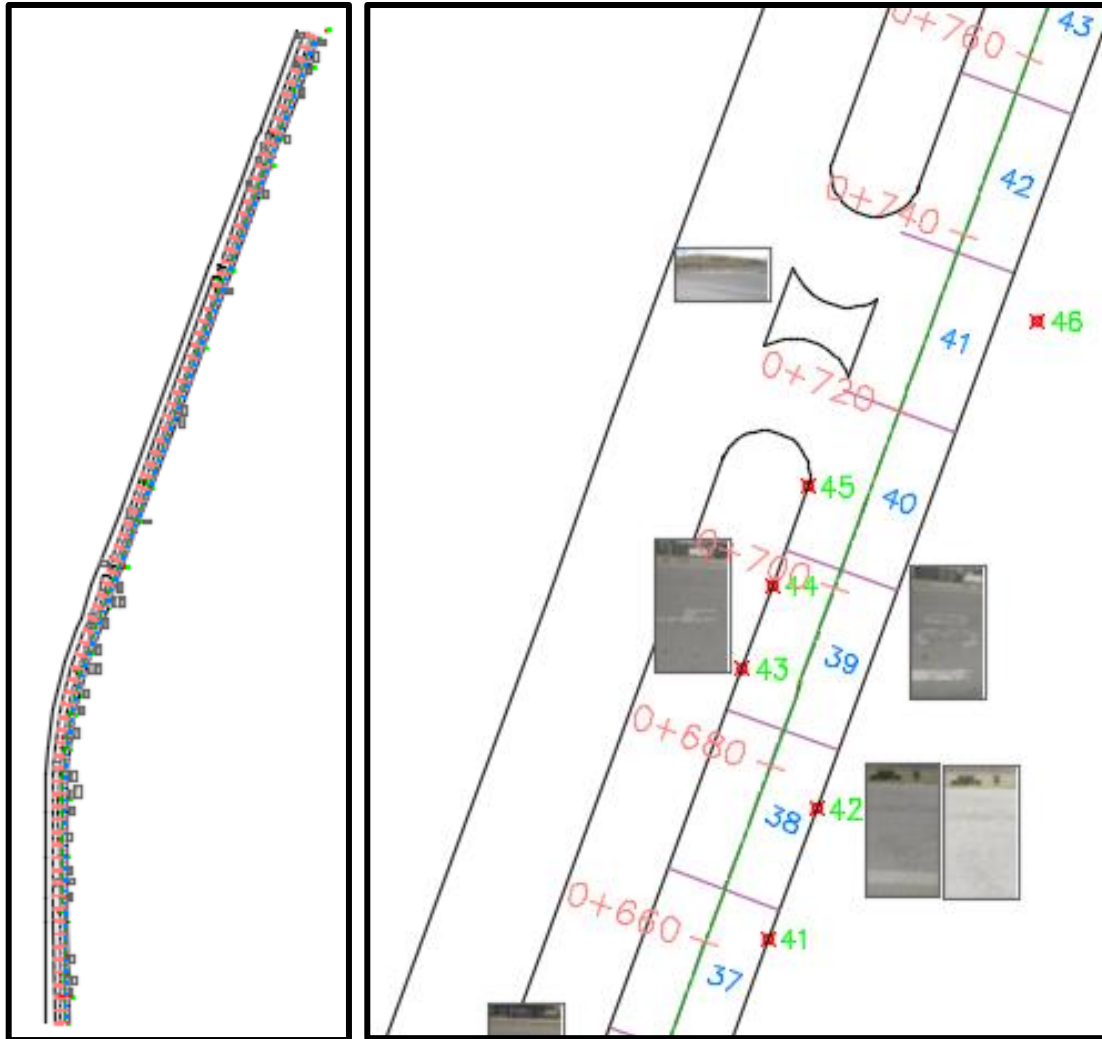
Figure 4: Hawary Shar Road Defect Layout Plan

Is a flexible pavement that extended from the Kobane interchange at the 60-meter Malik Mahmood ring road to the Hawari Shar Roundabout. The branch of road is a 2 way 4 lane road, which is 1620 m in length and 12.45m in width. For PCI determination the road branch was divided into 18 sections, each with the area of 1122.6m² and the sections was further divided into 5 sample units each of 224.52 m² as recommended by ASTM D6433 (Fig.4-3).

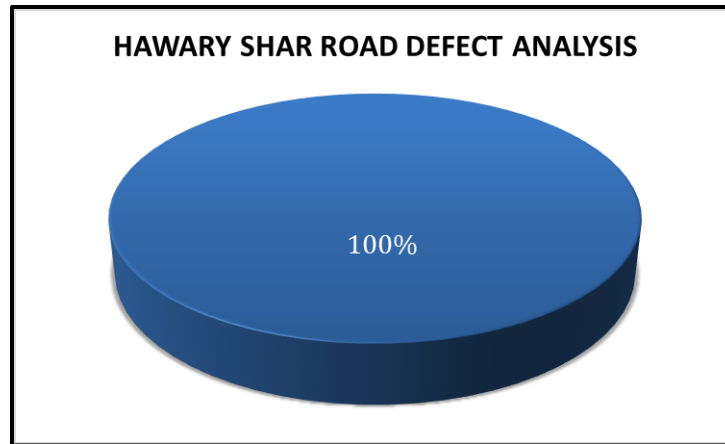
Figure 5: Hawary Shar Road Defect Analysis

From the analysis results for PCI, it was found that 100% of the road was in an excellent condition. This means the road is in a condition that no major treatment is required, but there are still cracks and potholes that require maintenance like sealing and small patching to prevent them from getting worse and maintaining the condition index of the road for a longer period of time.
