# **Flexible Pavement Distresses in Sulaymaniyah City**

**Rebin Mahmood Enayet**

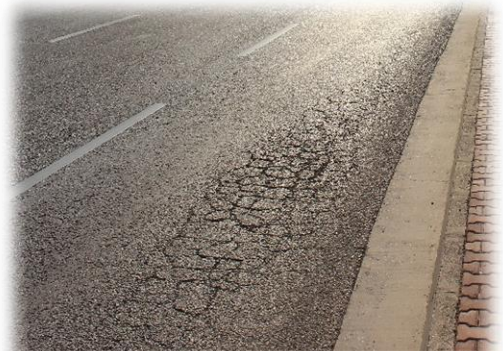
**Figure 2.** Fatigue Cracking

- a) **Fatigue Cracking:** Figure 2 Is the photo of the fatigue cracking on the existing road. It is a series of interconnected cracks in early stages of development. Develops into many-sided, sharp-angled pieces, usually less than 0.3 meters (m) on the longest side, characteristically with a chicken wire/alligator pattern, in later stages. [Note: in all tables, L=Low, M=medium and H=high].

The presence of fatigue cracking and their severities are presented in Table 2. Results show that there are a lot of fatigue cracking with a variety of severities on the Malik Mahmood ring road. The possible causes of these cracks are due to the excessive amount of axle loading, age of the road, weak surface or base or sub grade and poor drainages. The suggested maintenance methods for repairing this defect are based on the severity levels, for low severity levels use suitable amount of sealant to prevent water entering in to the road layers and for moderate and high severity levels full depth patch is effective.

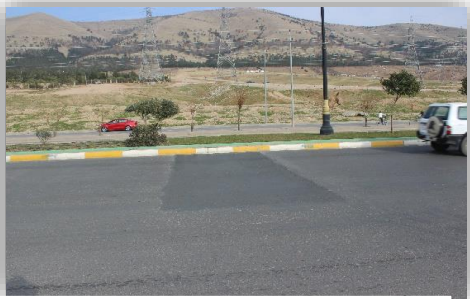
**Figure 5.** Patching

d) **Patching:** Figure 5. Is the photo of the patching on the existing road, Patching is a part of the pavement surface greater than 0.1m<sup>2</sup> that have been removed and replaced with additional materials applied to the pavement after the original construction.

The presence of patching and their severities are presented in Table 5. Results indicate that there are a wide range of patching with a variety of severities on the Malik Mahmood ring road. These patching causes the pavement more roughness and leads to joint cracks. The possible causes of these cracks are due to several types of previous cracks that have been treated or replaced with new pavement and may lead to patching distresses such as treatment of potholes, removal of fatigue cracking, shoving and corrugation patching and as a result of excessive traffic loads, poor quality of materials that are used to construction and poor implementation of asphalt. The suggested maintenance methods for repairing this defect are repair actions in themselves but they can be treated with removal or placement of new overlay.

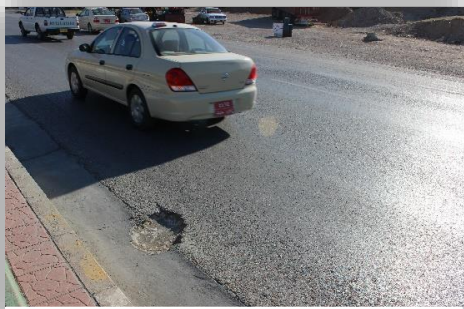
**Figure 6.** Potholes

e) **Potholes:** Figure 6. Is the photo of the patching on the existing road, Pothole is a hole in a road surface that penetrate the road through the hot mix asphalt layer down to the base course of the pavement. The availability of patching and their severities are presented in Table 6, which shows that there are a lot of patching with a variety of severities on the selected area. This type of distress causes the pavement to allow moisture to infiltrate the layers and causes roughness which can cause serious damage to vehicles going at high speed.

The possible causes of these defects are basically severe alligator cracking that is not treated. The interconnected alligator cracks create small chunks of pavement which will be dislodged as vehicles drive over them which forms the pothole and also the possible causes of pothole are weak spots in the base or subgrade, Poor surface mixtures, pavement surface have been dislodged and heavy traffic volume. The most effective method that is suggested as a maintenance method for repairing this type of distress is to remove dislodged chunks and then patched.

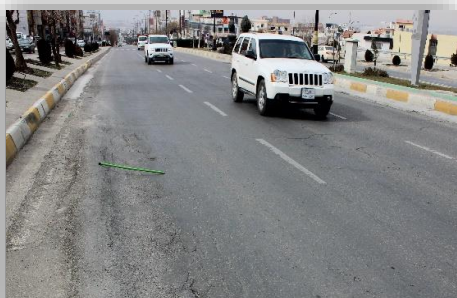
**Figure 7.** Rutting

f) **Rutting:** Figure 7. Is the photo of the rutting on the existing road. Rutting is a form of distress, which is a surface depression in the path of the wheel. The availability of rutting and their severities are presented in Table 7, which shows that there are a lot of rutting with a variety of severities on the selected area. This type of distress tend to pull vehicles into the rut path which inflicts vehicle damage.

The possible causes of rutting including heavy truck loading during high-temperature climates, consolidation or lateral movement of materials and problems in mix design such as excessive asphalt content, mineral filler, and insufficient amount of angular aggregate. The most effective method that is suggested as a maintenance method for repairing this type of distress is based on the severity levels of the rutting, if the depth of the rutting is too small it can be left untreated otherwise deep ruts should be removed and replaced by new pavement.

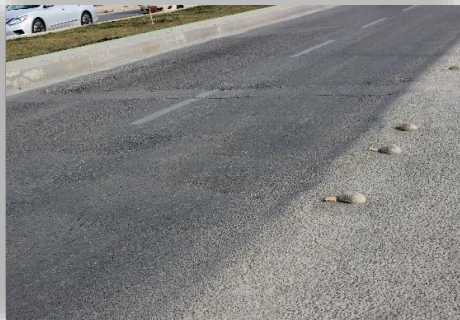
**Figure 8.** Corrugation and shoving

**g) Corrugation and shoving:** Figure 8. Is the photo of the corrugation and shoving on the Malik Mahmood ring road. Shoving is a longitudinal displacement of a localized area of the pavement surface. The presence of shoving and their severities are presented in Table 8. The recorded data shows that there are a lot of shoving with a variety of severities on the selected road. These corrugation and shoving causes the pavement more roughness and discomfort for vehicles.

The possible causes of corrugation and shoving including heavy truck loading, excessive moisture in the pavement structure and an unstable hot-mix asphalt layer with poor mix design. The effective maintenance method for repairing this type of distress is for small localized areas of corrugation or shoving, remove the distorted pavement and patch and for large corrugated or shoved areas indicative of general HMA failure, remove the damaged pavement and overlay.

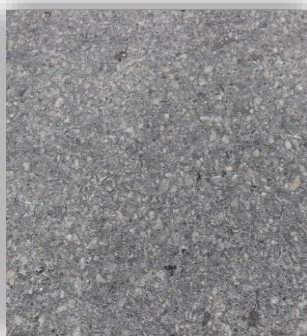
**Figure 9.** Raveling

**h) Raveling and Polished aggregate:** Figure 9 and 10. Is the photo of the raveling and polished aggregate of the Malik Mahmood ring road. Raveling is loss of material that covered asphalt surface that ranges from loss of fines to loss of some coarse aggregate, while polished aggregate is the surface binder worn away to expose coarse aggregate.

The presence of raveling and polished aggregate with their severities are presented in Table 9. The recorded data shows that there are a wide range of raveling and polished aggregate on the selected pavement, these raveling and polished aggregate, water collecting and loss of skid resistance.

The possible causes of these types of distresses are heavy and repeated traffic volume, water and loss of bond between aggregate particles and the asphalt binder as a result of inadequate compaction during construction. The effective maintenance method for repairing this type of distress is applying a skid resistant slurry seal, remove the defected area and patch or overlaying.
