## **Paybar Ali Shawnim**

# **Roads and Traffic Management in Sulaymany and its Suburban Areas**

**( A Critical review on Geometric Design of the Roads & their associated components including Visible Road Markings and Traffic Signs & Signals )**

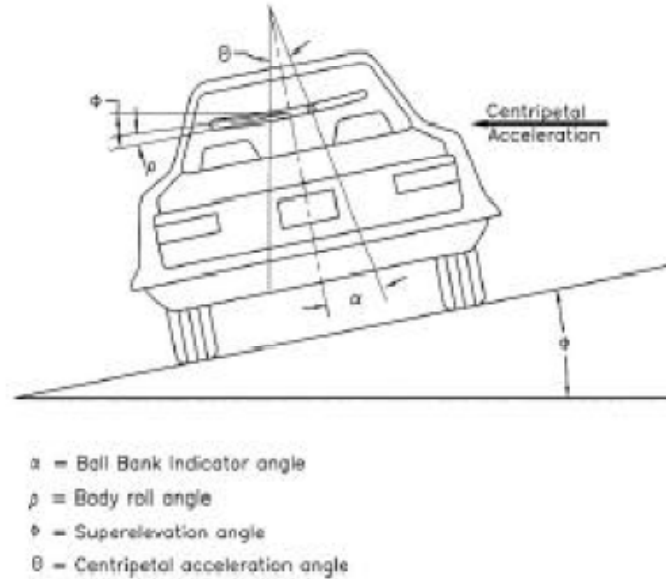
Figure ( 1 )

Roads leading through suburbs and to other towns which are mostly speedy roads in our mountainous region must comply with the Super Elevation requirements in their design on bends , which is worked out from a simple engineering procedure , See figure ( 1 ) , for this purpose , Road Designers can follow AASHTO Standard Code , but in fact they seem they did not, or otherwise , the implementing team failed to comply with . As examples ; the roads leading to Dokan , Koya , and to Hiran and Shaqlawa . ( More details can be obtained on request from my e-mail address given at the end of this article ) .

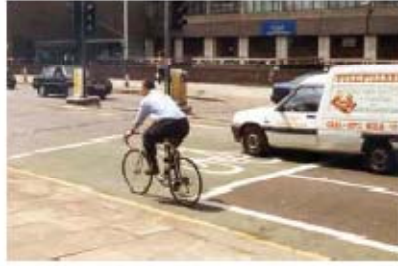
**Figure ( ۲ )**

Divide up roads in to two lanes , 1<sup>st</sup> of which to be marked for Emergency Vehicles and Public Bus lane which in turn may be sub-divided into narrower Green colored lane for use by Cyclists & Motor Bike riders , and the 2<sup>nd</sup> for general use by vehicles in general . See figure ( 2, 3 & 4 ) . These types of marking have not been seen so far in our region and to set an example , The Emergency Hospital is situated within a set of very narrow roads all around in a crowded market area behind the Civil Court Building , Emergency Vehicles getting in and out of the place, should get through slow traffic of inappropriate roads having no design considerations for such cases .

**Plate 9.1** Cycle advance at traffic signals.

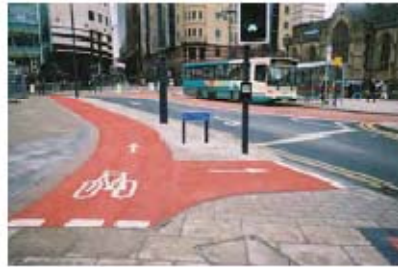
**Figure ( ۳ )**

**Plate 8.3** Off road cycle lane.

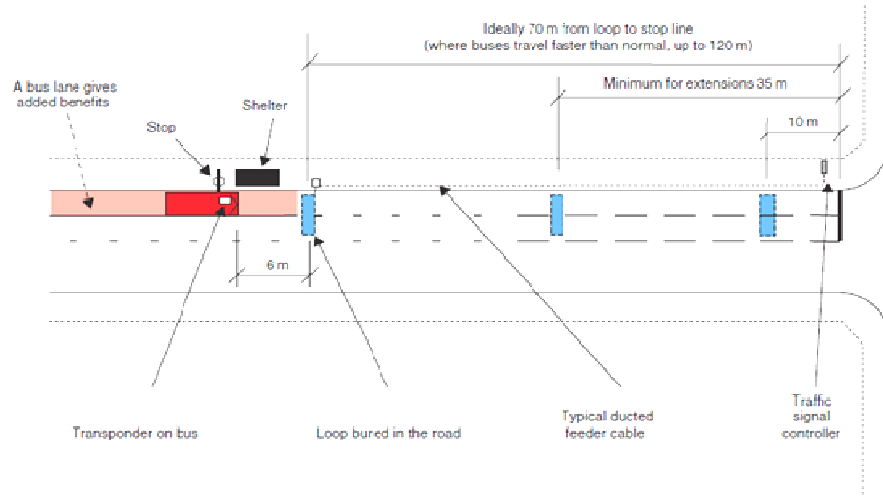
Figure ( 4 )

Fig. 9.6 Bus loop detector siting.

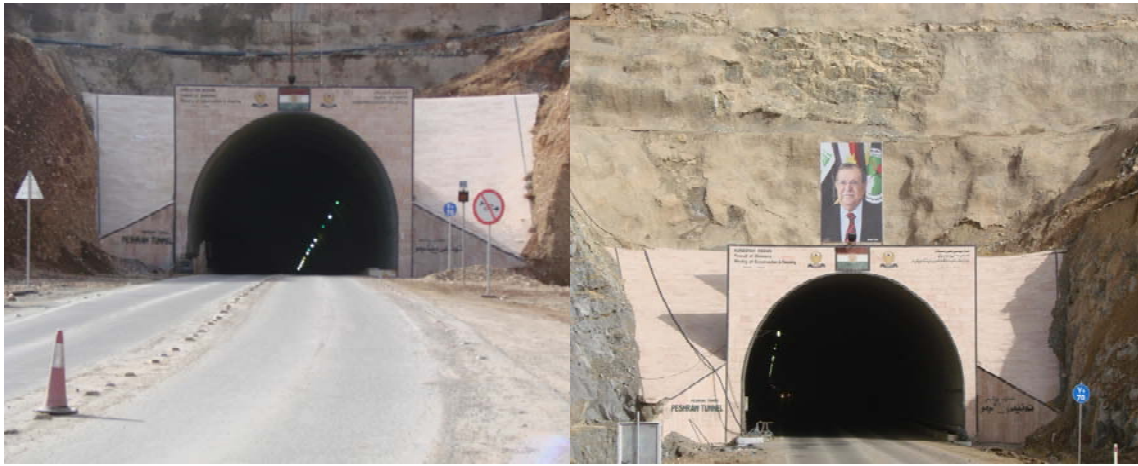
**Photos ( ١ & ٢ ) , Peshraw Tunnel**

This tunnel is an Un Safe tunnel may lead to lots of troubles at any moment in the future ( the followings are some of the most important critical points ) ;

- Lack of Ventilation ( Fume & Exhaust Gases remains un cleared through the tunnel all the time while it is in moderate frequent use )
- Lack of means of Fire protection in case of Fire Out breaks .
- Lack of the means of any sort of Human Protection in case of any kind of Emergencies people driving through could face .
- Lack of proper Inside Lightning , only a few inappropriate naked bulbs are installed in a very Unprofessional manner scattered at the beginning and at some other places .

- Lack of Water Drainage , Danger of Water Seepage ( Water Leakage ) , water discharges through most of the joints of the lining concrete sections underlining the tunnel , now a days water can be seen flowing in little amounts on the ground all over through the tunnel .
- Lack of Pedestrian side walkways for Break down and Emergencies . and finally ,
- No proper Signs and Signals put as to driving guidance in advance , on entry /or inside the tunnel .

**Back face ( Seetak area )**

**Front face**

Apart of Ventilation , Human Protection and Pedestrian Side walk ways , The rest of the points mentioned above can be embarked upon through simple installation works of which the Transportation Engineering Section is familiar with and can do .

As for those other points, e.g. Human Protection , The current Tunnel should have had another walk way tunnel constructed side by side parallel to the existing tunnel , used for many purposes such as for maintaining the current tunnel and for life saving ( Human Protection ) in case of emergencies such as fire out break or any sort of break down on the road . In deed , this means the construction of a new tunnel , tunneling works of a smaller scale than the current one , which needs new design and finance to get it done .

Ventilation problem can be sorted out in the way I have planned for within my research plans for rework ( a copy of which can be obtained by the related authority from my e-mail address mentioned at the end of this article ) .
