# توانای تیپه ریوون

ئەندازیار : ئارام سەلام

## WELCOME TO *The good, the bad and the ugly –* design and construction for access

The purpose of this resource is to explain how people with a disability benefit from good design and construction and why precise application of relevant technical specifications is necessary to achieve the greatest level of access for the greatest number of people.

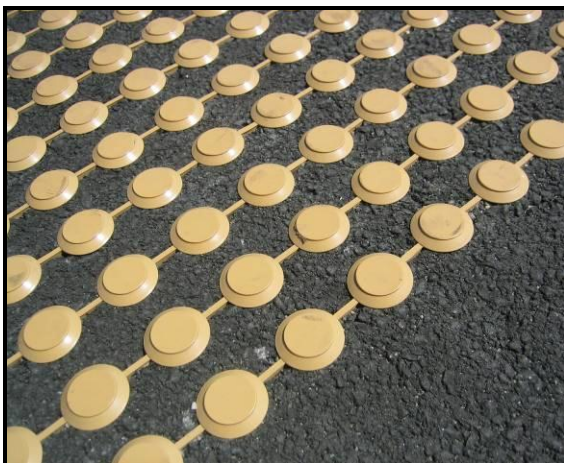
Photo 1 shows discrete-type and photo 2 shows integrated-type warning TGSIs.

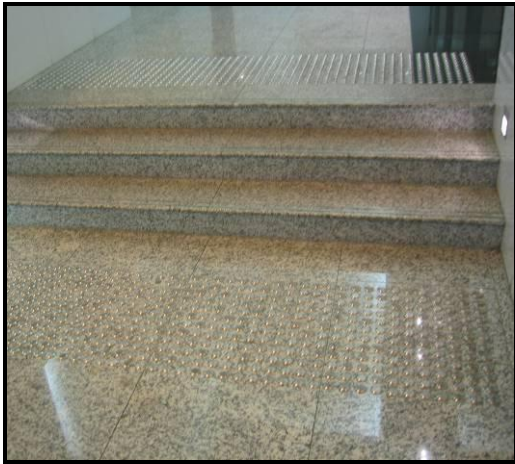
*Photo 3*

The TGSIs in photo 3 and 4 do not meet the specifications of AS 1428.4 as they do not have the required luminance contrast. For TGSIs to be useful to as many people as possible a minimum of 30% luminance contrast compared to the surrounding floor/ground surface is required. These photos also show a number of other non-compliant features in relation to handrails and the lack of colour contrast nosings which are addressed in other parts of this document.

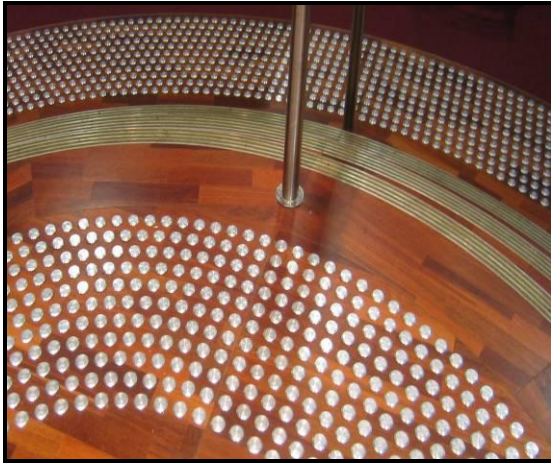
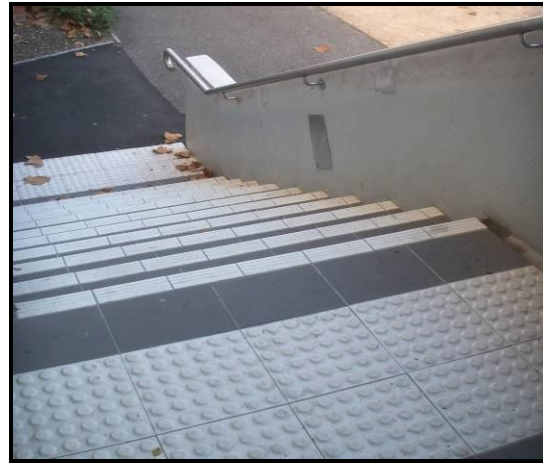
Photos 5 and 6 show TGSIs that have high luminance contrast as specified in AS1428.4. Note the correct setback from the top nosings of 300 +/-10 mm and the minimum depth of 600mm.

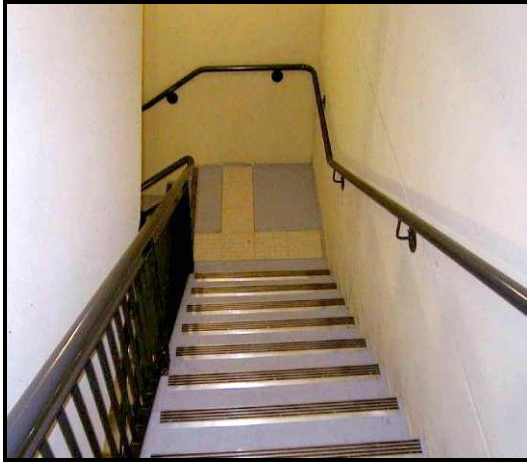
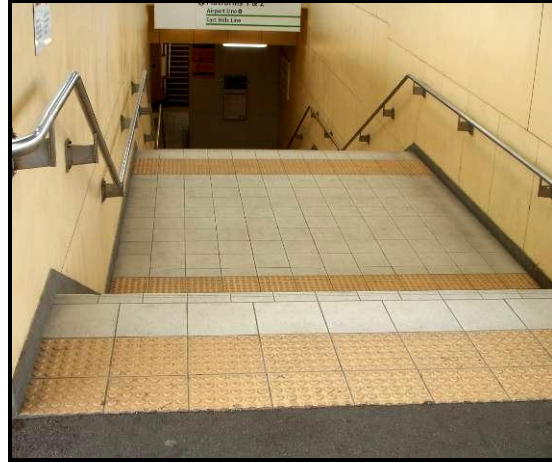
Photos 7 and 8 show incorrect installations as the TGSIs are not required on either intermediate landing as both handrails are continuous.

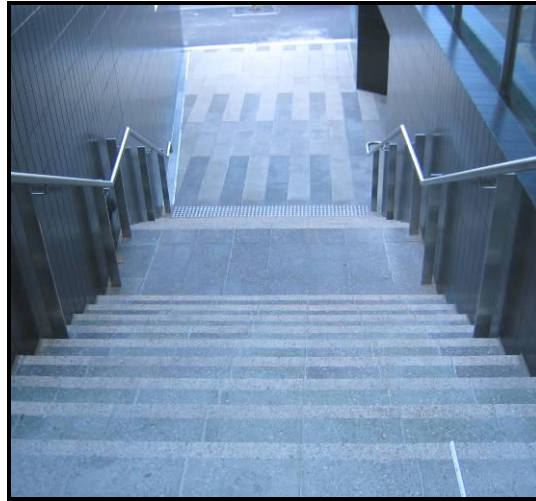
*Photo 10*

Photo 10 shows the correct interpretation of requirements for TGSIs on an intermediate landing with no handrail break: there are no TGSIs on the landing.

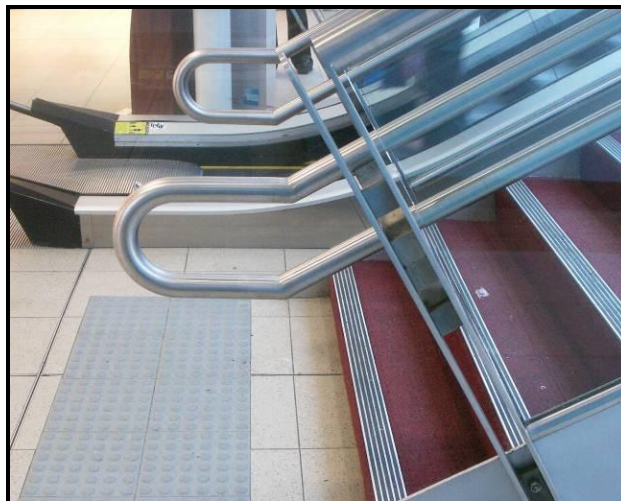
*Photo 1 shows a well-designed and constructed handrail*

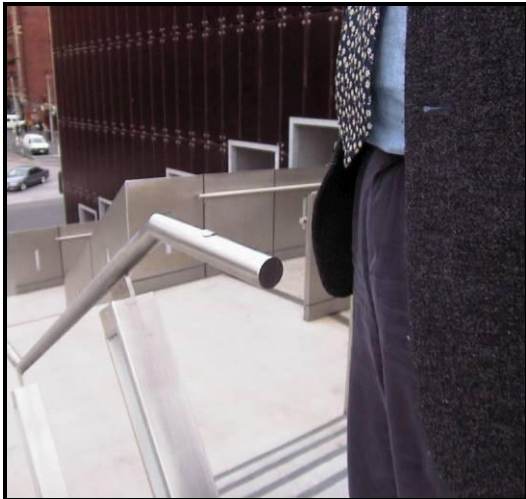
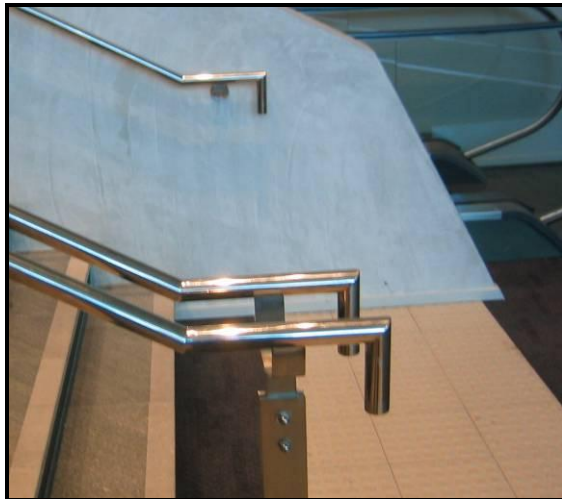
The handrails in photos 2 – 5 do not meet the specifications of AS 1428.1 for handrails on stairs suitable for people with a disability as they do not return to a side wall or downwards and back on themselves 180°.

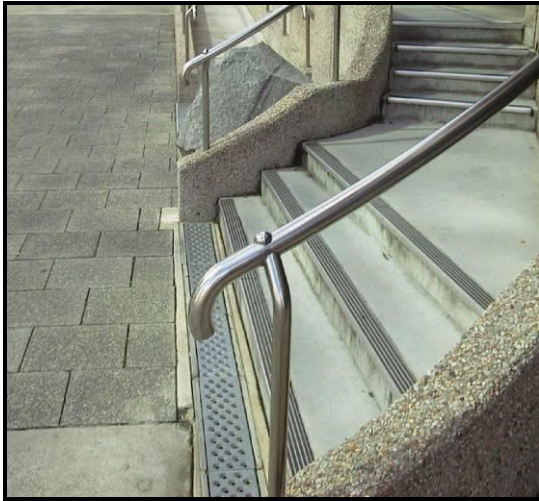
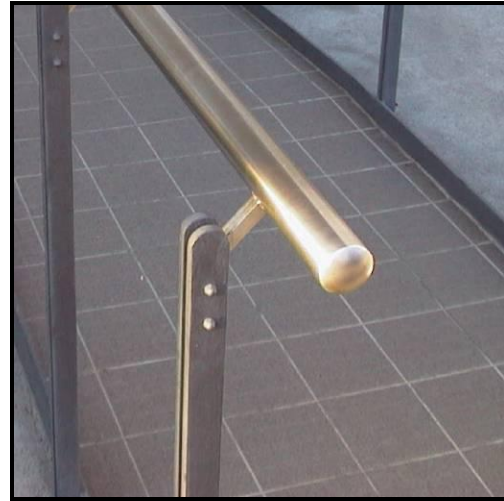
In addition the handrails in photos 4 and 5 do not comply with AS1428.1 because they do not have the required 270° top arc clear along the full length of the handrail or the minimum 15mm clearance under the handrail for finger and thumb transition as set out in the diagram below (taken from AS 1428.1 2001).

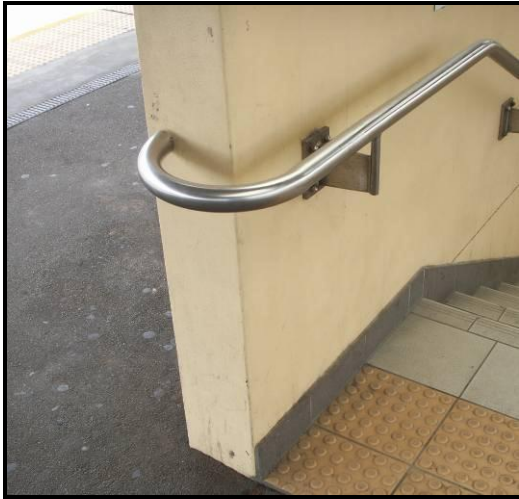
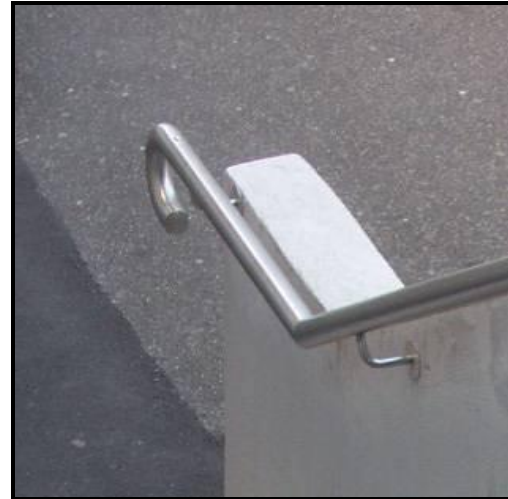
Photo 6 shows the correct application of returning the handrail back to a side wall and the required 270° top arc clearance. Photo 7 has the alternative application of returning back on itself 180°.

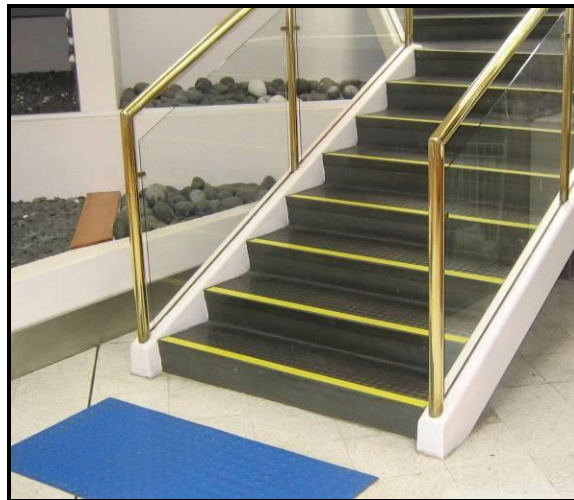
*Photo 8*

Handrails at the bottom of stairs should extend for the depth of one tread and then horizontally for at least 300mm. Photo 8 shows none of the required handrail extension features.

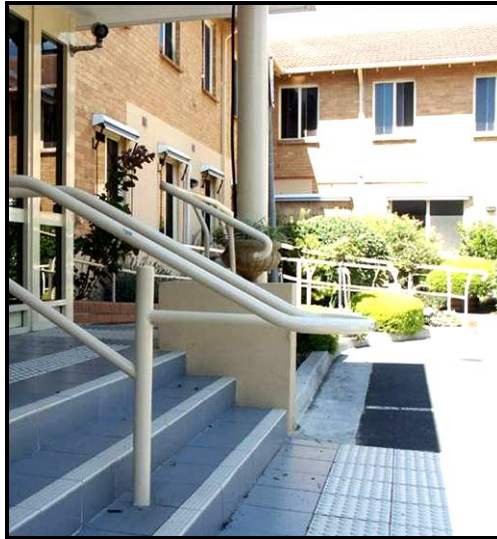
*Photo 9*

Photo 9 shows a handrail that appears to stick out into a path of travel. Care has to be taken to make sure the stairway is set back to allow for the correct handrail configuration so that the handrail does not encroach on the transverse path of travel. All too often the stairs are built hard up on the boundary line without the handrail configuration being taken into consideration.

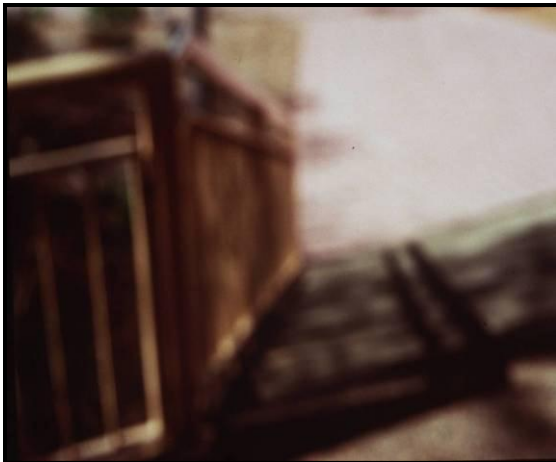
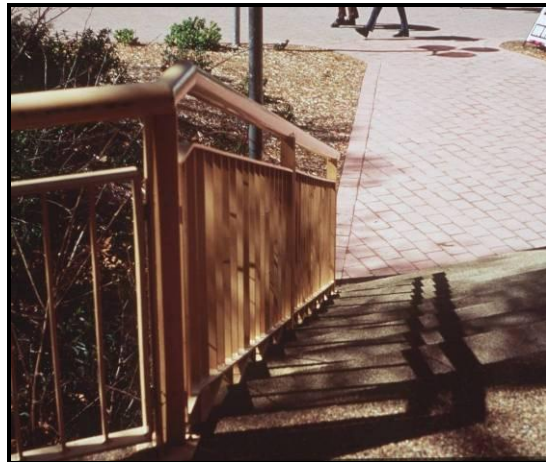
Photo 2 shows an example of the typical view a person with a vision impairment may experience (note no definition between treads/goings). Photo 3 shows the same stairs as seen by a person with 20/20 vision.

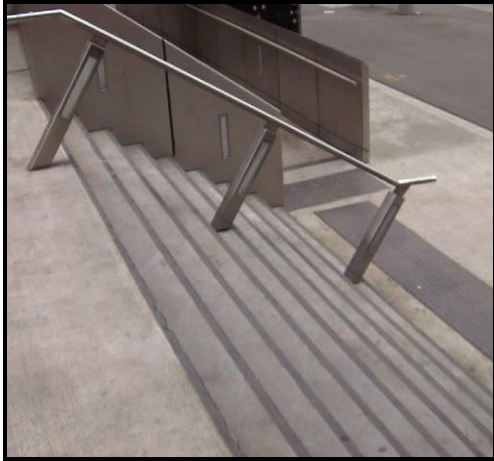
*Photo 4*

Photos 4 – 7 show nosing treatments that would not meet the requirements of AS1428.1.

Although the treatment, for example, in photo 4 may meet the criteria in the dry weather it will not in the wet weather as the luminance contrast is lost when the concrete becomes wet.

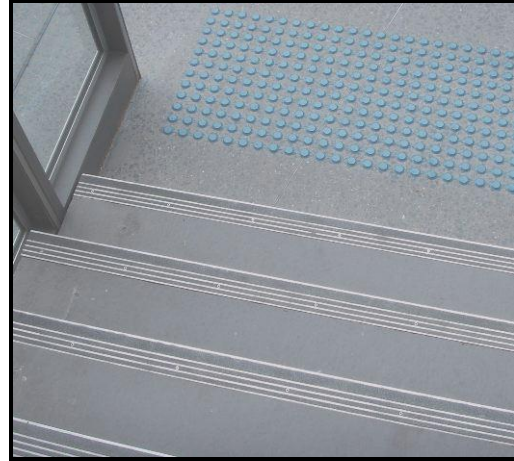
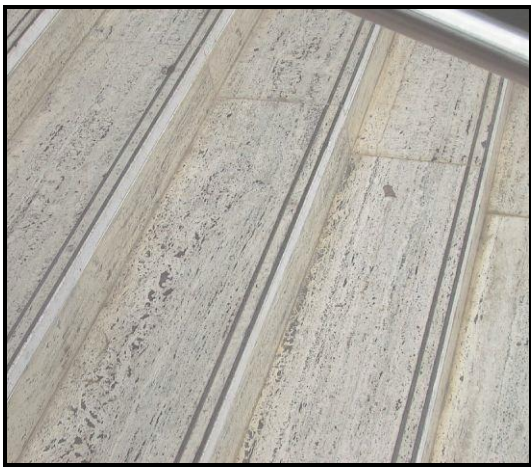
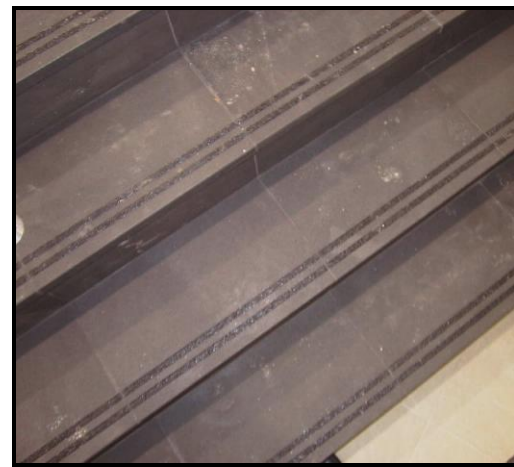
Photos 5, 6 and 7 are all variations of thin inserts placed in the nosing for slip resistance and will not achieve the required minimum 30% luminance contrast.

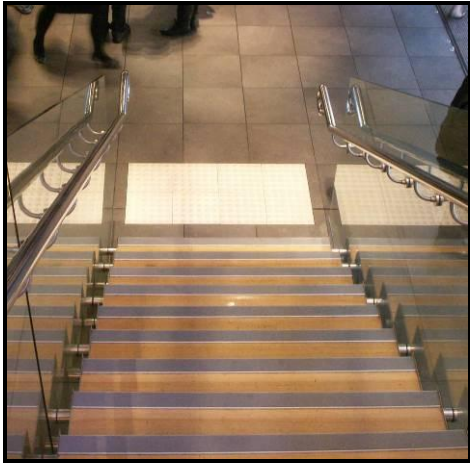
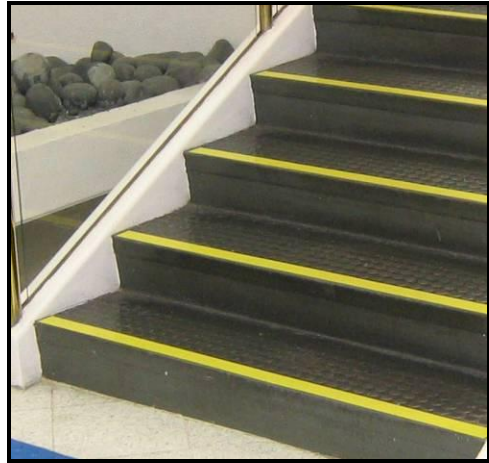
Photos 8 and 9 show the required minimum luminance contrast and depth of treatment on the nosings of the treads/goings.

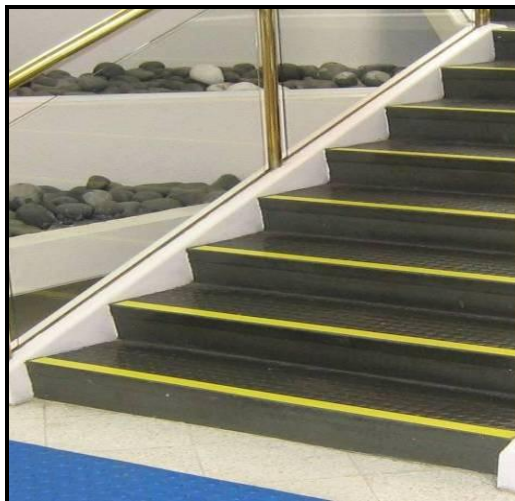
*Photo 1 shows a set of stairs with no open risers*

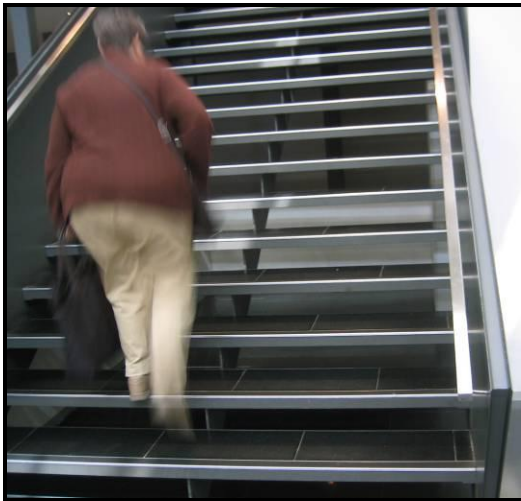
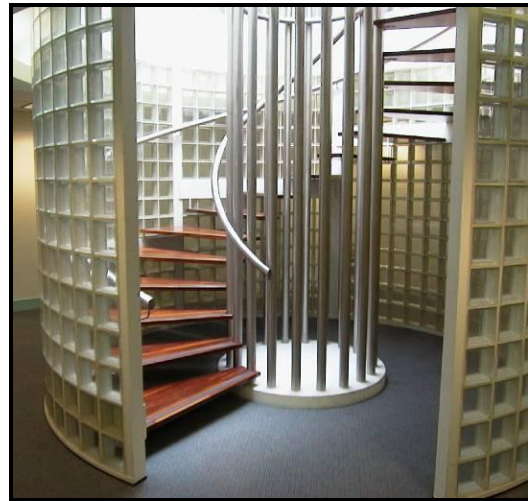
None of the stairways in photos in 2 – 5 meet the requirements of stairways suitable for people with disabilities in AS1428.1. Photos 2, 3 and 4 show open risers, with 3 and 4 showing light sources coming from behind the stairways, thus creating a strobing effect as one ascends the stairways. People using walking sticks or canes could also lose their footing if their stick slipped through the openings.

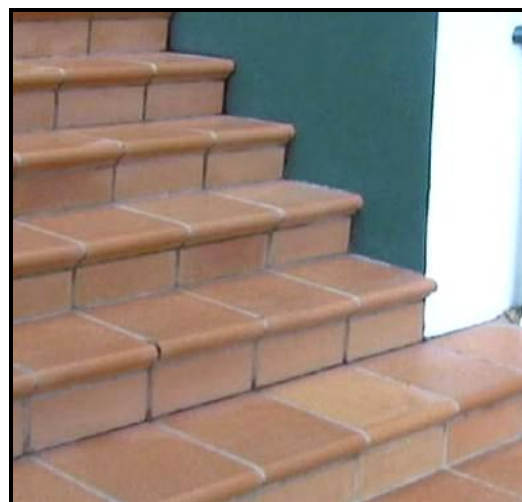
*Photo 5*

Photo 5, although showing enclosed and opaque risers this stairway still presents as a problem for people with a prosthesis or someone with ambulant disabilities that restricts leg movements due to the protruding lip which might catch someone's toe.

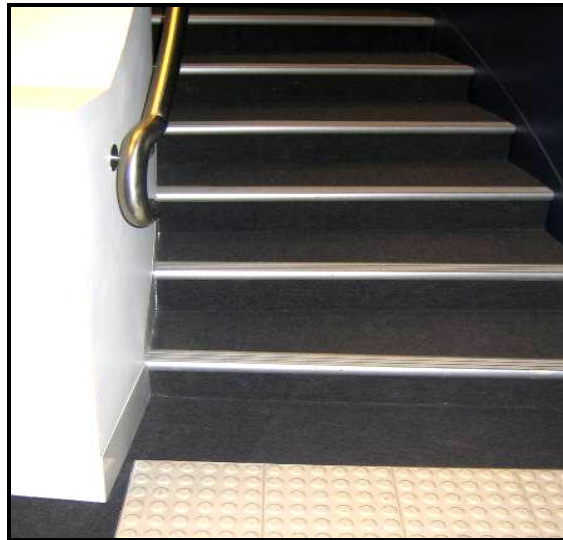
*Photo 6*

Photo 6 shows the required enclosed opaque risers with no overhangs.

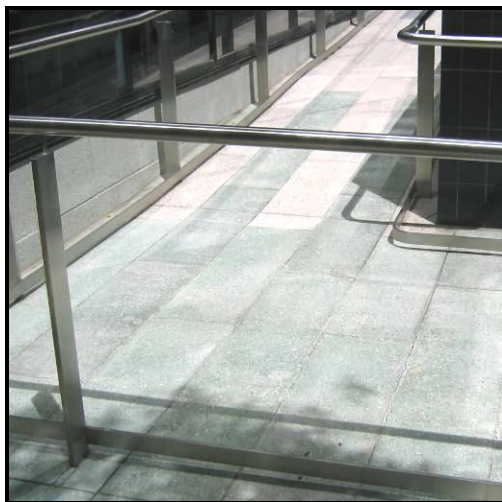
*Photo 1 shows a ramp with appropriate handrails and kerb rails*

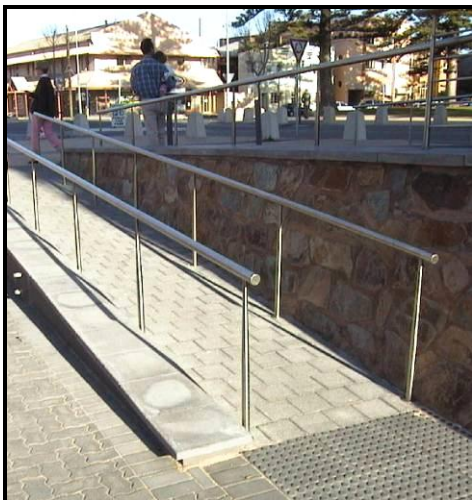
*Photo 2*

The handrails in photos 2 and 3 do not meet the specifications of AS 1428.1 as they do not return to a side wall or downwards and back on themselves 180°.

Photo 3 shows the handrail end at a height where a small child could accidentally run into it and injure their head. The handrails in photos 2, 3 and 4 do not meet AS 1428.1 because the handrails do not extend out horizontally for a minimum of 300mm past the transition point in the change of plane.

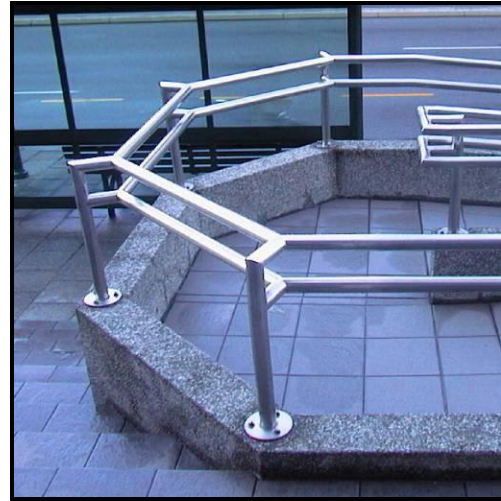
*Photo 5*

Photos 4 and 5 do not have the required clearance for the full length of the hand rails as the fixings intrude into the required clear top 270° arc and 15mm minimum clearance under the handrail (see diagram in *Issue 2*).

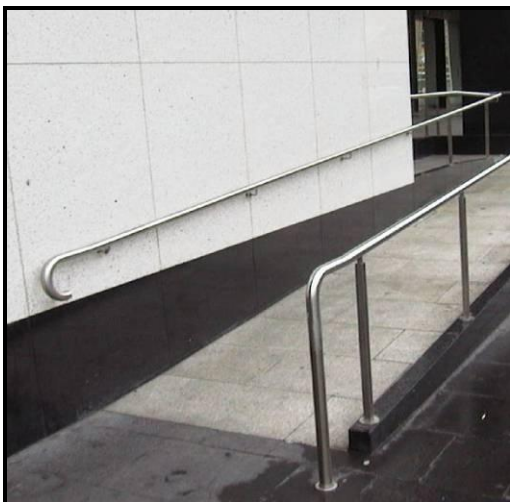
*Photo 6*

Photos 6 and 7 show the correct application of returning the handrail down and back onto itself to form the 180° return or onto a post. Note also the required clearances on the top 270° arc of the handrail and the 15mm directly under the handrail to allow for an uninterrupted transition along the full length of the handrail for fingers and thumbs.

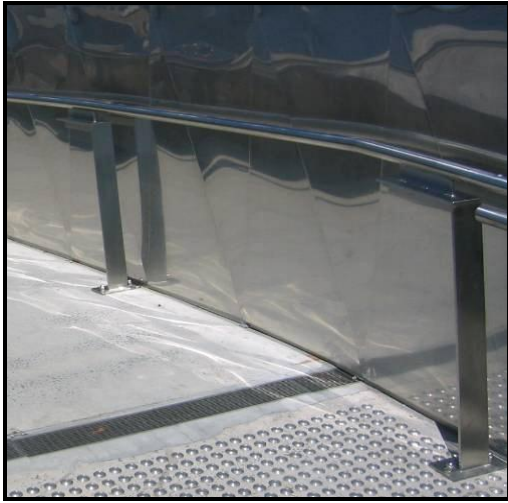
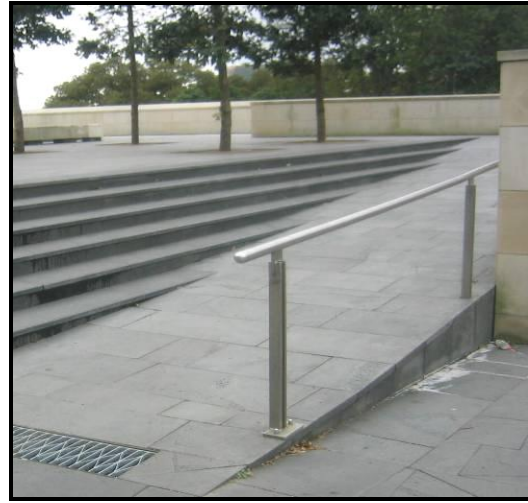
The ramps in photos 8 and 9 do not comply with AS 1428.1 because they have no kerbs or kerb rails. The ramp in photo 10 has the kerb rail incorrectly located as it intrudes into the trafficable surface of the ramp beyond the inside edge of the handrail. It is required to be parallel with the inside edge of the handrail or set back no further than 100mm.

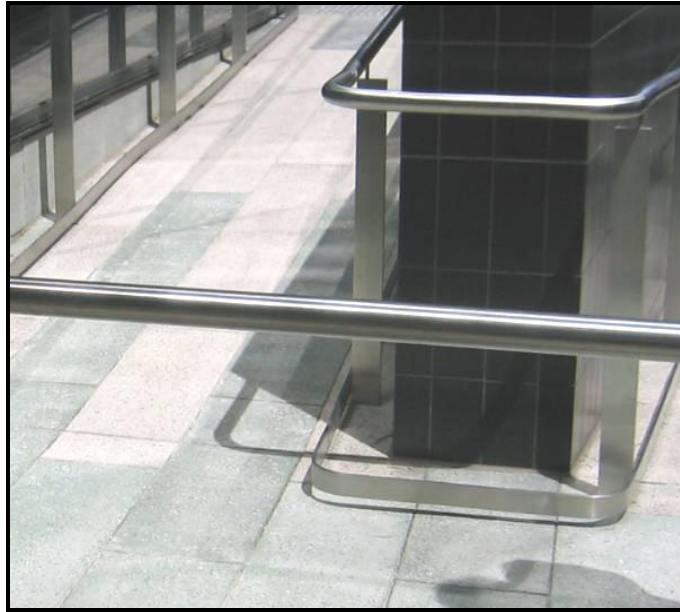
*Photo 11*

In photo 11 the kerb rails are parallel with the inside edge of the handrail and located as required by AS1428.1.

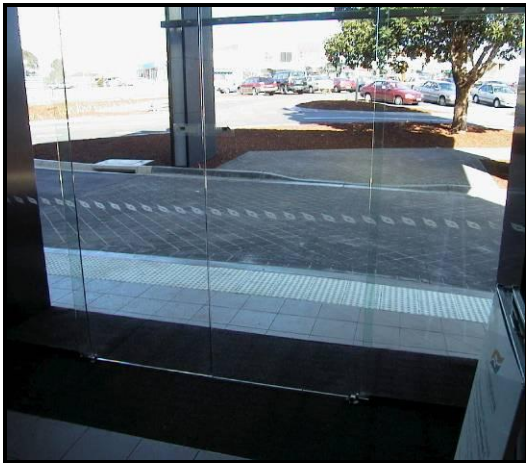
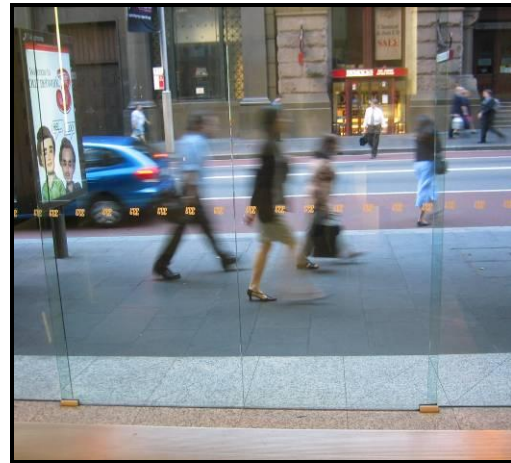
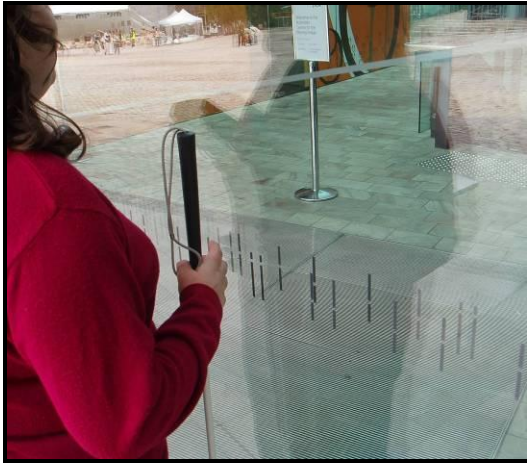
The visual indicators in photos 2 - 5 are located too high and/or do not meet the specifications of AS 1428.1. The intent of the requirement is to have a solid 75mm line extending across the full width of the glazed doorway and sidelights. These photos have in all cases a broken line of symbols or words, none of which have a depth of 75mm.

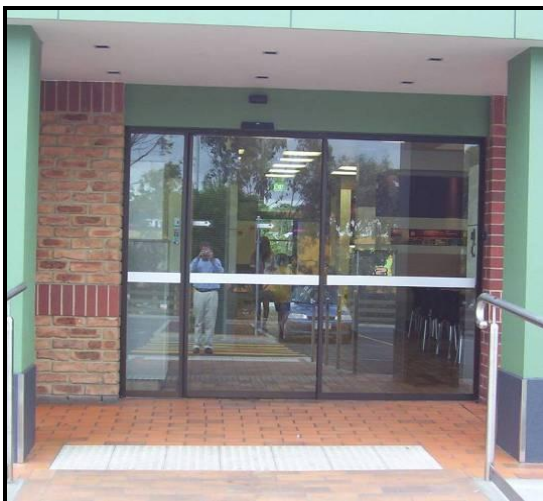
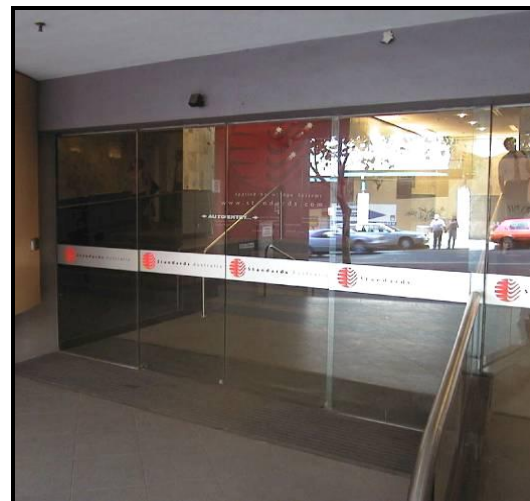
Photos 6 and 7 show the correct application of visual indicators on fully glazed doors.

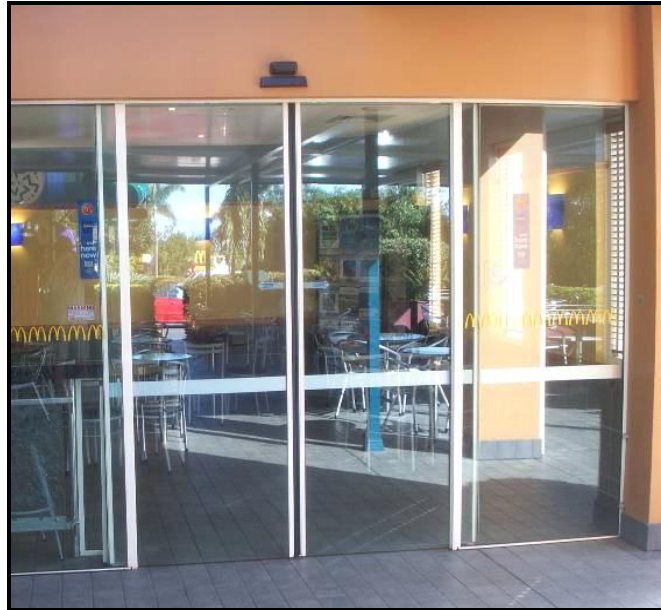
*Photo 12*

The visual indicator in photo 12 complies with AS 1428.1 as it has the required luminance contrast of at least 30 percent and is located at the appropriate height of 900mm – 1000mm above the finished floor.

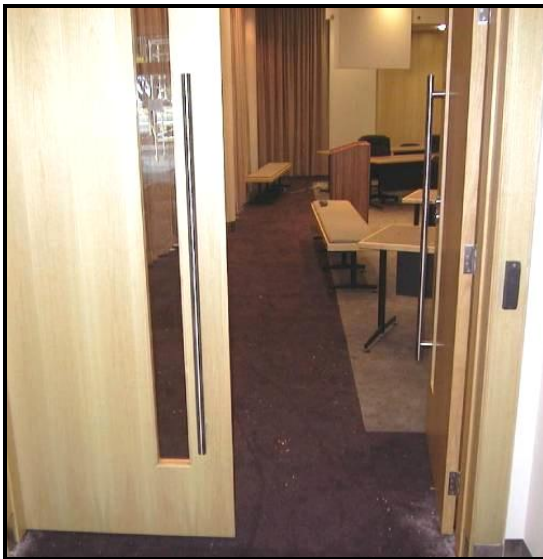
*Photo 2*

Photos 2 and 3 show larger manual doors that are often used that can exceed the maximum required force as set out by AS1428.1. To overcome this issue electronic door opening systems may be used.

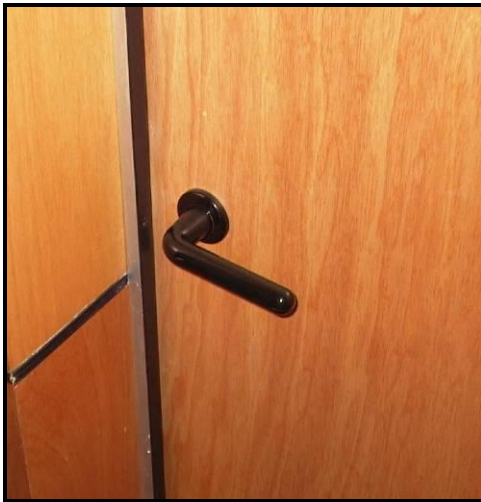
*Photo 4*

Photos 4 and 5 show “L” type lever handles. “D”-type lever handles are preferred as they provide the added advantage of reducing the risk of a person's hand slipping off the lever when operating the latch and opening the door.

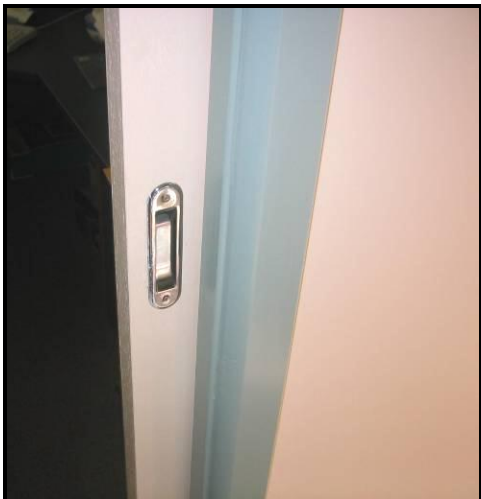
*Photo 6*

The recessed sliding door handle and door knob shown in photos 6 and 7 are extremely difficult for people with hand, wrist or arm disabilities to use due to reduced dexterity and strength.

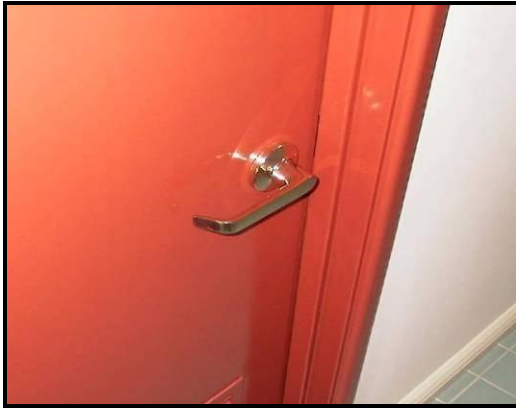
*Photo 8*

The “D” type lever handles in photos 8 and 9 are very user friendly for people with hand, wrist or arm impairments. Note the set out from the face of the door is such so as not to cause hand or wrist entrapment.

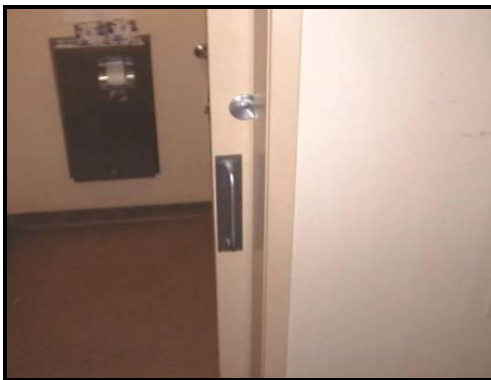
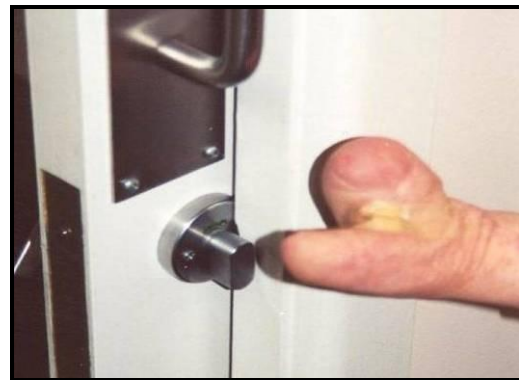
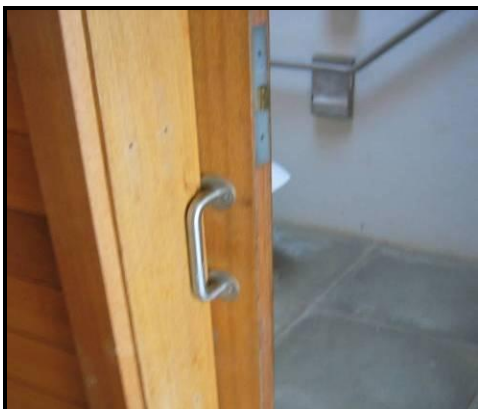
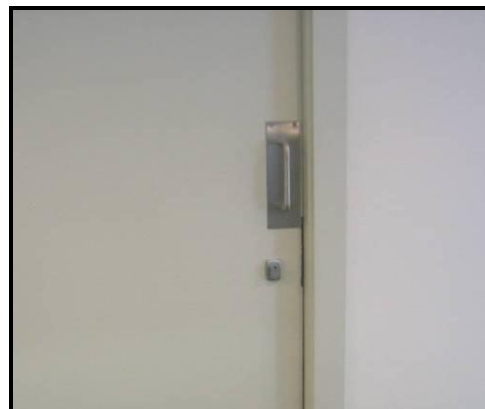
Minimum clearance of the door handles from the jambs shown in photos 10 - 13 has not been achieved in accordance with AS1428.1. This can result in injury to the knuckles when the door is opened or closed.

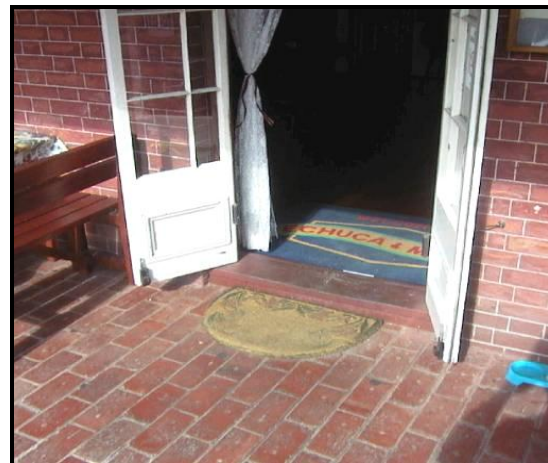
*Photo 3*

Photos 2 and 3 show entries with sills that restrict access by people who use wheelchairs and some with mobility disabilities, who might, for example, use a walking frame.

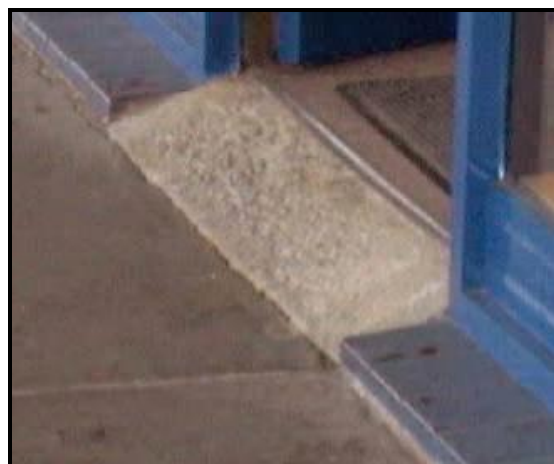
*Photo 5*

Photo 5 shows a threshold ramp that has a small lip at the top and no suitable treatment at the sides of the ramp, note the corner of the projecting tiles that can be trip hazards.

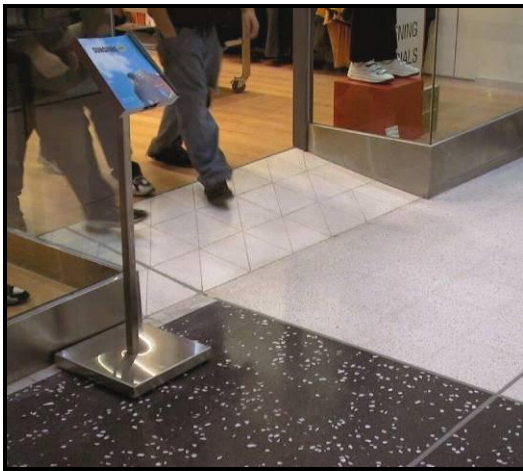
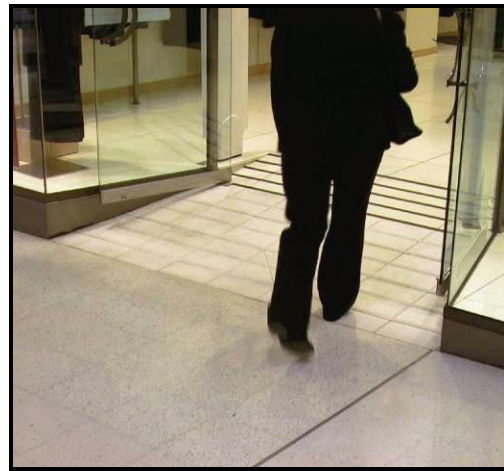
Both step ramps in photos 6 and 7 are at entrances to businesses that leave their doors open throughout business hours. Although there is no landing before the door these premises have implemented an alternative solution.

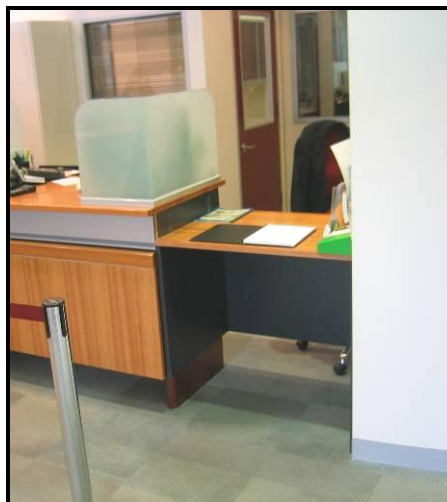
*Photo 1 shows a well-designed and constructed reception desk*

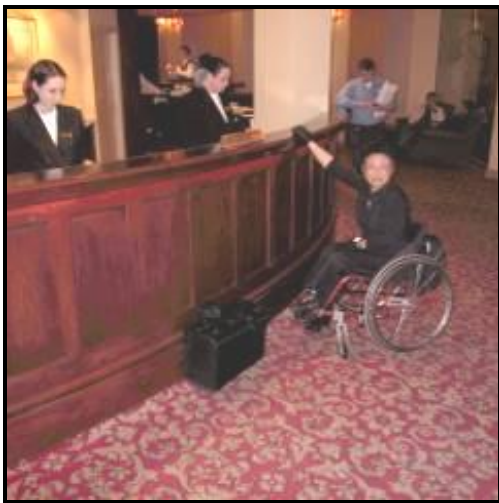
*Photo 2*

Photo 2 shows a recently refurbished hotel reception that could have had a section of the reception counter lowered and made accessible while maintaining the style and ambience.

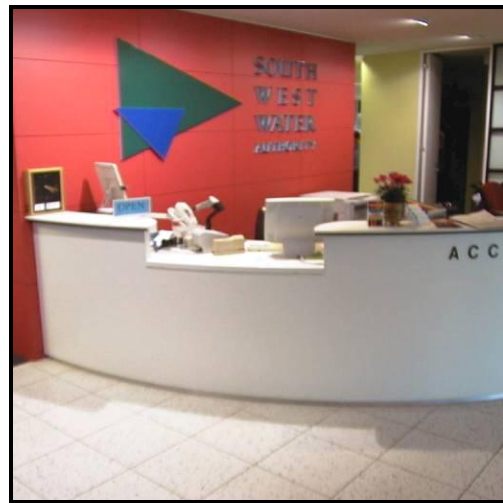
*Photo 3*

The counter in photo 3 has a lowered section but no provision is made for a frontal approach.

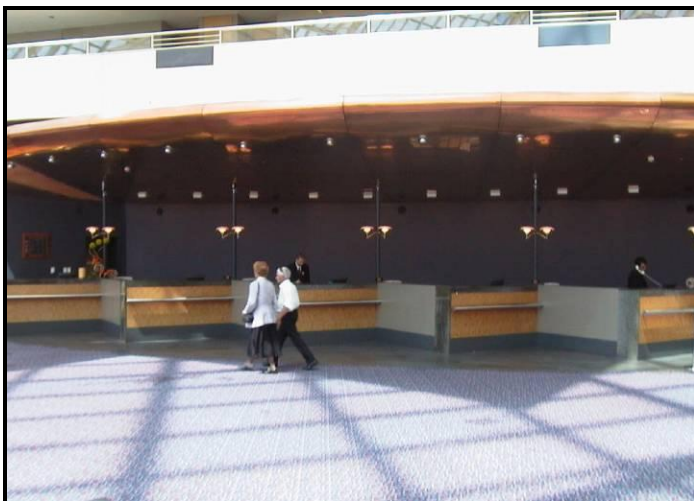
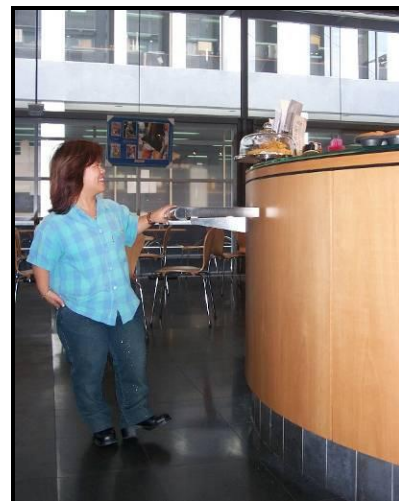
Photo 4 shows five reception counters of which one could have been made accessible. Photo 5 is a counter in a coffee shop that would only have needed the front section lowered to allow for ease of payment and receipt of goods.

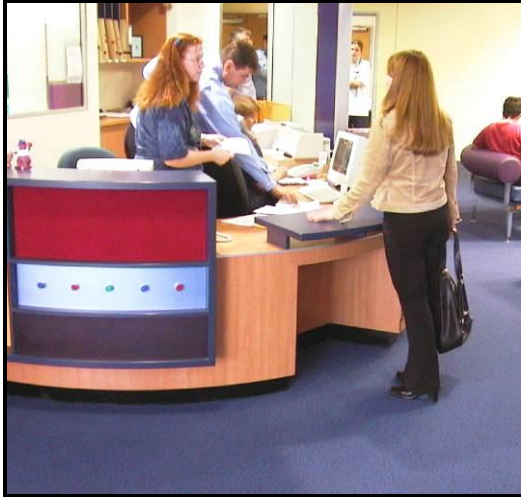
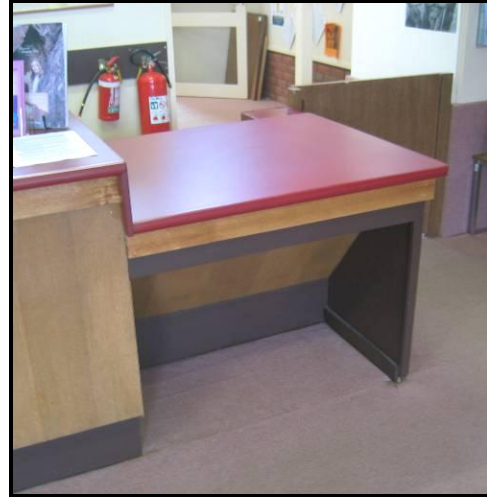
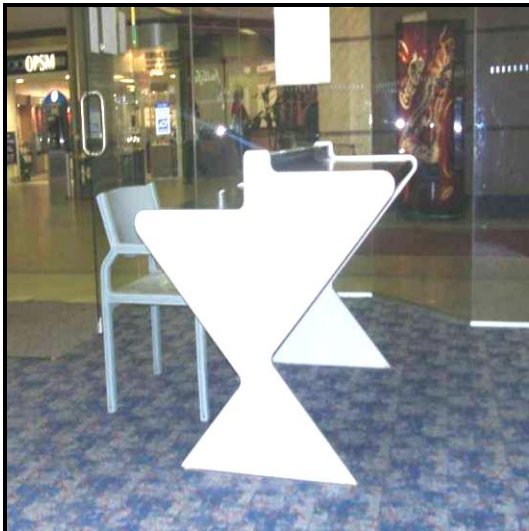
Photos 6, 7 and 8 show reception desks and counters that allow for a frontal approach with adequate toe plate and knee space and have a suitable surface height.

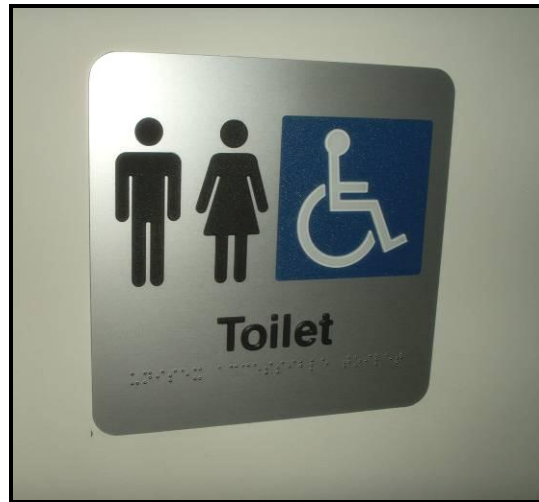
*Photo 1 shows clear signage for toilets*

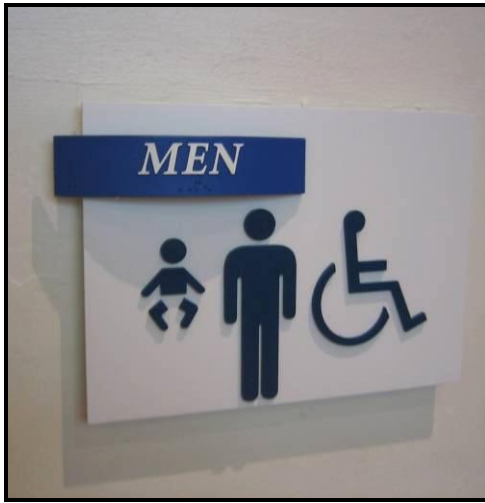
*Photo 2*

The signs in photos 2, 3 and 4 have all used incorrect fonts. The sign in photo 2 has used a serif type font and in upper case, which can make it difficult for people with a vision impairment to understand the sign due to the varying thicknesses in the font.

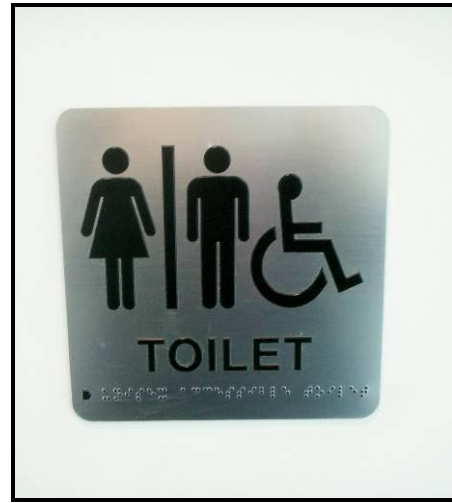
*Photo 3*

The sign in photo 3 has a line between the male and female figures, which indicates a separate accessible facility for each gender. Accessible facilities must always be non-gender specific to enable a male occupant and their female carer or assistant (or visa versa) to enter an accessible facility through a non specific gender area.

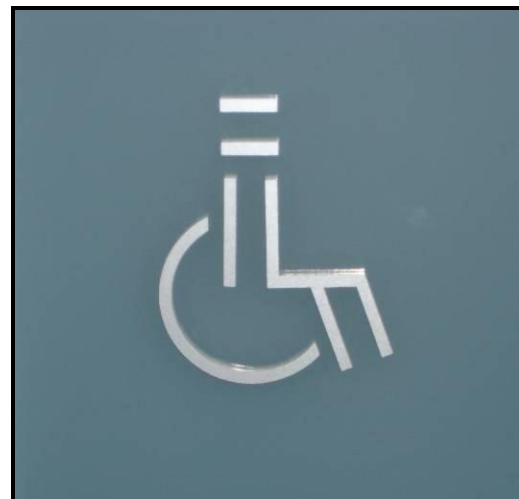
*Photo 5*

Photo 5 shows a stylized version which may be quite unrecognizable by many people with cognitive or intellectual disabilities.

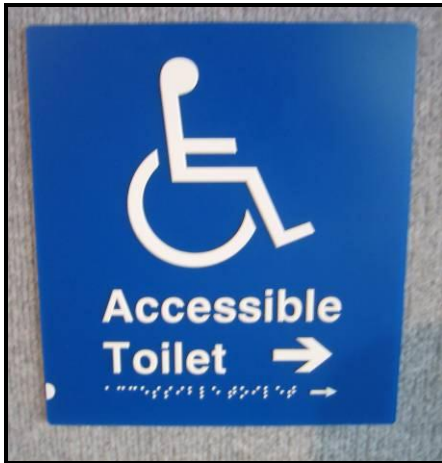
*Photo 6*

Both signs in photos 6 and 7 have used the correct symbol and colours for disability and required font styles along with the Braille. Note: the arrow on the sign has been repeated in the Braille section of the signs.

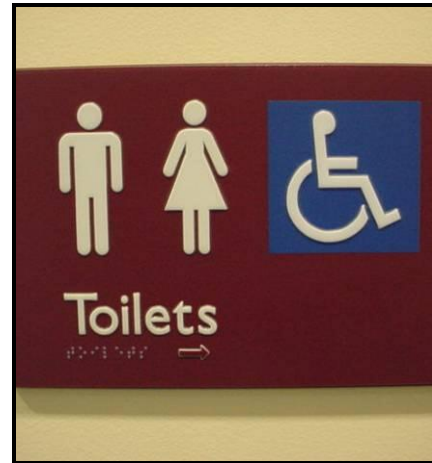
*Photo 7*

Photo 7 shows the correct symbols to be used identifying a unisex accessible facility without a dividing line between the male and female figures.

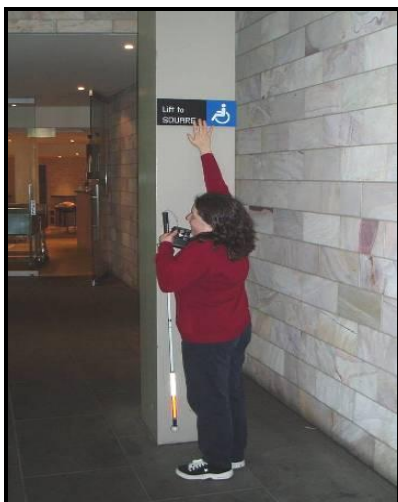
*Photo 8*

The sign in photo 8 is definitely too high being outside the 1200mm to 1600mm range above the finished floor level required by AS 1428.1. People in a seated position in a wheelchair may not be able to tilt their head back on an angle to read a sign higher than 1600mm above the finished floor level due to their disability.

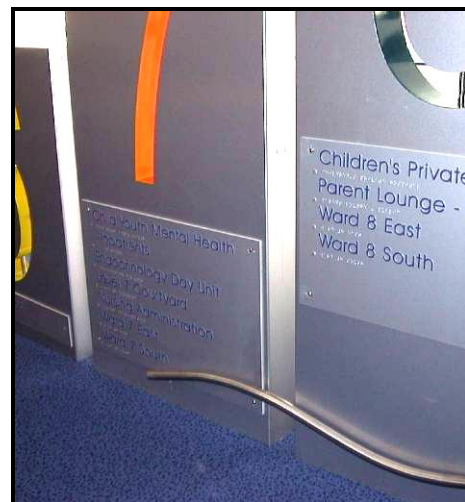
*Photo 9*

The sign in photo 9 is definitely too low as it would not be possible for a person to read the Braille unless they were laying on the ground.

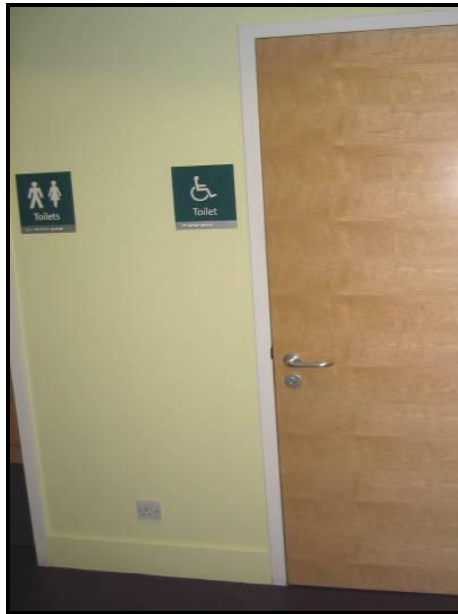
*Photo 10*

The sign in photo 10 is within the correct height range, which allows it to be read in relative comfort by all members of the community.

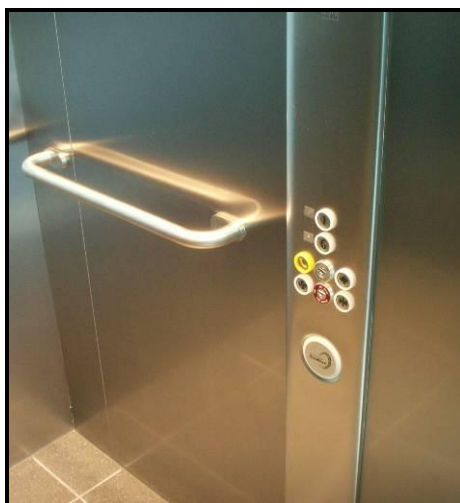
*Photo 1 shows good position for control buttons*

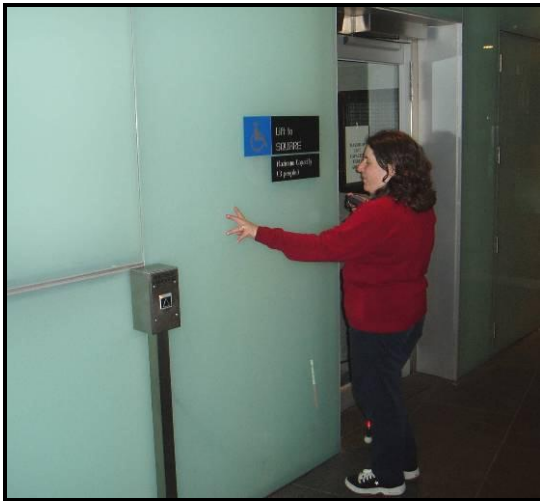
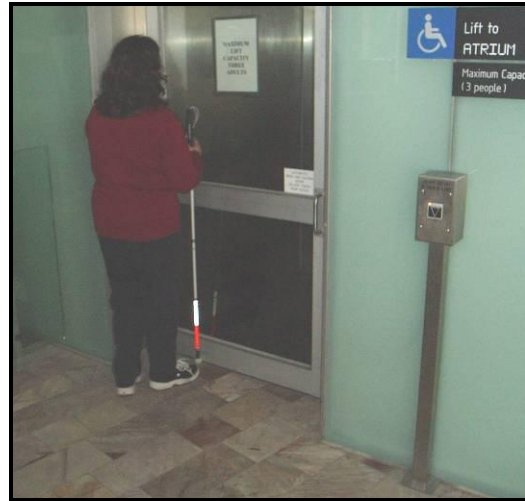
Photos 2 and 3 show the call buttons for the same lift at different locations on each floor and too far away from the lift, which makes them difficult to locate for a person who is blind or vision impaired.

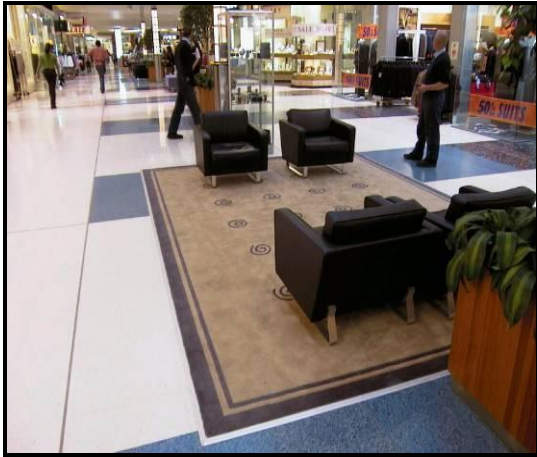
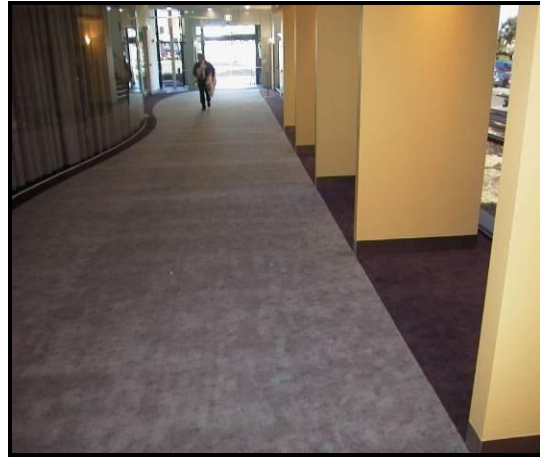
Photos 6 and 7 show floor coverings that are likely to meet the slip resistance requirements and do not produce excessive glare from overhead lighting.

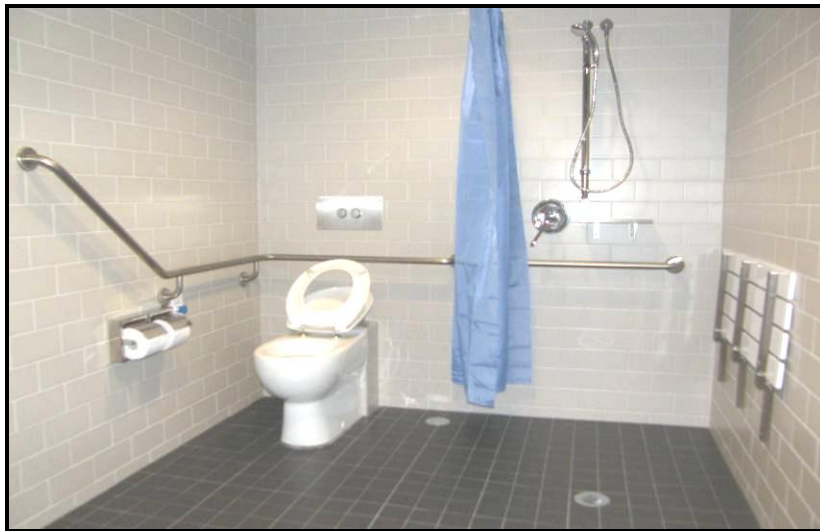
*Photo 1 shows a good example of correct installation of toilet and shower fittings*
