# توانای تیپه ریوون

ئەندازیار : ئارام سەلام

## WELCOME TO *The good, the bad and the ugly –* design and construction for access

The purpose of this resource is to explain how people with a disability benefit from good design and construction and why precise application of relevant technical specifications is necessary to achieve the greatest level of access for the greatest number of people.

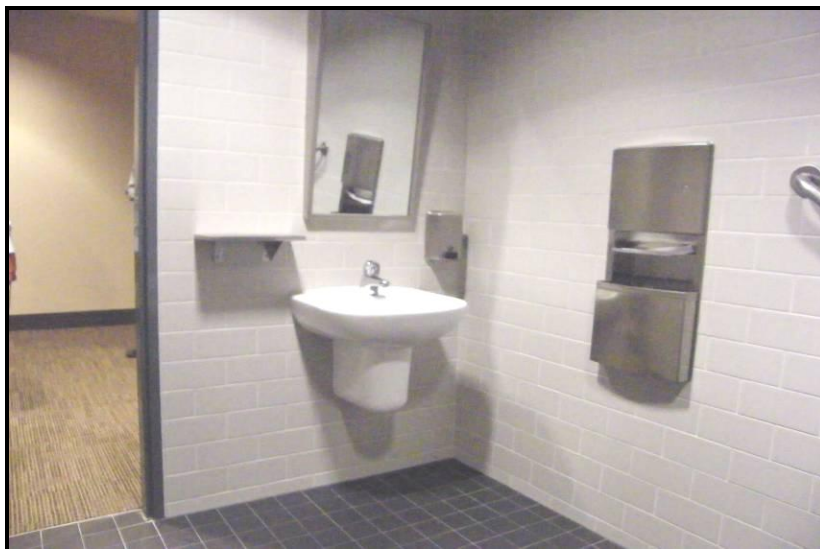
*Photo 2 shows a good example of the installation of a washbasin and other fittings, including a shelf as required by Table F2.4 of the BCA, note that tilt mirrors are not a requirement of AS1428.1.*

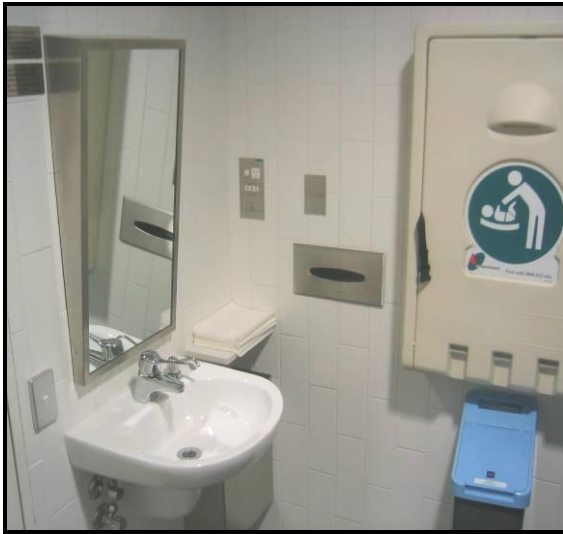
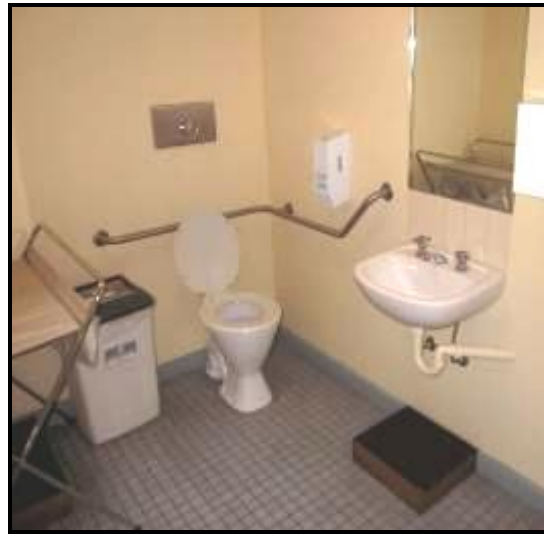
Photos 1 and 2 show intrusions into the required circulation space for the pan.

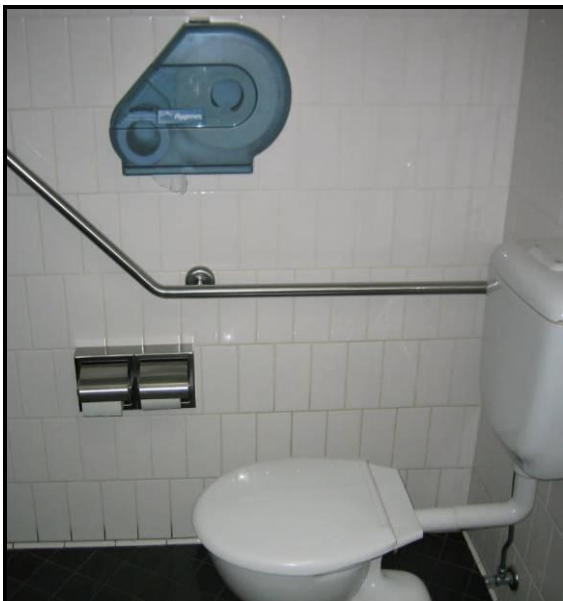
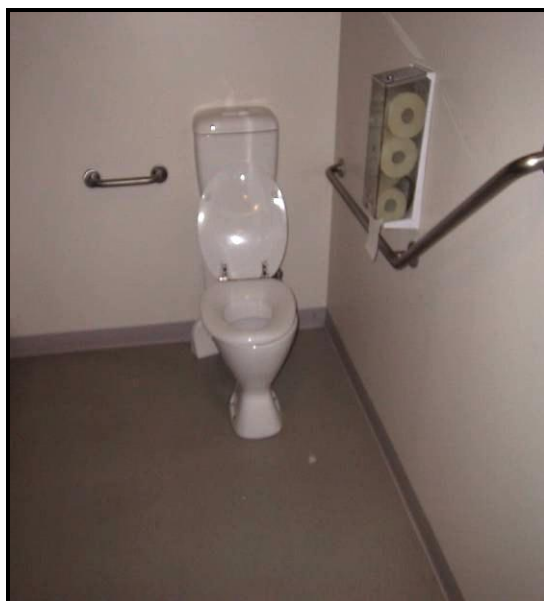
Photos 3 and 4 have a toilet paper holder above the grab rail, which does not allow users to take advantage of the side grab rail to use as support when rising from the pan.

their wheelchair. The toilet roll holders above the grab rails do not allow users to carry out this procedure.

Correct location of the toilet paper holder is below the grab rail as was originally designed for in photo 3.

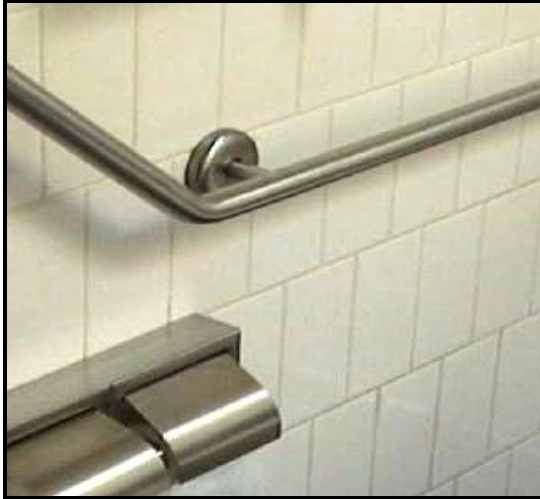
*Photo 5*

Photo 5 shows the wrong central fitting on the grab rail. They are attached to the side of the grab rail and not underneath it. The top 270° arc is required to be clear along the full length of the horizontal and 30° - 45° angled section of the rail. People have injured themselves when “grabbing” at the grab rail by catching their fingers on the central fixings.

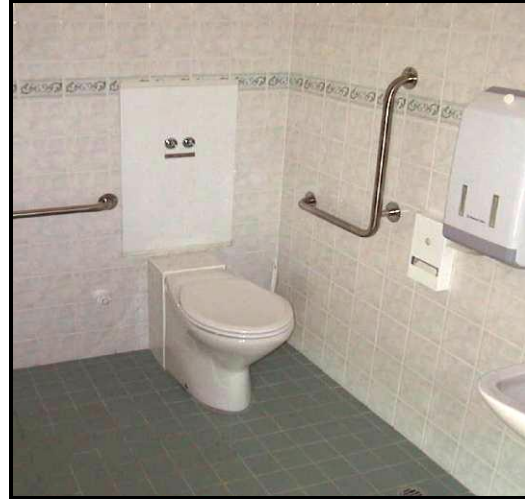
*Photo 6*

Photo 6 shows the toilet paper fixture too far from the front of the pan, which requires users to lean forward to get the paper. People with limited upper trunk control may and have fallen off the pan whilst reaching for the paper in this location.

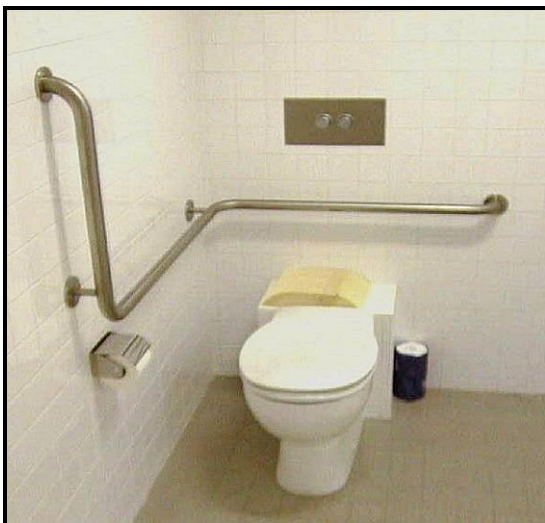
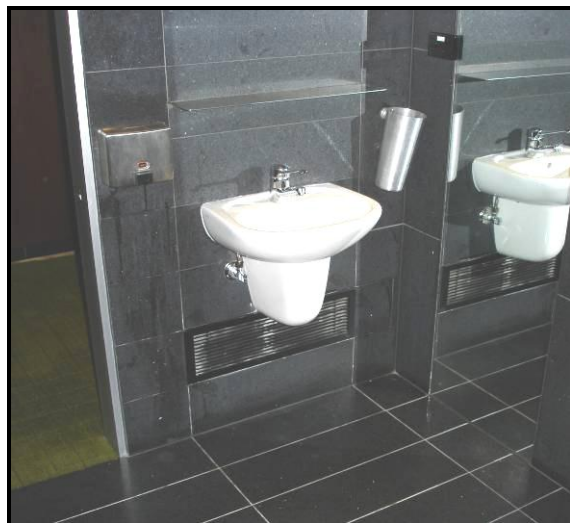
Photo 7 shows the correct location for the toilet roll holder and photo 8 shows the required minimum 300mm for the basin from the swing of the door thereby allowing enough circulation space at the door to open it when exiting.

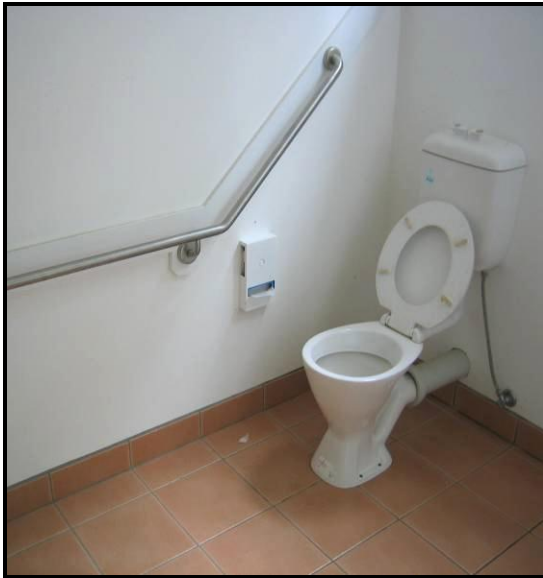
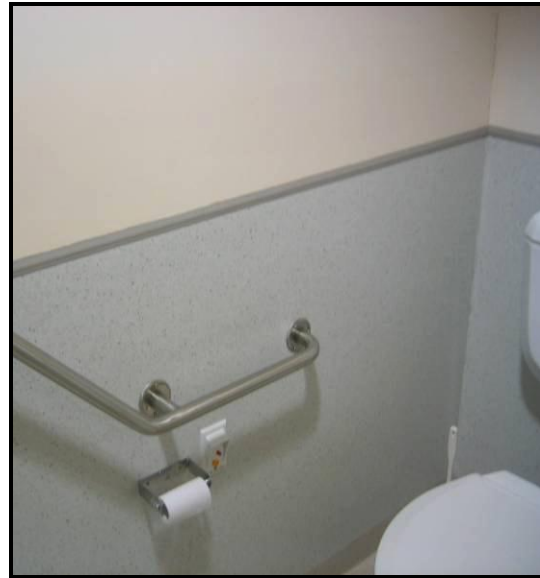
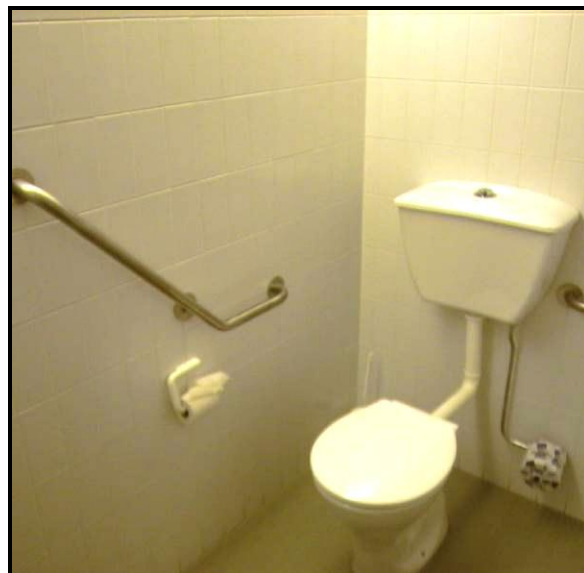
Photo 9 shows the handrail fitted totally the wrong way round and photos 10 and 11 have incorrect grab rails fitted as they do not extend back to within 50 - 60mm from the rear wall.

When carrying out a frontal transfer onto the pan, a person will pull themselves onto the pan by stretching out their arm to gain maximum purchase on the rail and then pull themselves forward.

If the grab rail does not extend back to within the 50 - 60mm from the rear wall they will not be able to comfortably pull themselves forward onto the pan as their purchasing power drops off when their arm is in the bent position.

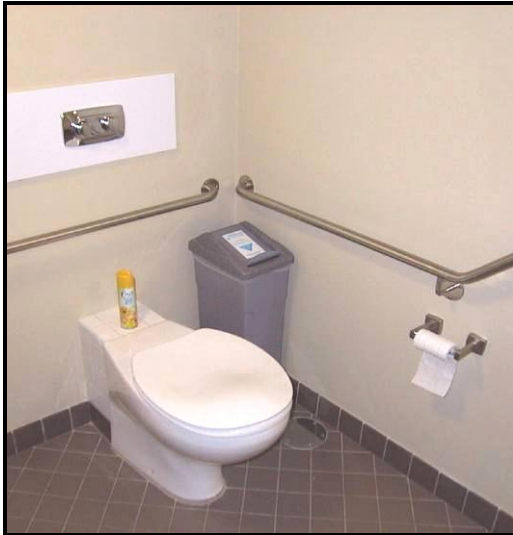
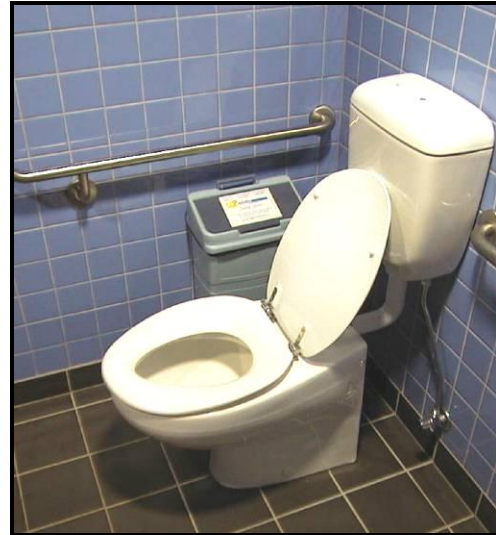
Photos 12 and 13 show correct type of grab rail used and fixed within 50 – 60mm of rear wall.

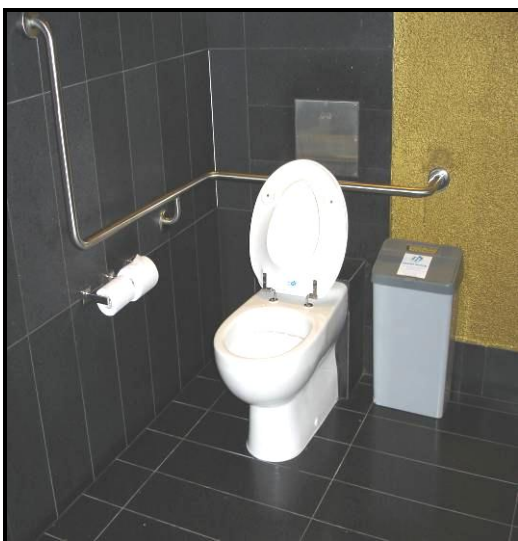
*Photo 14*

Photo 14 shows a sanitary napkin bin, which should be in the corner at the rear of the pan. The bins cannot be moved by many of the users of these facilities, if they do try to move them it is likely that they may be knocked over. Their positioning restricts those users who wish to carry out a side transfer to the pan.

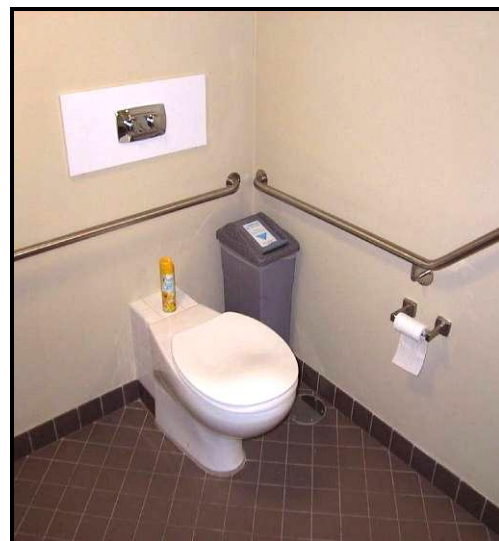
*Photo 15*

The bin in photo 15 is placed in the corner out of the way of users who can now carry out side, frontal or half frontal transfers without difficulty whilst also allowing the bin to be within reach of the pan.

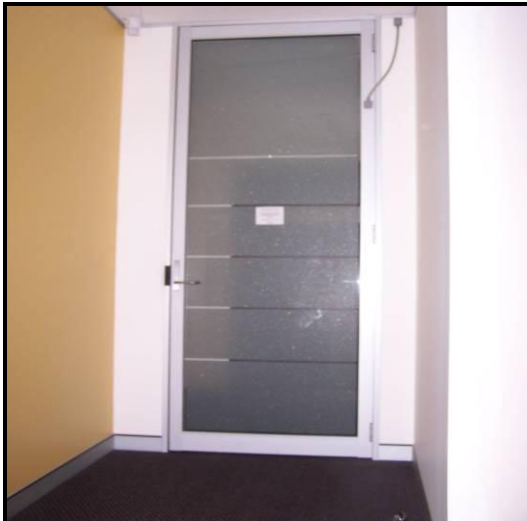
*Photo 1*

While in Photo 1 it appears that the approach to the door is sufficient to allow for a 470mm nib wall on the door latch side for a front-on approach the installation of the door did not allow adequate area for a latch side nib wall. As

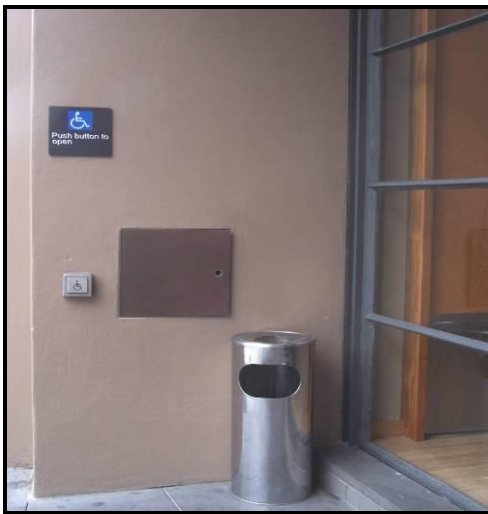
*Photo 3*

Photos 3 and 4 below illustrate an alternative solution applied to an entrance door to an existing building where a ramp has been installed and the landing was too small to provide the required circulation space for the side-on approach to a door swinging towards the user.

Photo 3 shows the push button control and signage as the door is approached and photo 4 shows the door opened by the powered door opener which in this instance is held open for approximately 15 seconds.

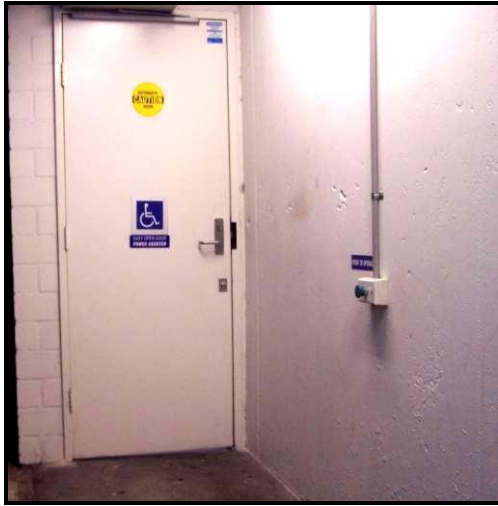
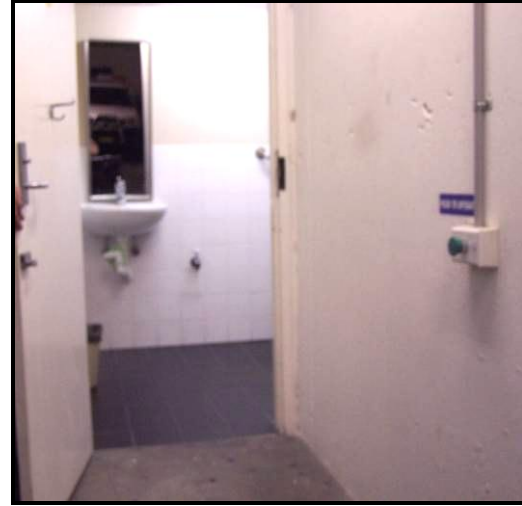
Photos 5 and 6 below illustrate an alternative solution applied to a door to a unisex accessible toilet within an existing building.

Photo 5 shows the nib wall on the latch side is significantly less than the 470mm minimum required circulation space for the front-on approach to a door swinging towards the user. The push button control on the right of photo 5 is correctly located beyond the swing arc of the door. Photo 6 shows the door automatically opened to allow for easy access.
