Cracks

Cracks in Concrete

FOUNDATION CRACK EVALUATION - How to Inspect & Evaluate Building Foundation Cracks & Movement & Foundation Crack Patterns

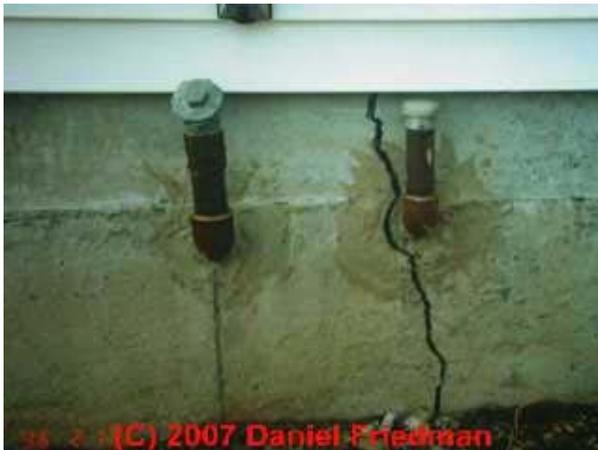
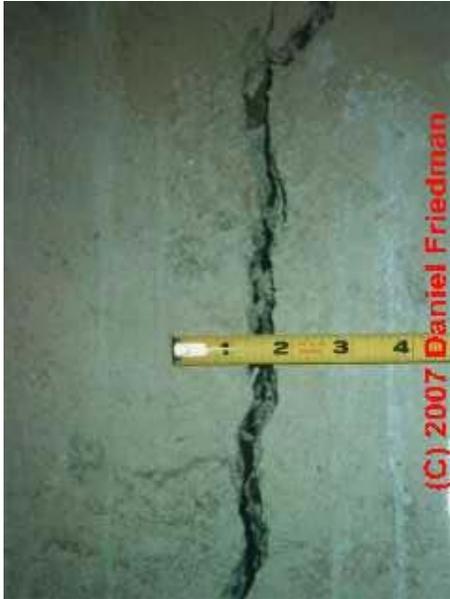
In the photos shown here, substantive cracks appeared and continued to increase in size in this poured concrete foundation used to support a modular home which had recently been completed. The cracks and foundation movement were probably due to a combination of: poorly prepared foundation footings, blasting on an adjacent building lot to prepare that site for new construction, and possibly omission of steel reinforcement in the poured wall.

The cracks in this building foundation wall were visible shortly after construction as vertical hairline openings (less than 1/16" wide) in the right hand foundation wall, above grade and inside in the basement. Within a year the owner reported several times that the cracks were becoming noticeably wider.

A careful inspection of the building interior suggested that the front foundation wall and portions of the right foundation wall were settling. There were no corresponding cracks in the finished surfaces of the structure, probably because this was very stiffly-framed modular construction. Notwithstanding the absence of damage upstairs, this was a problem that deserved further evaluation and repairs. The builder may have repaired the foundation by supporting it from below using one of the methods described at **FOUNDATION REPAIR METHODS**.

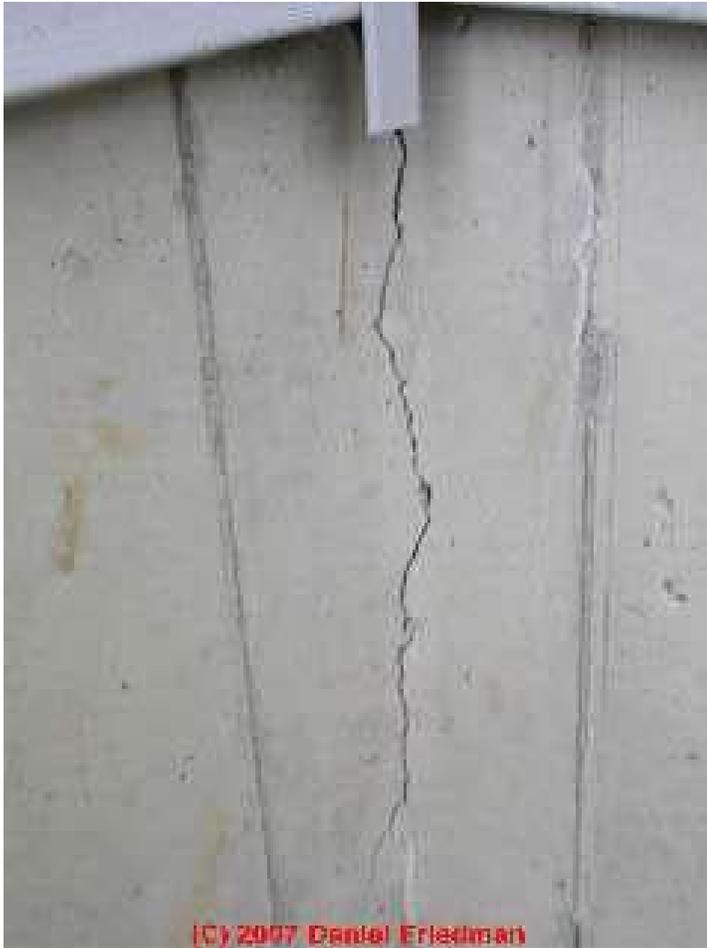
This settlement crack probably occurred during initial footing settlement. Notice that it is wider at the top than the bottom of the crack.

This suggests that the footing to the left or right of the crack has moved downwards; with further downwards movement as we move further from the crack itself.

If this is new construction and the crack does not change in width the site conditions may have stabilized.
